LISTING & GRADING OF HERITAGE BUILDINGS & PRECINCTS IN MUMBAI
TASK II: Review of Sr. No. 317 to 632 of the Heritage Regulations

369 RAGHAVJI ROAD PRECINCT

1.0		DENOMINATION
1.1	Name of Premises	Raghavji Road Precinct (8 buildings – Krishna Kunj, Rele Chambers, The Cliff, Hill View, Batrisi Bhavan, Rock View, Tulsi Mahal, Botiwala Building)

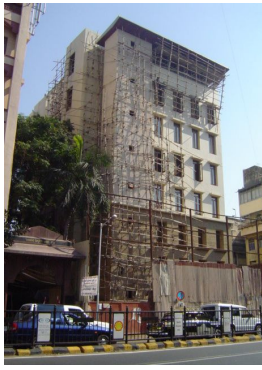
374 VASANT VILAS

1.0	DENOMINATION
1.1	Name of Premises Vasant Vilas
1.2	Earlier Name None
1.3	Built In Completely demolished and rebuilt in 2005
2.0	ACCESS ROADS
2.1	Main Babulnath Marg

12.0		ADDITIONAL NOTES/REFERENCES/DOCUMENTS AVAILABLE/RECOMMENDATIONS & SUGGESTIONS FOR IMPLEMENTATION
		The building has been completely demolished and rebuilt and therefore should be de-listed

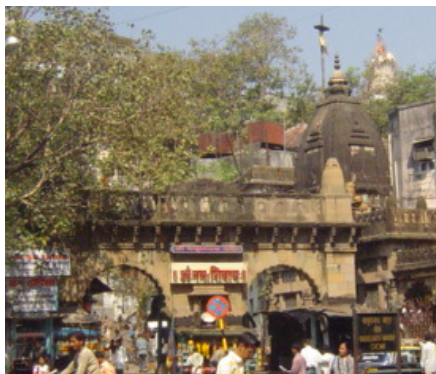
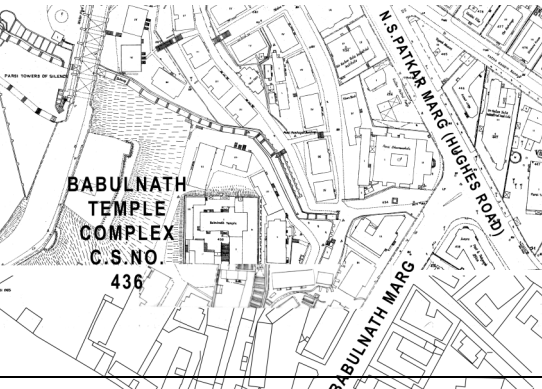
375 BABULNATH TEMPLE COMPLEX

1.0		DENOMINATION
1.1	Name of Premises	Babulnath Temple Complex
1.2	Earlier Name	Babulnath Mandir
1.3	Built In	Original shrine was built in 1780. Present temple building and chawls built in 1900 Extension Date(if any): None

7.7	Articulation	<p>Temple has decorative arches connecting columns; statues of idols crowning the arches and also above columns on the external façade; decorative cast iron hand rails; wooden gallery supported by carved stone brackets of the <i>sabhamandap</i>; steel columns of the gallery; temple annexe has steel and stone columns and decorative arches connecting them</p> <p>Office building has stained glass windows; projecting balconies on decorative stone beams; decorative cornices</p> <p>Pujaris residence wing has decorative timber brackets on first and second floors; decorative cast iron handrails</p> <p>Chawl has decorative timber brackets supporting balconies; stucco in lime concrete for the handrails of the central balconies; decorative cast iron hand rails</p>

8.6	Fire Precaution	No precautions taken
8.7	Other (HVAC/BMC/Security Systems)	None observed
9.0		CONDITION
9.1	Plinth	Plinth of the main temple and the temple annexe is intact; The plinth of office building, pujaris residence and chawl have discoloration of stone indicating some rising damp

9.2	Walls	The main temple wall has discoloration in some parts; office building, pujaris residence and chawl have dry moss on the facades
9.3	Floor	floor of the main temple, the annexe and the pujaris residence have no damage; Many portions of the floor of the chawl are damaged

9.4	Stairs	The cast iron stairs of the main temple show minor signs of corrosion. some of the treads of the staircase of the pujaris residence and chawls show wear and tear due to continuous usage

9.5	Openings	Some of the arched openings of main temple have cracks at the crown; most of the glass panels of the windows of the chawls on the side facades are broken; some of the frames of the openings in the pujaris residence broken; no damage recorded for the openings of the office building The doors and windows in the chawls are in need of restoration but fortunately retain most of the original design.

9.6	Roofing	No damage recorded for the roof of the main temple; steel members of the roof of the temple annexe are corroded; many of the wooden rafters and boards of the roof of the pujaris residence, chawl and the ground floor of the office building damaged; The rafters and battens of the pitched roof of the chawl damaged.

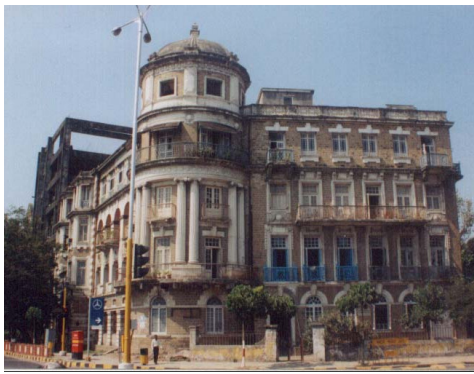
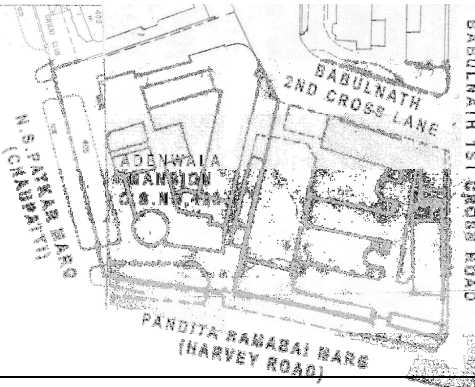
376 AGA KHAN GYMKHANA

1.0	DENOMINATION
1.1	Name of Premises Aga Khan Gymkhana /Adenwalla mansion (Suresh Bhavan)
1.2	Earlier Name Adenwalla Mansion
1.3	Built In Early 20 th century Extension Date(if any):

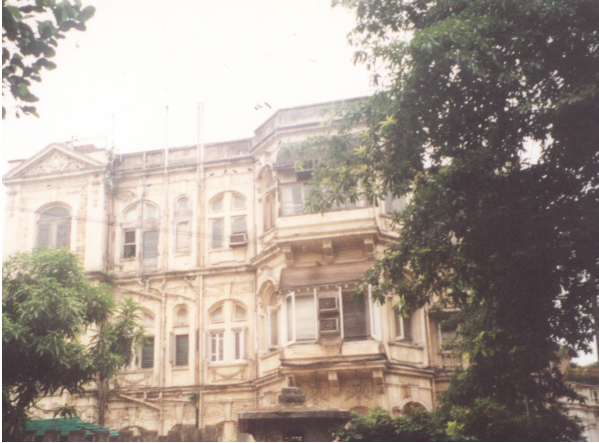
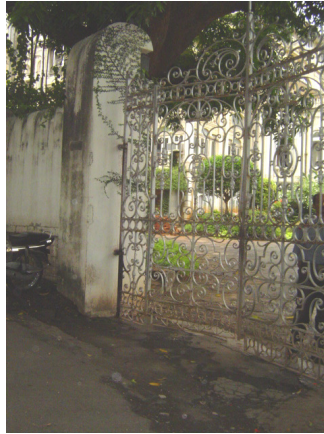
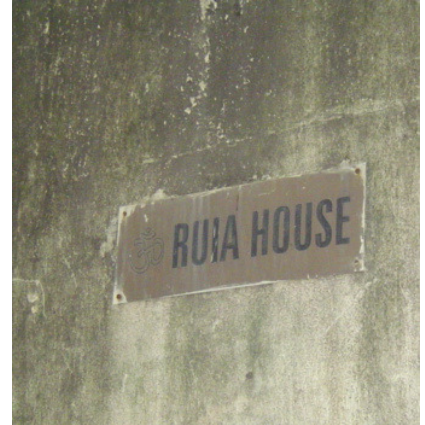
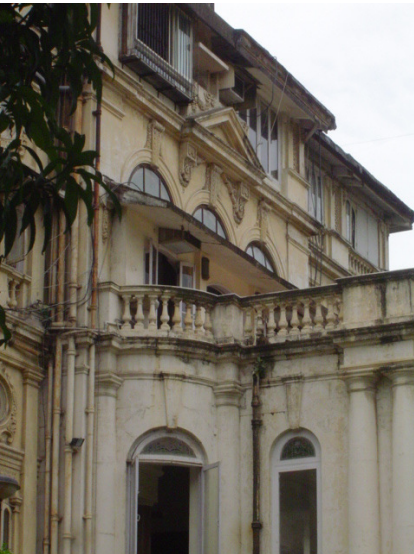
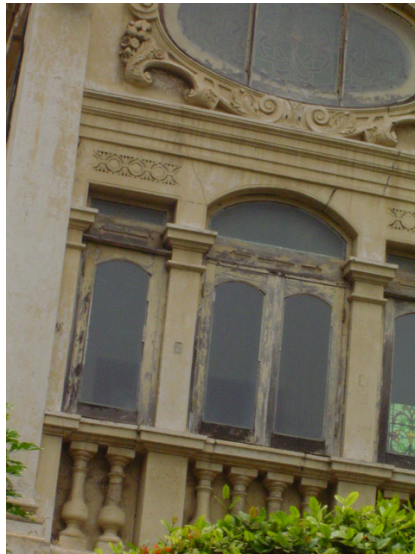
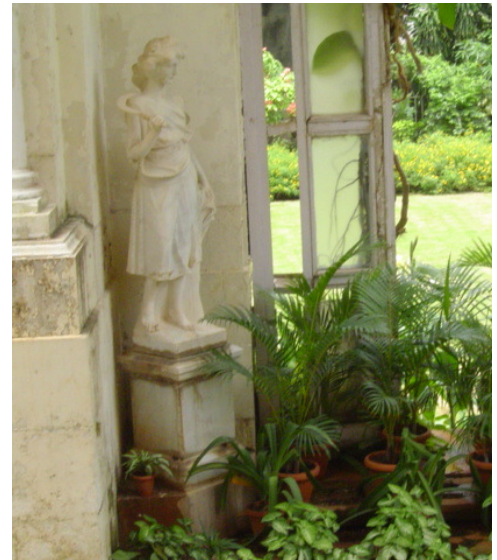
387	RUIA HOUSE	
		Neo-classical triangular pediments, decorative cornice bands, segmental arched openings with decorative keystones and architraves, decorative timber jhilmils, Neo-Classical entrance gate in wrought iron, oriel window with ornamentation around it and leaded stained glass, rustications emphasising corners, Italianate balustrades, Tuscan columns Internal Statuary in the garden, marble steps leading up to the entrance deck, Art deco entrance lobby with marble flooring in Art Deco designs.

5.2	Architectural Description	Built like a Neo-Classical mansion in a large sprawling garden, this mansion enjoys the serenity of the compound as it is set back from the main roads. The entrance gate on B.Hire Marg leads up to the porch of the main mansion through a tarred road. This ground plus two storied structure is built in a combination of buff coloured Malad basalt stone laid in ashlar masonry with detailing in white Porbandar lime stone. The mansion is characterised by the use of its Neo-Classical pediments, decorative cornice bands, oriel windows with decorative stained glass and ornamentation around it.

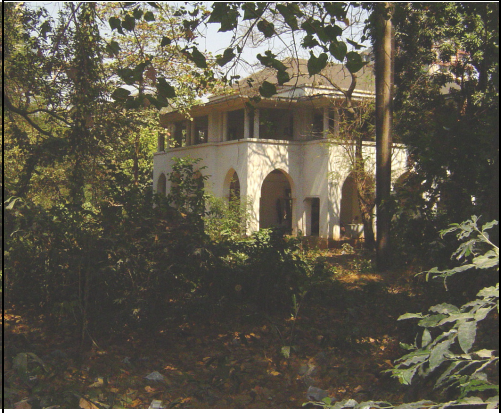
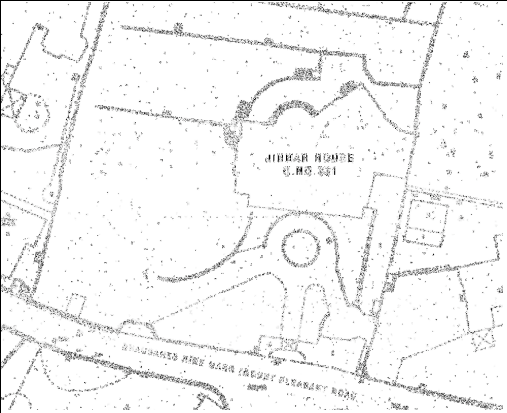
391 JINNAH HOUSE

1.0		DENOMINATION
1.1	Name of Premises	Jinnah House
1.2	Earlier Name	Jinnah House
1.3	Built In	Jinnah House was designed by the eminent architect, Claude Batley and completed in 1936. Mohammed Ali Jinnah personally supervised the construction of this house and lived here for several years until Independence. 1936 Extension Date (if any): None

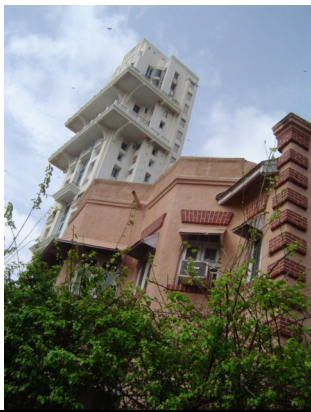
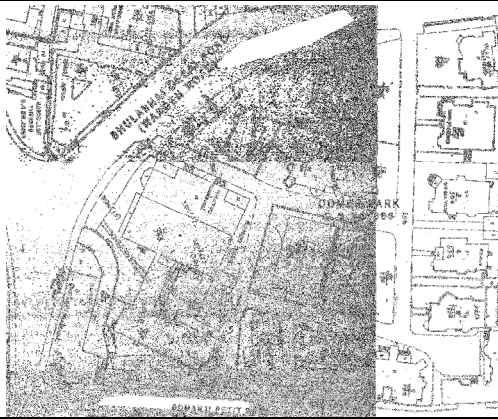
393 OOMER PARK COMPLEX

1.0		DENOMINATION
1.1	Name of Premises	Oomer Park Complex (10 buildings – Memoon Building, Gulshan Building, Nirmal Building, Azad, Husein Manor, American View, Anmol, Orion, Vijaya Vilas, Retreat)

11.0		DP REMARKS/PERCEIVED THREATS
		None
12.0		ADDITIONAL NOTES/REFERENCES/DOCUMENTS AVAILABLE/RECOMMENDATIONS & SUGGESTIONS FOR IMPLEMENTATION
		<p>The buildings of Oomer Park Complex came up during the building boom of the 1930s in Mumbai. The ensemble of structures exhibits styles like the Art Deco, Indo-Deco and Colonial-hybrid style that are archetypal of that period. The buildings along with their special features are of significant architectural value as a group.</p> <p>However, 2 buildings – Memoon Building (along Bhulabhai Desai Road) & Anmol have been rebuilt into modern concrete structures and need to be delisted.</p>

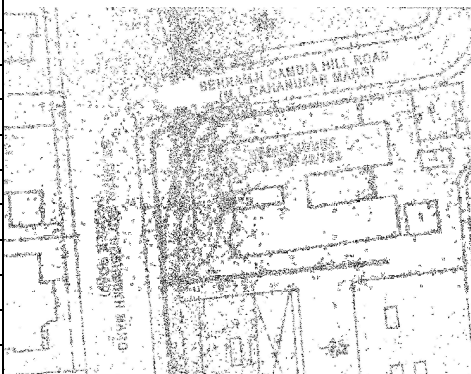
1.0		DENOMINATION	
1.1	Name of Premises	Eddie House	
1.2	Earlier Name	Eddie House	
1.3	Built In	1930s Extension Date(if any): None	
2.0		ACCESS ROADS	
2.1	Main	Dr. Gopalrao Deshmukh Marg (Pedder Road)

5.4	Value Classification	Existing Grade: Grade III Recommended Grade: Grade III A(arc), B(des), B(per)
6.0		TOPOGRAPHY
6.1	Floors	G+ 3 for the main building; two servants quarters, one with G + 2 and the other with G+1

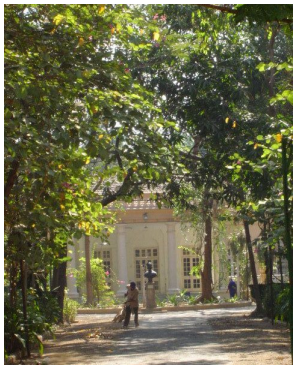
417	ADENWALLA BUNGALOW	
		façade of the building has full windows with glass panels Internal Building is not accessible
5.4	Value Classification	Existing Grade: Grade II B Recommended Grade : Grade II B A(arc) B(per) B (Des) G (grp)

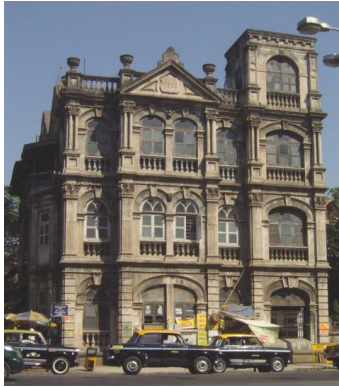
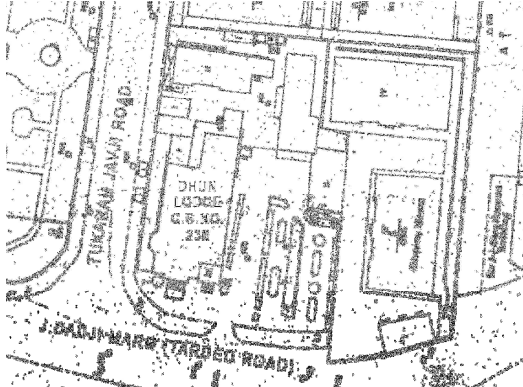
418	DHUN LODGE	
		<p>which is a room.</p> <p>Stylistic Classification The building is a typical Neo Classical residence, with ashlar stone masonry, pediments, Italianate balusters, arched openings with prominent keystones, rustication at the base floor and such typically Classical revival architectural detailing.</p>

5.3	Intrinsic	<p>Exterior The building has ashlar stone masonry, pediments, Italianate balusters, arched openings with prominent keystones, rustication at the base floor and such typically Classical revival architectural detailing.</p> <p>Interior The interior has timber staircase with teak wood handrails and banisters, patterned china mosaic and Bharat Tile flooring and quite a few remaining character defining elements.</p>
