Card No: 1		
	Ward (Part): C		
	CS No: 934, 935, 936		
	Plot Area: 560.1 m <sup>2</sup>		
	B U Area: 222.74 m <sup>2</sup>		
	Date: 27 June 2002		
	Record by: Urmi		
	Review by: Sanjay		
Int: Yes      Ext: Yes			
Photo. Ref: Album # 1, 2, 19			
<b>1.0 Denomination</b>

1.1	<b>Name of Premises</b>	Shriram Mandir	
1.2	<b>Earlier Name</b>	Shriram Mandir	
1.3	<b>Built In</b>	1812	
<b>2.0 Access</b>			
2.1	<b>Main</b>	On the west side from Ram Mandir road.

5.2	<b>Architectural Description</b>	The Shriram Mandir is the main structure of the temple complex and built adjacent to a water tank called Pushkarni/Pokhran/Kund. The temple and water tank are integral to each other, with the prayer hall of the temple overlooking the beautiful square Kund. The temple is a long single storied hipped sloping roof structure with the domed internal shrine ( <i>garbhagriha</i> ) and a <i>sabha mandap</i> (prayer hall) with overlooking gallery. The rectangular plan of the building is oriented in north-south direction. Carved wooden arches and colonnade in the prayer hall support the overlooking gallery. Externally the structure is patterned with floor to lintel level double shutter wooden windows at bot

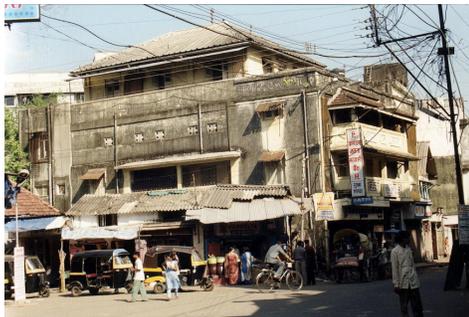
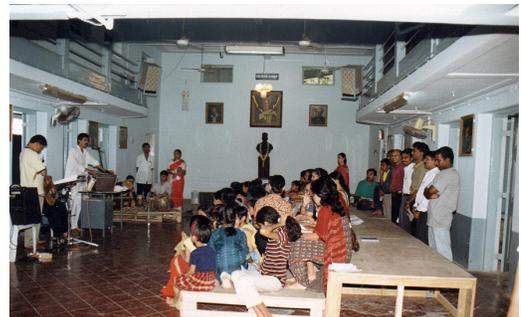
12.0		<b>Additional Photographs</b>

10.3	<b>Articulation &amp; Finishes</b>	None
11.0		<b>DP Remarks/Perceived Threats</b>
11.1	<b>Remarks</b>	None.
11.2	<b>Threats</b>	West and south façade will be demolished due to road widening.

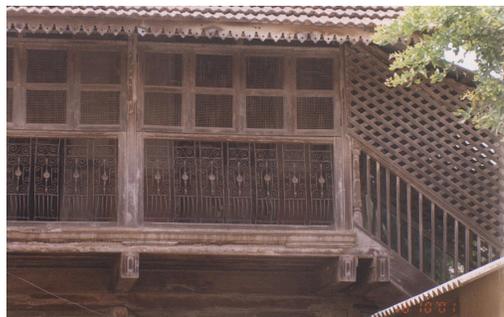
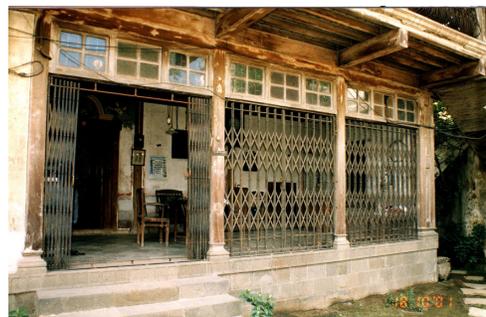
12.0		<b>Additional Photographs</b>

10.2	<b>Structure</b>	None
10.3	<b>Articulation &amp; Finishes</b>	None.
11.0		<b>DP Remarks/Perceived Threats</b>
11.1	<b>Remarks</b>	None.
11.2	<b>Threats</b>	The plot would be setback on the north side due to road widening and the entrance gate ( <i>dindi darwaaza</i> ) will be demolished

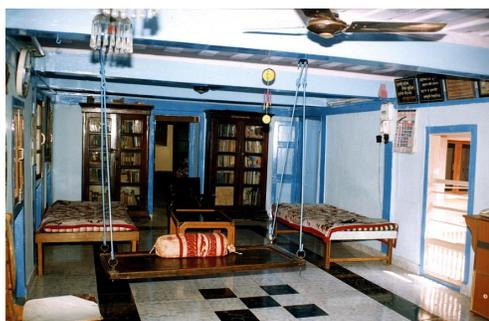
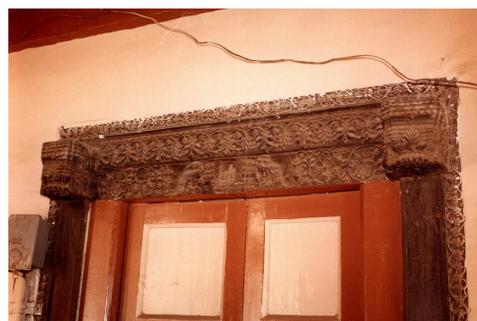
12.0		<b>Additional Photographs</b>

11.0		<b>DP Remarks/Perceived Threats</b>
11.1	<b>Remarks</b>	None.
11.2	<b>Threats</b>	The front western façade of the Wada will be demolished by road widening.

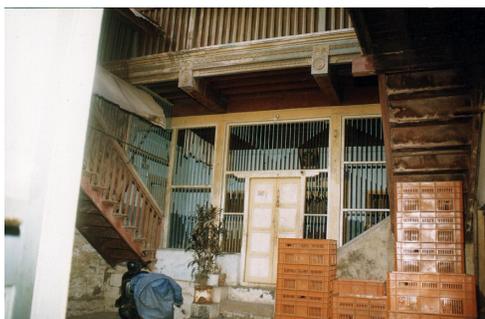
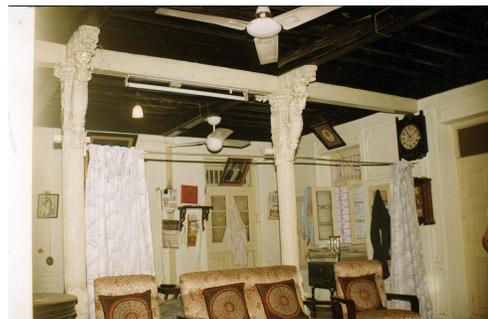
11.1	<b>Remarks</b>	None.
11.2	<b>Threats</b>	The northern side of the structure will be demolished by road widening.
12.0		<b>Additional Photographs</b>

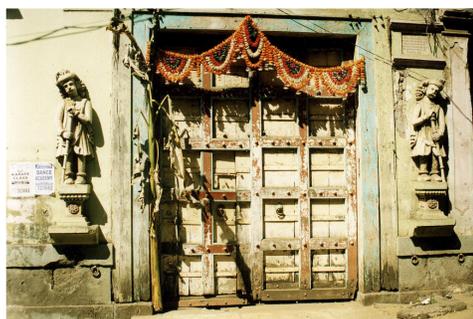
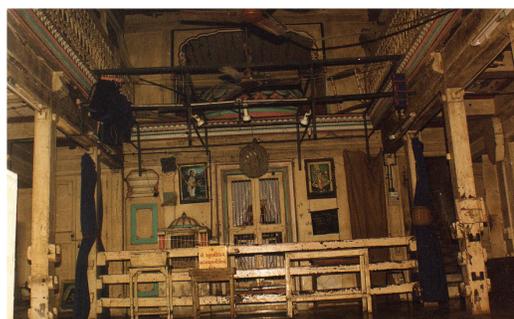
12.0	<b>Additional Photographs</b>

10.2	<b>Structure</b>	None
10.3	<b>Articulation &amp; Finishes</b>	None
11.0	<b>DP Remarks/Perceived Threats</b>	
11.1	<b>Remarks</b>	None.
11.2	<b>Threats</b>	None.

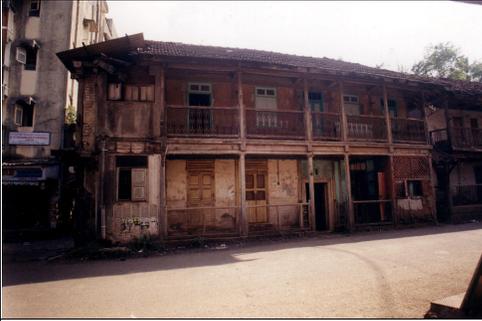
<b>Card No:</b> 25		
	<b>Ward (Part):</b> C		
	<b>CS No:</b> 857		
	<b>Plot Area:</b> 559.4 m <sup>2</sup>		
	<b>B U Area:</b> 489.99 m <sup>2</sup>		
	<b>Date:</b> 26 July 2002		
	<b>Record by:</b> Kushal		
	<b>Review by:</b> Urmi		
	<b>Int:</b> Yes <b>Ext:</b> Yes		
<b>Photo. Ref:</b> Album #1, 5			
<b>1.0</b>	<b>Denomination</b>		
<b>1.1</b>	<b>Name of Premises</b>	Phadke Wada	
<b>1.2</b>	<b>Earlier Name</b>	Oak Wada	
<b>1.3</b>	<b>Built In</b>	1800	
<b>2.0</b>	<b>Access</b>		
<b>2.1</b>	<b>Main</b>	On the north side from Bapusaheb Phadke road.	
<b>2.2</b>	<b>Subsidiary</b>	Two entries from open space on the west side.	
<b>3.0</b>	<b>Ownership pattern</b>		
<b>3.1</b>	<b>Present</b>	Private	
<b>3.2</b>	<b>Past</b>	Private	
<b>3.3</b>	<b>Status</b>	Owner	
<b>4.0</b>	<b>Use</b>		
<b>4.1</b>	<b>Present</b>	Residence	
<b>4.2</b>	<b>Past</b>	Residence	
<b>4.2</b>	<b>Usage</b>	Daily

<b>5.0</b>	<b>Significance &amp; Value Classification</b>		
<b>5.1</b>	<b>Townscape (Manmade)</b>	It is a typical Wada abutting Bapusaheb Phadke road. The house with the central court and its main entrance are oriented towards north direction.	
<b>5.2</b>	<b>Architectural Description</b>	It is a single storied sloping roof structure with rooms arranged in 'C' shape plan overlooking the entrance courtyard. The character of the entrance courtyard is further enhanced by the graceful floor to lintel level windows with railing and <i>jaffery</i> (jali) paneling around the openings. Exposed timber columns and beams with decorative brackets augment this simple Wada. The rear courtyard has a well and a <i>tulsi vrindavan</i> .	
<b>5.3</b>	<b>Intrinsic</b>	This Wada was owned by of Sardar Bhatkhande in 1812; then bought by Oak of Badlapur in 1850/60; and then went to Phadke in 1940. All the owners of this Wada have contributed to economical, social, political and educational activities in Kalyan. Prabhakar Nana Oak, the resident of this house organized Sarwajanak Ganesh Utsav in 1895. He was classmate of Morarji Desai, late PM of India; president of Kalyan Corporation and an active individual, Bapusaheb Oak stayed in this Wada between 1894-1967. For 40 years the Late G. K. Phadke led the socio-political activities in Kalyan from this Wada. He was MLC in 1937. Pandit Nehru had visited here for a meeting in 1936. His wife Saraswatibai was also a dedicated social worker and carried numerous social activities from here. This Wada has been witness to the origin of various social activities like women's association, education, local politics etc.

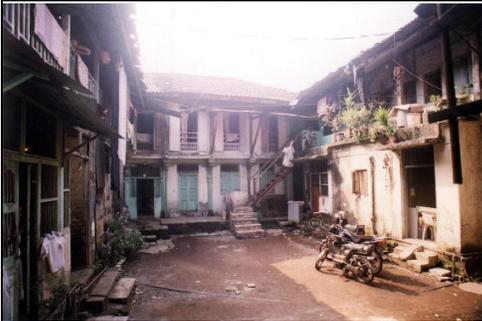
<b>Card No:</b> 26		
	<b>Ward (Part):</b> C		
	<b>CS No:</b> 804- 812, 814, 815A 829.		
	<b>Plot Area:</b> 930.39 m <sup>2</sup>		
	<b>B U Area:</b> Access denied		
	<b>Date:</b> 24 September 2002		
	<b>Record by:</b> Urmi		
	<b>Review by:</b> Sanjay		
	<b>Int:</b> Yes <b>Ext:</b> Yes		
<b>Photo. Ref:</b> Album # 5			
<b>1.0 Denomination</b>

1.1	<b>Name of Premises</b>	Apte Wada	<b>Note:</b> Access denied in Stage II.
1.2	<b>Earlier Name</b>	Apte Wada	
1.3	<b>Built In</b>	Around 18 <sup>th</sup> century	
<b>2.0 Access</b>

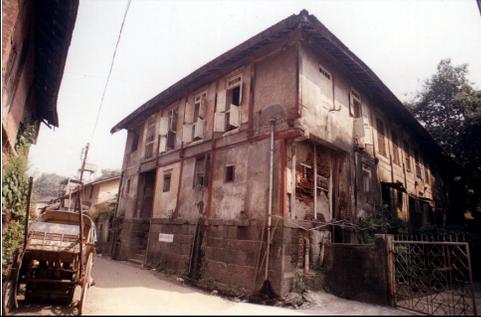
<b>Card No:</b> 27		
	<b>Ward (Part):</b> C		
	<b>CS No:</b> 1259		
	<b>Plot Area:</b> 412.2 m <sup>2</sup>		
	<b>B U Area:</b> 422.04 m <sup>2</sup>		
	<b>Date:</b> 25 July 2002		
	<b>Record by:</b> Urmi		
	<b>Review by:</b> Sanjay		
	<b>Int:</b> Yes <b>Ext:</b> Yes		
<b>Photo. Ref:</b> Album # 5			
<b>1.0</b>	<b>Denomination</b>		
<b>1.1</b>	<b>Name of Premises</b>	Gupte Wada	
<b>1.2</b>	<b>Earlier Name</b>	Dr. Gupte Wada	
<b>1.3</b>	<b>Built In</b>	19 <sup>th</sup> century.	
<b>2.0</b>	<b>Access</b>		
<b>2.1</b>	<b>Main</b>	On the west side from Bazaar Peth road.	
<b>2.2</b>	<b>Subsidiary</b>	On the east side, near Marathi school.	
<b>3.0</b>	<b>Ownership pattern</b>		
<b>3.1</b>	<b>Present</b>	Private	
<b>3.2</b>	<b>Past</b>	Private	
<b>3.3</b>	<b>Status</b>	Private	
<b>4.0</b>	<b>Use</b>		
<b>4.1</b>	<b>Present</b>	Residence	
<b>4.2</b>	<b>Past</b>	Residence

<b>4.2</b>	<b>Usage</b>	Daily	
<b>5.0</b>	<b>Significance &amp; Value Classification</b>		
<b>5.1</b>	<b>Townscape (Manmade)</b>	It is a Wada abutting the Bazaar Peth road.	
<b>5.2</b>	<b>Architectural Description</b>	It is a ground and upper storey 'C' shaped structure around a courtyard. It has a rear courtyard with a well and <i>tulsi vrindavan</i> . The house and its main entrance are oriented towards west direction. Ornamental niches in brick walls are also a distinct feature of this Wada; typical to the several Wada's in this region.	
<b>5.3</b>	<b>Intrinsic</b>	The Wada was owned by Phadke and later by Dr. Gupte, who was a well-known Gynaecologist. He was member of the Municipal Corporation for a number of years. It is believed that there was a post office for quite a few years in this Wada. Gopalrao, husband of Dr. Anand Gopal Joshi was an employee in this post office.	
<b>5.4</b>	<b>Value Classification</b>	HIS/USE/PER/CRF <b>Recommended Grade: III</b>

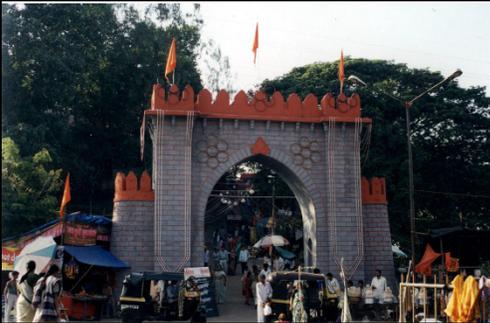
<b>Card No:</b> 28		
	<b>Ward (Part):</b> C		
	<b>CS No:</b> 338		
	<b>Plot Area:</b> 10150 m <sup>2</sup>		
	<b>B U Area: Of Temple:</b> 64 m <sup>2</sup>		
	<b>Date:</b> 1 September 2002		
	<b>Record by:</b> Paresh		
	<b>Review by:</b> Urmi		
	<b>Int:</b> Yes <b>Ext:</b> Yes		
<b>Photo. Ref:</b> Album # 9,14,22			
<b>1.0 Denomination</b>

1.1	<b>Name of Premises</b>	Durgadi Fort	
1.2	<b>Earlier Name</b>	Durgadi	
1.3	<b>Built In</b>	17 <sup>th</sup> century	
<b>2.0 Access</b>			
2.1	<b>Main</b>	From Bhivandi Murbad road, on the east side

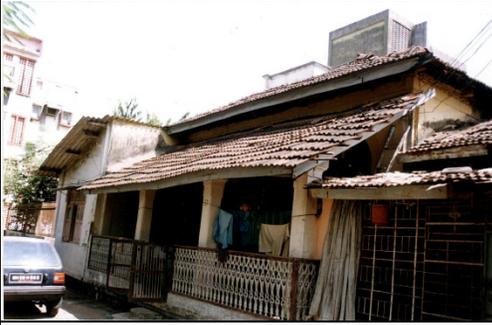
Card No: 31		
	Ward (Part): C		
	CS No: 613		
	Plot Area: 107.0 m <sup>2</sup>		
	B U Area: Access denied		
	Date: 24 September 2002		
	Record by: Urmi		
Review by: Sanjay			
Int: No                      Ext: Yes			
Photo. Ref: Album # 20			
<b>1.0 Denomination</b>

1.1 Name of Premises	Chaudhary House	<b>Note:</b> Access denied in Stage II.	
1.2 Earlier Name	Chaudhary House		
1.3 Built In	17 <sup>th</sup> century		
<b>2.0 Access</b>

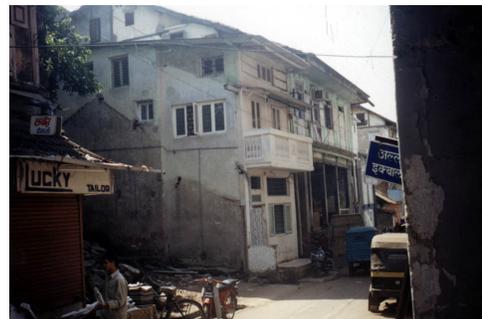
<b>Card No:</b> 34		
	<b>Ward (Part):</b> C		
	<b>CS No:</b> 153		
	<b>Plot Area:</b> 125.8 m <sup>2</sup>		
	<b>B U Area:</b> Access denied		
	<b>Date:</b> 24 September 2002		
	<b>Record by:</b> Urmi		
	<b>Review by:</b> Sanjay		
	<b>Int:</b> No <b>Ext:</b> Yes		
<b>Photo. Ref:</b> Album # 9			
<b>1.0 Denomination</b>

1.1	<b>Name of Premises</b>	Fangari House	<b>Note:</b> Access denied in stage II.
1.2	<b>Earlier Name</b>	Not available	
1.3	<b>Built In</b>	Not available	
<b>2.0 Access</b>

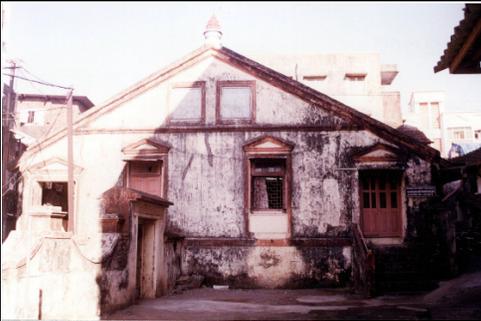
<b>Card No:</b> 35		
	<b>Ward (Part):</b> C		
	<b>CS No:</b> 178		
	<b>Plot Area:</b> 872 m <sup>2</sup>		
	<b>B U Area:</b> 307.61m <sup>2</sup>		
	<b>Date:</b> 2 September 2002		
	<b>Record by:</b> Paresh		
	<b>Review by:</b> Urmi		
	<b>Int:</b> No <b>Ext:</b> Yes		
<b>Photo. Ref:</b> Album # 7,8			
<b>1.0</b>	<b>Denomination</b>		
<b>1.1</b>	<b>Name of Premises</b>	Parsi Agiary	
<b>1.2</b>	<b>Earlier Name</b>	Parsi Agiary	
<b>1.3</b>	<b>Built In</b>	19 <sup>th</sup> century	
<b>2.0</b>	<b>Access</b>		
<b>2.1</b>	<b>Main</b>	On the west side, from Agiary road.	
<b>2.2</b>	<b>Subsidiary</b>	On the north side of the Agiary.	
<b>3.0</b>	<b>Ownership pattern</b>		
<b>3.1</b>	<b>Present</b>	Parsi Panchayat	
<b>3.2</b>	<b>Past</b>	Parsi Panchayat	
<b>3.3</b>	<b>Status</b>	Trust	
<b>4.0</b>	<b>Use</b>		
<b>4.1</b>	<b>Present</b>	Religious	
<b>4.2</b>	<b>Past</b>	Religious

<b>4.2</b>	<b>Usage</b>	Daily	
<b>5.0</b>	<b>Significance &amp; Value Classification</b>		
<b>5.1</b>	<b>Townscape (Manmade)</b>	It is an important religious structure of the Parsi community surrounded by residential apartments belonging to the families of the community. The main gate abuts the Agiary road on the west side.	
<b>5.2</b>	<b>Architectural Description</b>	The fire temple is a single storeyed structure with verandahs on two sides of the central altar. The complex also has two newly constructed residential apartments and a well in the front yard.	
<b>5.3</b>	<b>Intrinsic</b>	Parsi's resided in Kalyan since quite a long time, perhaps from 9th to 10th century. Kalyan may have been an ideal choice considering its inland location and defence security on the western coast of India. This Agiary is located near the creek and Parsi community resides in its vicinity. Hence this area is known as the 'Parsi Galli'. This Agiary was built in 1788 by Edulji Byramji and is still used by the Parsi community.

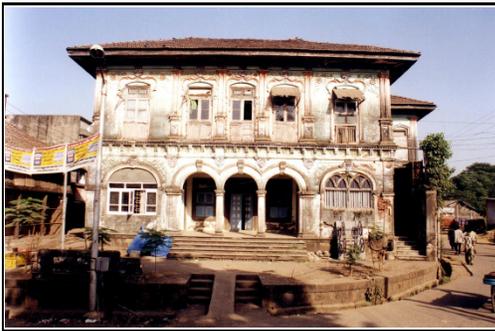
<b>Card No:</b> 37	
	<b>Ward (Part):</b> C	
	<b>CS No:</b> 87	
	<b>Plot Area:</b> 384.6 m <sup>2</sup>	
	<b>B U Area:</b> Access denied	
	<b>Date:</b> 24 September 2002	
	<b>Record by:</b> Urmi	
	<b>Review by:</b> Sanjay	
	<b>Int:</b> No <b>Ext:</b> Yes	
<b>Photo. Ref:</b> Album # 8

<b>1.0</b>	<b>Denomination</b>	
<b>1.1</b>	<b>Name of Premises</b>	Kumble Wada
<b>1.2</b>	<b>Earlier Name</b>	Kumble Wada
<b>1.3</b>	<b>Built In</b>	19 <sup>th</sup> century
<b>2.0</b>	<b>Access</b>	
<b>2.1</b>	<b>Main</b>	On the west side, from the junction of Farid and Provincial road
<b>2.2</b>	<b>Subsidiary</b>	From Provincial road
<b>3.0</b>	<b>Ownership pattern</b>	
<b>3.1</b>	<b>Present</b>	Private
<b>3.2</b>	<b>Past</b>	Private
<b>3.3</b>	<b>Status</b>	Owner
<b>4.0</b>	<b>Use</b>	
<b>4.1</b>	<b>Present</b>	Residence
<b>4.2</b>	<b>Past</b>	Residence
<b>4.2</b>	<b>Usage</b>	Daily
<b>5.0</b>	<b>Significance &amp; Value Classification</b>	
<b>5.1</b>	<b>Townscape (Manmade)</b>	Impressive street presence at the junction of the Provincial road.
<b>5.2</b>	<b>Architectural Description</b>	Kumble Wada is a single storied sloping roof structure with a spacious entrance verandah approached by wide stone steps. It has ornamental doors and windows, fixed stain glass window panels, Corinthian order in plasterwork around lintels and cornices making an intricately embellished facade. The prominent elliptical window arches and semicircular verandah arches also enhance the ornamentation of the facade.

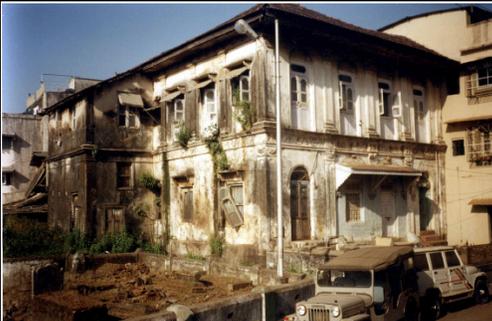
<b>Card No:</b> 39		
	<b>Ward (Part):</b> C		
	<b>CS No:</b> 497		
	<b>Plot Area:</b> 390.5 m <sup>2</sup>		
	<b>B U Area:</b> Access denied		
	<b>Date:</b> 24 September 2002		
	<b>Record by:</b> Urmi		
	<b>Review by:</b> Sanjay		
	<b>Int:</b> <b>Ext:</b>		
<b>Photo. Ref:</b> Album # 9			
<b>1.0 Denomination</b>

1.1	<b>Name of Premises</b>	Phalke Wada	<b>Note:</b> Access denied in Stage II.
1.2	<b>Earlier Name</b>	_____	
1.3	<b>Built In</b>	_____	
<b>2.0 Access</b>

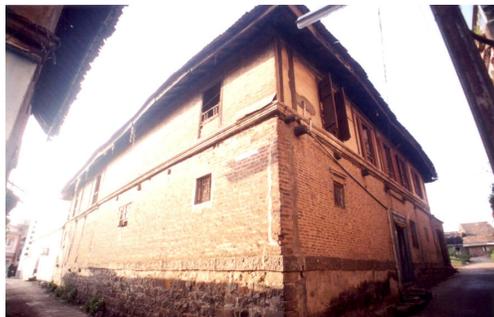
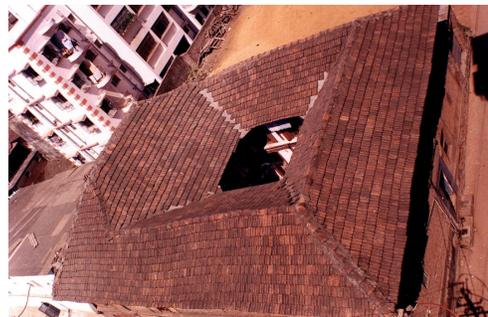
11.0		<b>DP Remarks/Perceived Threats</b>
11.1	<b>Remarks</b>	None
11.2	<b>Threats</b>	None
12.0		<b>Additional Photographs</b>

9.10	<b>Overall condition</b>	Fair <b>Maintenance level: Fair</b>
10.0		<b>Transformation</b>
10.1	<b>Form</b>	None
10.2	<b>Structure</b>	The wooden staircase on the east side of the courtyard is replaced by a steel staircase. A toilet block is added to the south side of the courtyard.

10.3	<b>Articulation &amp; Finishes</b>	The mangalore tile roof and wooden members of the rice mill portion is replaced by A.C sheet and steel section members.

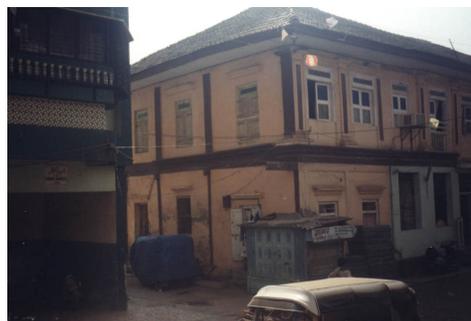
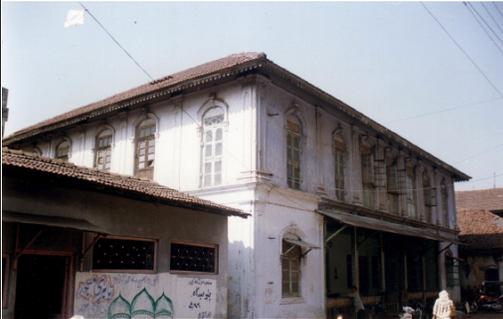
11.1	<b>Remarks</b>	None.
11.2	<b>Threats</b>	None.
12.0		<b>Additional Photographs</b>

9.8	<b>Services</b>	Good
9.9	<b>Outbuildings</b>	Good
9.10	<b>Overall condition</b>	Good <b>Maintenance level: Good</b>
10.0		<b>Transformation</b>
10.1	<b>Form</b>	A verandah on the south side has been added similarly also the floor above the verandah has been extended.

10.2	<b>Structure</b>	None
10.3	<b>Articulation &amp; Finishes</b>	The glazed panels of the first floor windows are replaced by new panels.
11.0		<b>DP Remarks/Perceived Threats</b>

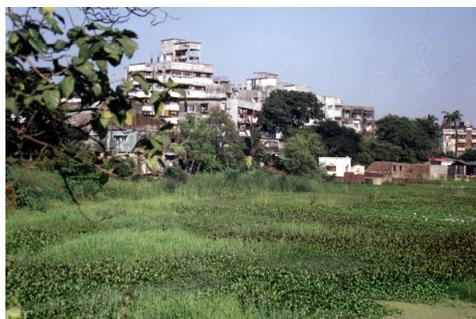
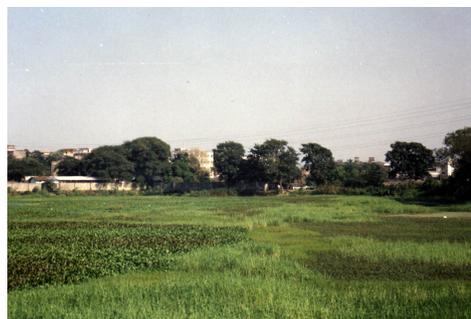
11.2	Threats	The periphery of lake is demarcated as reservation no. 103 for garden and Beautification, no. 102 for post office, no. 109 for parking.
<b>12.0</b>		<b>Additional Photographs</b>

10.1	Form	A boat club under construction is projecting in the northeast corner of the lake.
10.2	Structure	None
10.3	Articulation & Finishes	None
<b>11.0</b>		<b>DP Remarks/Perceived Threats</b>
<b>11.1</b>	<b>Remarks</b>

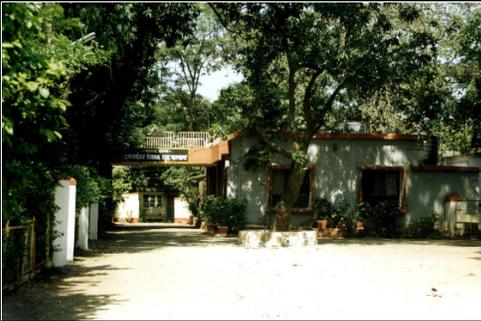
<b>Card No:</b> 61		
	<b>Ward (Part):</b> B		
	<b>CS No:</b> 3008 A		
	<b>Plot Area:</b> 10972.4 m <sup>2</sup>		
	<b>B U Area:</b> 386.72 m <sup>2</sup>		
	<b>Date:</b> 9 August 2002		
	<b>Record by:</b> Paresh		
	<b>Review by:</b> Urmi		
	<b>Int:</b> Yes <b>Ext:</b> Yes		
<b>Photo. Ref:</b> Album # 10			
<b>1.0 Denomination</b>

1.1	<b>Name of Premises</b>	Dak Bungalow	
1.2	<b>Earlier Name</b>	Dak Bungalow	
1.3	<b>Built In</b>	1880-90	
<b>2.0 Access</b>			
2.1	<b>Main</b>	On the south side from the Kalyan Murbad road.

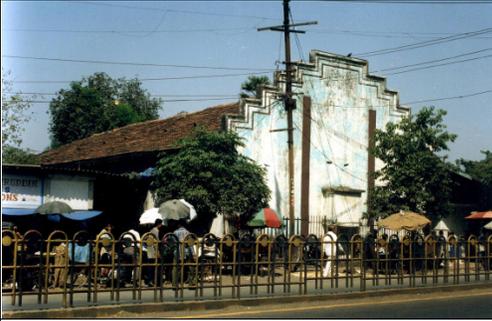
<b>Card No:</b> 62		
	<b>Ward (Part):</b> C		
	<b>CS No.:</b> 2940		
	<b>Plot Area:</b> 606.20 m <sup>2</sup>		
	<b>B U Area:</b> 451.0 m <sup>2</sup>		
	<b>Date:</b> 2 August 2002		
	<b>Record by:</b> Kushal		
	<b>Review by:</b> Urmi		
	<b>Int: Yes</b> <b>Ext: Yes</b>		
<b>Photo. Ref:</b> Album # 10			
<b>1.0 Denomination</b>

1.1	<b>Name of Premises</b>	Chhaya Talkies	
1.2	<b>Earlier Name</b>	Urmikar hall	
1.3	<b>Built In</b>	1930-40	
<b>2.0 Access</b>			
2.1	<b>Main</b>	On the south side from Kalyan Murbad road.

5.2	<b>Architectural Description</b>	It is a rectangular gable roof cinema hall abutting a main road.	
5.3	<b>Intrinsic</b>	Not available	
5.4	<b>Value Classification</b>	HIS	<b>Recommended Grade: III</b>
<b>6.0 Topography</b>

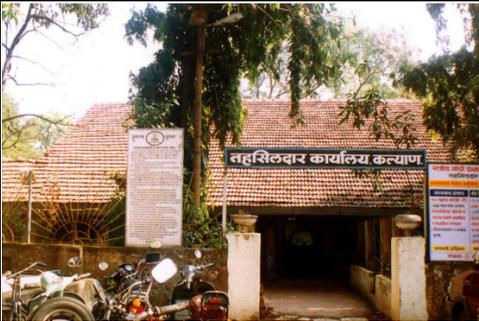
<b>Card No:</b> 64		
	<b>Ward (Part):</b> C		
	<b>CS No:</b> 3251, 3251/1, 3252, 3253, 3253/1-7		
	<b>Plot Area:</b> 1648 m <sup>2</sup>		
	<b>B U Area:</b> 1076 m <sup>2</sup>		
	<b>Date:</b> 27 July 2002		
	<b>Record by:</b> Urmi		
	<b>Review by:</b> Sanjay		
	<b>Int:</b> Yes <b>Ext:</b> Yes		
<b>Photo. Ref:</b> Album # 21			
<b>1.0 Denomination</b>

1.1	<b>Name of Premises</b>	Mamledar Kacheri	
1.2	<b>Earlier Name</b>	Mamledar Office	
1.3	<b>Built In</b>	1850- 60	
<b>2.0 Access</b>			
2.1	<b>Main</b>	On the west side from Kalyan Murbad road connecting station to Phule Chowk.

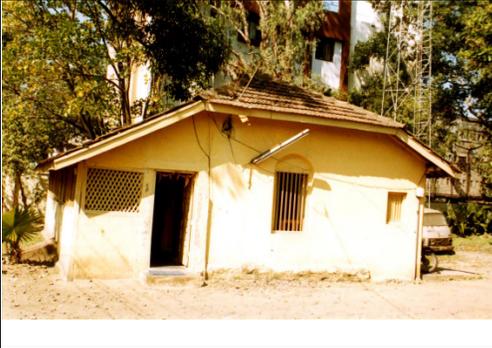
Card No: 65	
	Ward (Part): C	
	CS No: 2903 1 to 10, 2904 1 to 10, 2905, 2906	
	Plot Area: 1781.3 m <sup>2</sup>	
	B U Area: 2093.50 m <sup>2</sup>	
	Date: 2 August 2002	
	Record by: Kushal	
	Review by: Urmi	
	Int: Yes      Ext: Yes	
Photo. Ref: Album # 10		
<b>1.0</b>	<b>Denomination</b>

1.1	Name of Premises	Police line
1.2	Earlier Name	Police line
1.3	Built In	1870
<b>2.0</b>	<b>Access</b>	
2.1	Main	On the northeast side off Phule chowk road.

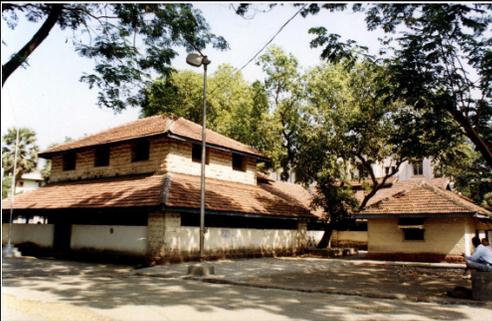
<b>Card No:</b> 66		
	<b>Ward (Part):</b> C		
	<b>CS No:</b> 3266 A, 3266 B		
	<b>Plot Area:</b> 9852 m <sup>2</sup>		
	<b>B U Area:</b> 634 m <sup>2</sup>		
	<b>Date:</b> 16 August 2002		
	<b>Record by:</b> Paresh		
	<b>Review by:</b> Urmi		
	<b>Int:</b> Yes <b>Ext:</b> Yes		
<b>Photo. Ref:</b> Album # 23			
<b>1.0 Denomination</b>			
<b>1.1 Name of Premises</b>	Court		
<b>1.2 Earlier Name</b>	Asst. Collector Bungalow		
<b>1.3 Built In</b>	1878-80		
<b>2.0 Access</b>			
<b>2.1 Main</b>	On the south side, from Kalyan Murbad road.		
<b>2.2 Subsidiary</b>	On the north side		
<b>3.0 Ownership pattern</b>			
<b>3.1 Present</b>	Government		
<b>3.2 Past</b>	Government		
<b>3.3 Status</b>	Government		
<b>4.0 Use</b>			
<b>4.1 Present</b>	Court		
<b>4.2 Past</b>	Residence, court		
<b>4.2 Usage</b>	Daily		
<b>5.0 Significance &amp; Value Classification</b>			
<b>5.1 Townscape (Manmade)</b>	The building is located on the corner plot to the west of Phule Chowk abutting Kalyan Murbad road on the south side.

<b>5.2 Architectural Description</b>	It is a ground storey structure with sloping roof and a verandah on all sides. The central part of the structure is rectangular in plan with hipped roof and high parapet walls enclosing the verandah. The complex also has a newly constructed double storied R.C.C structure opposite the old building separated by a central open space. The double height of the courtroom (clear storey) projecting above the lean to roof of the verandah is characteristic of the court.		
<b>5.3 Intrinsic</b>	Not available		
<b>5.4 Value Classification</b>	ARC/HIS/DES	<b>Recommended Grade:</b> IIA	
<b>6.0 Topography</b>			
<b>6.1 Floors</b>	Ground floor		
<b>7.0 Construction</b>			
<b>7.1 Plinth</b>	30 cm high plinth in local black basalt stone coursed masonry with 120 cm wide basalt stone steps.		
<b>7.2 Walls</b>	Load bearing structure of 45 cm thick external and internal walls in exposed stone coursed masonry.

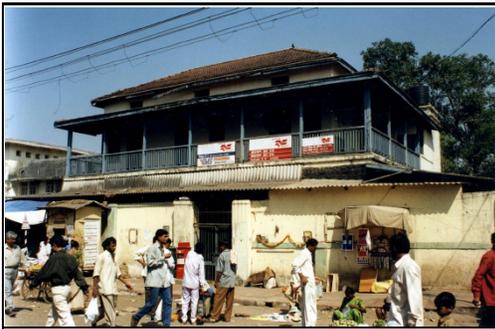
<b>Card No:</b> 67	
	<b>Ward (Part):</b> C	
	<b>CS No:</b> 3265	
	<b>Plot Area:</b> 519.0 m <sup>2</sup>	
	<b>B U Area:</b> 290.0 m <sup>2</sup>	
	<b>Date:</b> 1 August 2002	
	<b>Record by:</b> Urmi	
	<b>Review by:</b> Sanjay	
	<b>Int:</b> Yes <b>Ext:</b> Yes	
<b>Photo. Ref:</b> Album # 10

<b>1.0</b>	<b>Denomination</b>	
<b>1.1</b>	<b>Name of Premises</b>	Post Office
<b>1.2</b>	<b>Earlier Name</b>	Post Office
<b>1.3</b>	<b>Built In</b>	1880
<b>2.0</b>	<b>Access</b>	
<b>2.1</b>	<b>Main</b>	On the west side, from Ambedkar road.
<b>2.2</b>	<b>Subsidiary</b>	On the west side, from Ambedkar road
<b>3.0</b>	<b>Ownership pattern</b>	
<b>3.1</b>	<b>Present</b>	Government
<b>3.2</b>	<b>Past</b>	Government
<b>3.3</b>	<b>Status</b>	Government
<b>4.0</b>	<b>Use</b>	
<b>4.1</b>	<b>Present</b>	Post office
<b>4.2</b>	<b>Past</b>	Post office
<b>4.2</b>	<b>Usage</b>	Daily
<b>5.0</b>	<b>Significance &amp; Value Classification</b>	
<b>5.1</b>	<b>Townscape (Manmade)</b>	It is located on a plot abutting Ambedkar road on the northeast side that leads to Phule Chowk.
<b>5.2</b>	<b>Architectural Description</b>	It consists of a single, sloping roof structure in a compound. It has rectangular plan with 'L' shaped verandah on the first floor with sloping roof. Elegant wooden railing along the verandah is an interesting feature of this structure.

<b>5.3</b>	<b>Intrinsic</b>	After railways were started, the main post office was established in this structure. The railway mail service was also carried out from this building.
<b>5.4</b>	<b>Value Classification</b>	ARC/HIS/USE/CRF <b>Recommended Grade: IIA</b>
<b>6.0</b>	<b>Topography</b>	
<b>6.1</b>	<b>Floors</b>	Ground floor
<b>7.0</b>	<b>Construction</b>	
<b>7.1</b>	<b>Plinth</b>	45 cm high in local black basalt stone un-coarsed masonry with R.C.C plinth added as the verandah.
<b>7.2</b>	<b>Walls</b>	Framed structure in columns and beams with 50 cm thick stone masonry load bearing external walls.
<b>7.3</b>	<b>Floor</b>	R.C.C first floor slab supported by R.C.C beams and columns.
<b>7.4</b>	<b>Stairs</b>	1 m wide single flight wooden staircase with 90 cm high wooden decorative baluster railing on the south side of the main structure.
<b>7.5</b>	<b>Openings</b>	Timber framed double shutter glazed panel doors and windows for both the floors. Glazed panelled ventilators above the windows.

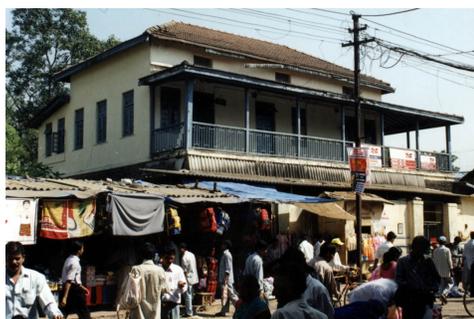
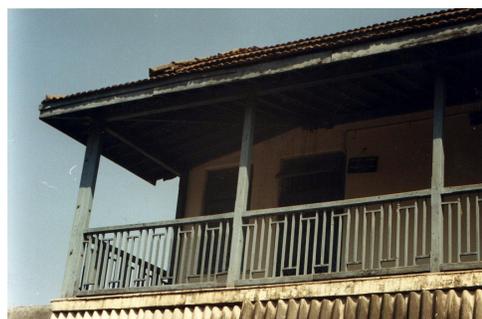
10.3	<b>Articulation &amp; Finishes</b>	Mangalore tile roof changed to asbestos cement roofing on south end of the main structure.
11.0		<b>DP Remarks/Perceived Threats</b>

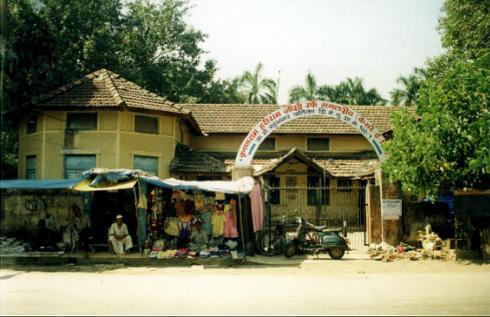
<b>Card No:</b> 69		
	<b>Ward (Part):</b> C		
	<b>CS No:</b> 1964 B		
	<b>Plot Area:</b> 611.7 m <sup>2</sup>		
	<b>B U Area:</b> 225.71 m <sup>2</sup>		
	<b>Date:</b> 14 August 2002		
	<b>Record by:</b> Urmi		
	<b>Review by:</b> Sanjay		
	<b>Int:</b> Yes <b>Ext:</b> Yes		
<b>Photo. Ref:</b> Album # 6,7			
<b>1.0</b>	<b>Denomination</b>		
<b>1.1</b>	<b>Name of Premises</b>	Gagalsheth School	
<b>1.2</b>	<b>Earlier Name</b>	Kesari Hind Gagalsheth School	
<b>1.3</b>	<b>Built In</b>	1930-35	
<b>2.0</b>	<b>Access</b>		
<b>2.1</b>	<b>Main</b>	From the north side on Bazaar Peth.	
<b>2.2</b>	<b>Subsidiary</b>	None	
<b>3.0</b>	<b>Ownership pattern</b>		
<b>3.1</b>	<b>Present</b>	Kalyan Municipal Corporation	
<b>3.2</b>	<b>Past</b>	Private	
<b>3.3</b>	<b>Status</b>	Kalyan Municipal Corporation	
<b>4.0</b>	<b>Use</b>		
<b>4.1</b>	<b>Present</b>	Educational	
<b>4.2</b>	<b>Past</b>	Educational

<b>4.2</b>	<b>Usage</b>	Daily	
<b>5.0</b>	<b>Significance &amp; Value Classification</b>		
<b>5.1</b>	<b>Townscape (Manmade)</b>	It was the first girls' school in Kalyan located along a lane to the northwest of Shivaji chowk.	
<b>5.2</b>	<b>Architectural Description</b>	The school is a 'C' shape ground storey structure planned around a court in a compound. The two ends of 'C' shape plan are octagonal in shape. A colonnade verandah runs along the inner side of the structure and facing the entrance court.	
<b>5.3</b>	<b>Intrinsic</b>	Gagal Seth Joshi was a wealthy <i>Gujarati</i> rice merchant of Kalyan. He owned a well-known shop and house on the Bazar Peth road. He was conferred the title of "Kaiser - E - Hind" by the Britishers. Gagal Seth had made financial contributions for the education of Municipal corporation sweepers and down trodden people staying behind the school.	
<b>5.4</b>	<b>Value Classification</b>	HIS/DES <span style="float: right;"><b>Recommended Grade: II B</b></span>

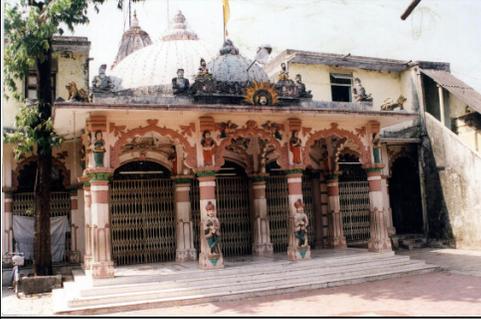
<b>Card No:</b> 70		
	<b>Ward (Part):</b> C		
	<b>CS No:</b> 1959, 1842 B		
	<b>Plot Area:</b> 2275 m <sup>2</sup>		
	<b>B U Area:</b> 441.805 m <sup>2</sup>		
	<b>Date:</b> 14 August 2002		
	<b>Record by:</b> Paresh		
	<b>Review by:</b> Urmi		
	<b>Int:</b> Yes <b>Ext:</b> Yes		
<b>Photo. Ref:</b> Album # 6			
<b>1.0</b>	<b>Denomination</b>		
<b>1.1</b>	<b>Name of Premises</b>	New Vishnu Mandir	
<b>1.2</b>	<b>Earlier Name</b>	Vishnu Mandir	
<b>1.3</b>	<b>Built In</b>	1894-95	
<b>2.0</b>	<b>Access</b>		
<b>2.1</b>	<b>Main</b>	On the north side from Maulana Azad road.	
<b>2.2</b>	<b>Subsidiary</b>	Next to main entrance door [on the west side]	
<b>3.0</b>	<b>Ownership pattern</b>		
<b>3.1</b>	<b>Present</b>	Institutional	
<b>3.2</b>	<b>Past</b>	Institutional	
<b>3.3</b>	<b>Status</b>	Institutional	
<b>4.0</b>	<b>Use</b>		
<b>4.1</b>	<b>Present</b>	Religious

<b>4.2</b>	<b>Past</b>	Religious	
<b>4.2</b>	<b>Usage</b>	Daily	
<b>5.0</b>	<b>Significance &amp; Value Classification</b>		
<b>5.1</b>	<b>Townscape (Manmade)</b>	The temple is located on a plot abutting the 12 m wide Maulana Azad road in the core of old Kalyan.	
<b>5.2</b>	<b>Architectural Description</b>	This complex abutting a main road has a temple, girl's school and chawl arranged around a central court. The temple has a colonnaded ornamental arched entrance porch, domed prayer hall, shrine and pujari's residence. The temple and its shrine face the east direction. The chawl and the school are double storied wood framed structures with verandah along its entire length facing the court.	
<b>5.3</b>	<b>Intrinsic</b>	The Vishnu Mandir is centrally located with houses surrounded on all the four sides like 'Pols' of Gujarat. The idol of Vishnu is antique and was found in the Lendi lake (1896) that has now been transformed into Subhash Maidan. The temple premises consist of a girl's high school, which was constructed in 1932.

<b>5.4</b>	<b>Value Classification</b>	ARC/HIS/CUL/CRF <b>Recommended Grade: II B</b>	
<b>6.0</b>	<b>Topography</b>		
<b>6.1</b>	<b>Floors</b>	The front prayer hall of the temple is ground floor while the rear part is a ground + one for pujari's residence.	
<b>7.0</b>	<b>Construction</b>		
<b>7.1</b>	<b>Plinth</b>	60 cm high plinth in local black basalt stone coursed masonry with 780 cm wide entrance steps in polished marble tiles in the porch.	
<b>7.2</b>	<b>Walls</b>	Load bearing structure of 40 cm thick external and internal walls in brick masonry. The prayer hall has 30 cm diameter columns.	
<b>7.3</b>	<b>Floor</b>	R.C.C slab supported on load bearing walls.	
<b>7.4</b>	<b>Stairs</b>	90 cm wide external straight flight R.C.C staircase with R.C.C. railing, treads and risers in I.P.S finish on the south side of the temple.	
<b>7.5</b>	<b>Openings</b>	The prayer hall is entered through a M.S collapsible door fixed in between the columns. 100 x 190 cm timber frame double shutter wood paneled door with fixed M.S grill ventilator of the pujari's house is entered from the south wing of the prayer hall.

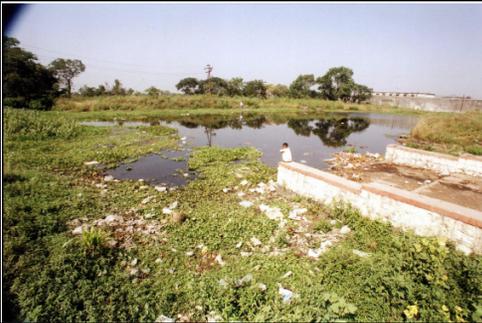
<b>Card No:</b> 72		
	<b>Ward (Part):</b> C		
	<b>CS No:</b> Survey No: 34		
	<b>Plot Area:</b> 75000 m <sup>2</sup>		
	<b>B U Area:</b> Not applicable		
	<b>Date:</b> 1 September 2002		
	<b>Record by:</b> Paresh		
	<b>Review by:</b> Urmi		
	<b>Int:</b> -NA- <b>Ext:</b> Yes		
<b>Photo. Ref:</b> Album # 25			
<b>1.0</b>	<b>Denomination</b>		
<b>1.1</b>	<b>Name of Premises</b>	Rahatale Talao [lake]	
<b>1.2</b>	<b>Earlier Name</b>	Rahatale Talao [lake]	
<b>1.3</b>	<b>Built In</b>	Natural site.	
<b>2.0</b>	<b>Access</b>		
<b>2.1</b>	<b>Main</b>	From Sapada road on the west edge off the Bhivandi Murbad road on the south side.	
<b>2.2</b>	<b>Subsidiary</b>	None	
<b>3.0</b>	<b>Ownership pattern</b>		
<b>3.1</b>	<b>Present</b>	Kalyan Municipal Corporation	
<b>3.2</b>	<b>Past</b>	Government	
<b>3.3</b>	<b>Status</b>	Municipal Corporation	
<b>4.0</b>	<b>Use</b>

<b>4.1</b>	<b>Present</b>	Not in use	
<b>4.2</b>	<b>Past</b>	Used for irrigating farmland.	
<b>4.2</b>	<b>Usage</b>	Not in use	
<b>5.0</b>	<b>Significance &amp; Value Classification</b>		
<b>5.1</b>	<b>Townscape (Natural)</b>	It is a large irregular shaped natural lake spread in a catchment area accessed through a by-lane off the Bhivandi Murbad road on the north side.	
<b>5.2</b>	<b>Architectural Description</b>	It is an irregular shape water body spread in an area of 75,000 sq.mts, located near a main road and a jail.	
<b>5.3</b>	<b>Intrinsic</b>	Not available	
<b>5.4</b>	<b>Value Classification</b>	NAT/URB <b>Recommended Grade: II A</b>	
<b>6.0</b>	<b>Topography</b>		
<b>6.1</b>	<b>Floors</b>	Not applicable	
<b>7.0</b>	<b>Construction</b>		
<b>7.1</b>	<b>Plinth</b>	Not applicable	
<b>7.2</b>	<b>Walls</b>	None	
<b>7.3</b>	<b>Floor</b>	Not applicable	
<b>7.4</b>	<b>Stairs</b>	None	
<b>7.5</b>	<b>Openings</b>	Not applicable

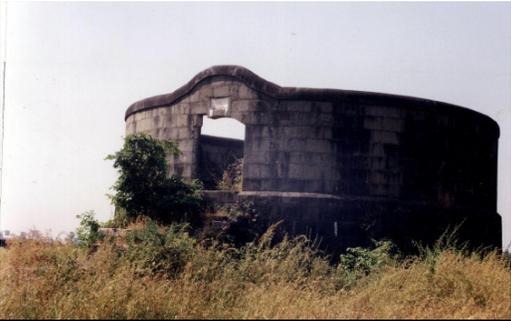
<b>Card No:</b> 73	
	<b>Ward (Part):</b> C	
	<b>CS No:</b> Survey no: 77	
	<b>Plot Area:</b> 28200 m <sup>2</sup>	
	<b>B U Area:</b> 162.75 m <sup>2</sup>	
	<b>Date:</b> 1 September 2002	
	<b>Record by:</b> Paresh	
	<b>Review by:</b> Urmi	
<b>Int:</b> Yes <b>Ext:</b> Yes		
<b>Photo. Ref:</b> Album # 13		
<b>1.0</b>	<b>Denomination</b>	
<b>1.1</b>	<b>Name of Premises</b>	Parsi Vihir [well]
<b>1.2</b>	<b>Earlier Name</b>	Parsi Vihir [well]
<b>1.3</b>	<b>Built In</b>	1780
<b>2.0</b>	<b>Access</b>	
<b>2.1</b>	<b>Main</b>	From the east side off the Adhar wadi Gandhari road.
<b>2.2</b>	<b>Subsidiary</b>	None
<b>3.0</b>	<b>Ownership pattern</b>	
<b>3.1</b>	<b>Present</b>	Parsi Panchayat
<b>3.2</b>	<b>Past</b>	Parsi Panchayat
<b>3.3</b>	<b>Status</b>	Parsi Panchayat
<b>4.0</b>	<b>Use</b>	
<b>4.1</b>	<b>Present</b>	None
<b>4.2</b>	<b>Past</b>	Parsi's disposal of the dead.

<b>4.2</b>	<b>Usage</b>	Not in use.
<b>5.0</b>	<b>Significance &amp; Value Classification</b>	
<b>5.1</b>	<b>Townscape (Manmade)</b>	It is a well (Tower of silence) of the Parsi community for the rituals and rites of the dead. It is in a large compound located at the periphery of the city.
<b>5.2</b>	<b>Architectural Description</b>	The Parsi Vhir is a circular stone well in a compound of high stone masonry wall. This stone well (Dokhma) is built in black dressed coursed stone masonry raised on a high plinth and is accentuated by an arch lintel above the entrance. There is square shaped brick masonry well on the east side of the compound and a ground floor vaulted structure on the north side.
<b>5.3</b>	<b>Intrinsic</b>	There are two wells in the compound of which one is in brick and the other in stone. Bricks were used for construction of well prior to 1560 and later stone was used. This indicates that the Parsi's were staying in Kalyan since a very long time and the size of their population in Kalyan. Next to the well is a fire temple, which is surrounded by stone wall on all sides.

<b>5.4</b>	<b>Value Classification</b>	ARC/HIS/CUL/DES/USE/CRF/GRP <b>Recommended Grade: II A</b>
<b>6.0</b>	<b>Topography</b>	
<b>6.1</b>	<b>Floors</b>	Ground floor
<b>7.0</b>	<b>Construction</b>	
<b>7.1</b>	<b>Plinth</b>	240 cm high plinth in local black basalt stone coursed masonry with 130 cm wide flight of projecting entrance steps on the east side of the well.
<b>7.2</b>	<b>Walls</b>	30 cm thick wall in dressed basalt stone masonry with stone coping rising to a height of 235 cm above the plinth, enclosing the platform around the well.
<b>7.3</b>	<b>Floor</b>	Not applicable
<b>7.4</b>	<b>Stairs</b>	Not applicable
<b>7.5</b>	<b>Openings</b>	130 x 175 cm opening with plaster moulded framed entrance on the east side of the well.
<b>7.6</b>	<b>Roofing</b>	(Well) None, Vaulted roof of the rectangular structure used for resting is on the north side.
<b>7.7</b>	<b>Articulation</b>	None
<b>7.8</b>	<b>Interiors</b>	270 cm, wide single row of receptacles is radially arranged in basalt stone slabs with 370 cm diameter central well.
