BALLARD BUNDER GATEHOUSE

CONSERVATION REPORT

DOCUMENTATION, ANALYSIS & PROCESS

K.UNWALLA ARCHITECTS, MAY 2005

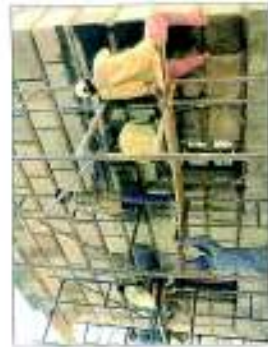
Facade cleaning in progress

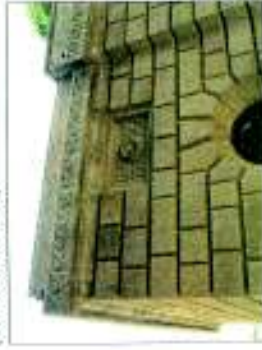
Beauty of façade features restored.

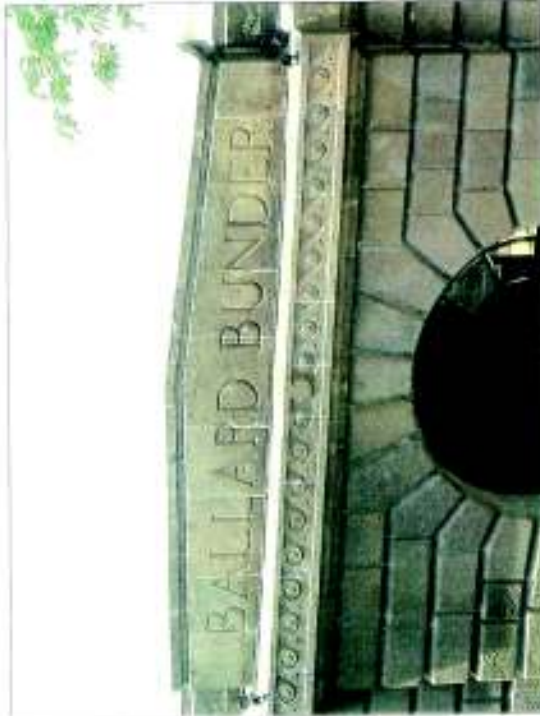
FRONT PEDIMENT WITH THE NAME TABLET AFTER RESTORATION

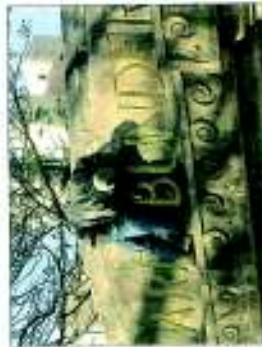
Rear pediment being cleaned.

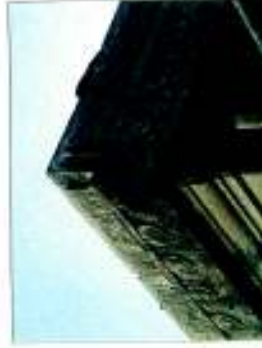
Restoration of façade features brings out the delicacy of the motifs.

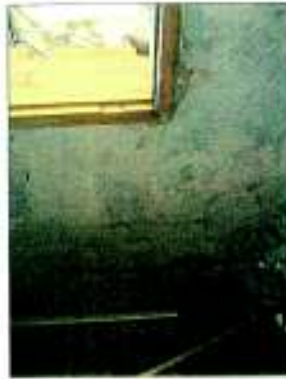
Composite stone walls with brick inner leaf along three sides of the ante-rooms. Note the north wall devoid of the brick leaf, constructed in massive stones, stacked up in a single pile

- Cement plastered (later intervention), last decade) painted walls
- Stains of Leakage
- Opening up of cement plaster revealed composite stone (massive stones arranged in single thickness, stacked up in horizontal courses) and Brick masonry (1/2 brick thick) wall, except the north wall, which is devoid of the brick layer.

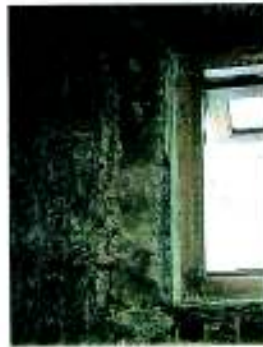
Stone lintels above square headed openings in the rooms

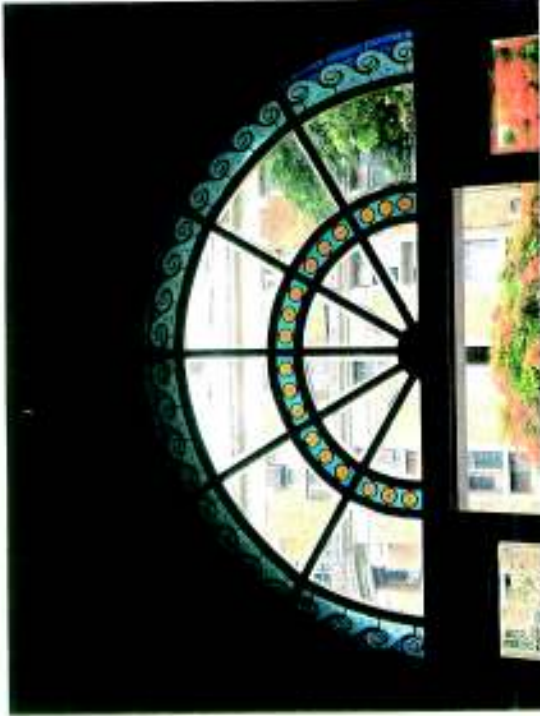
ARCHED OPENING AFTER RESTORATION

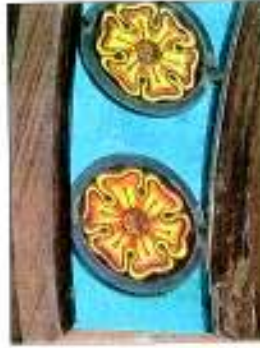
Stained glass panel in the semi-circular
fixed portion of the opening.

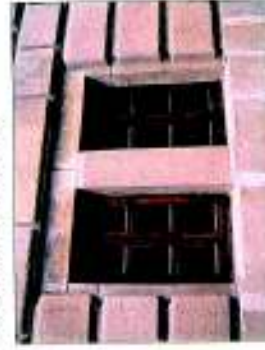
Original window frames and shutters
replaced by new windows.

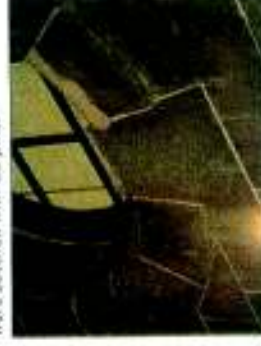
Opening restored after removal of elements causing the damage.

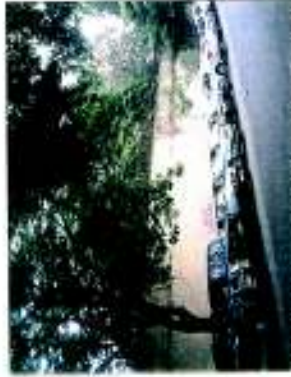
SECURITY WALL DEPRIVED THE VIEW OF THE GATEHOUSE FROM BALLARD ESTATE

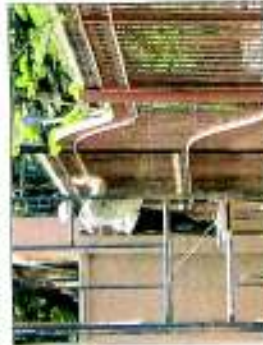
Grill Fence being placed in position. The design of the grill fence is derived from the design of triple gates at Alexandria Docks

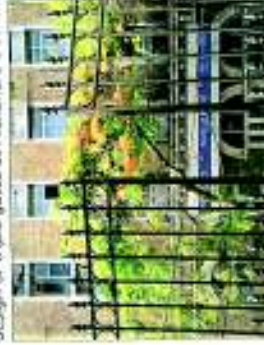
Grand Entrance gateway placed in central alignment with the structure offers entry to the site from (Shearj) Wababooas Road

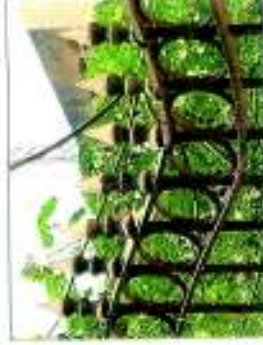
Decorative pinnacles placed on the curved profile of the grill fence.

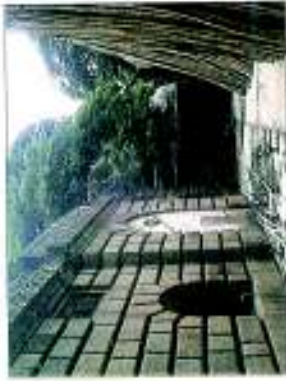
GATEHOUSE SURROUNDED BY HARD PAVING – BEFORE RESTORATION

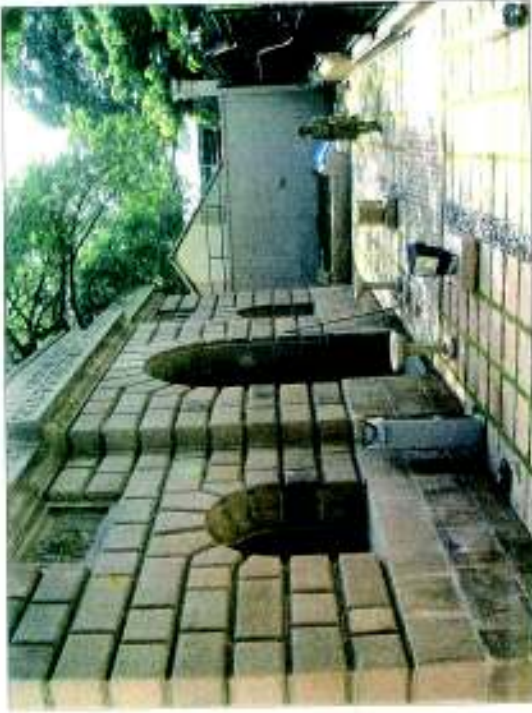
ENHANCED LANDSCAPE SETTING - AFTER RESTORATION

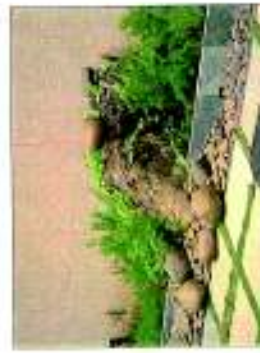
Old tree trunk explored in the excavation preserved and developed as a landscape feature.

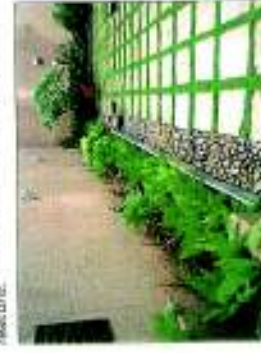
Grass jointed shahbad tile paving edged by the French drain topped with a layer of pebbles

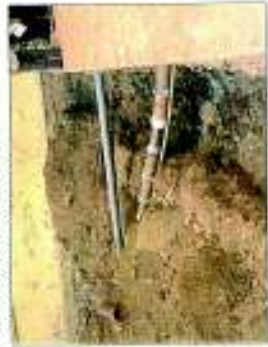
Drainage alignments explored while excavation

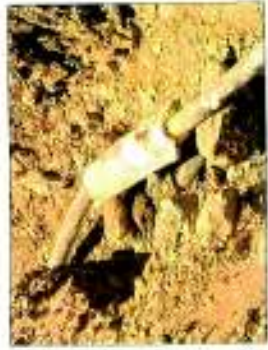
Junction at LT cable after it was realigned with an extension.
