Mumbai University Convocation Hall

Scheme for Restoration

Abha Narain Lambah Associates – Conservation Architects & Historic Building Consultants

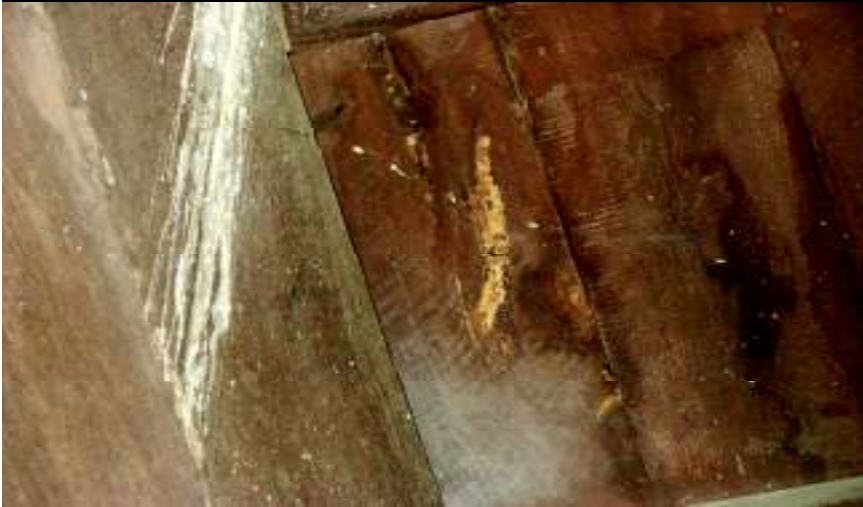
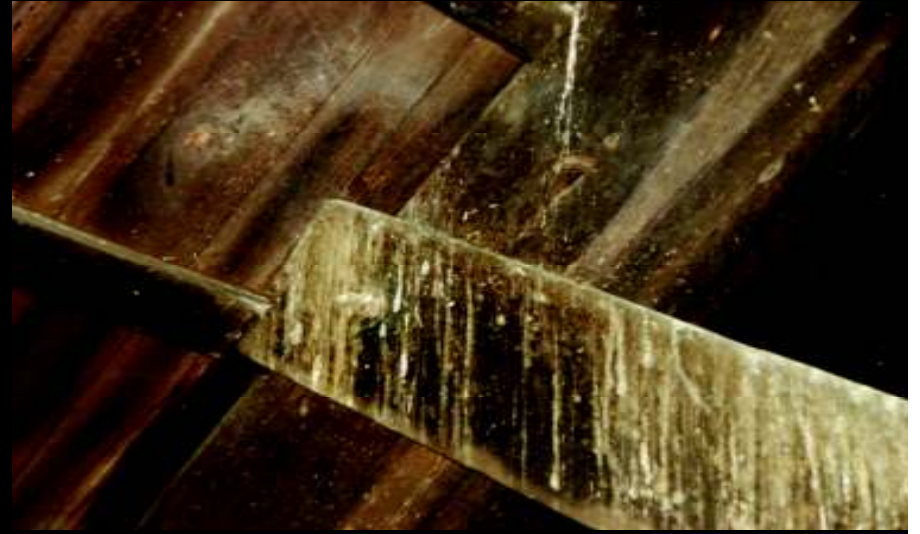
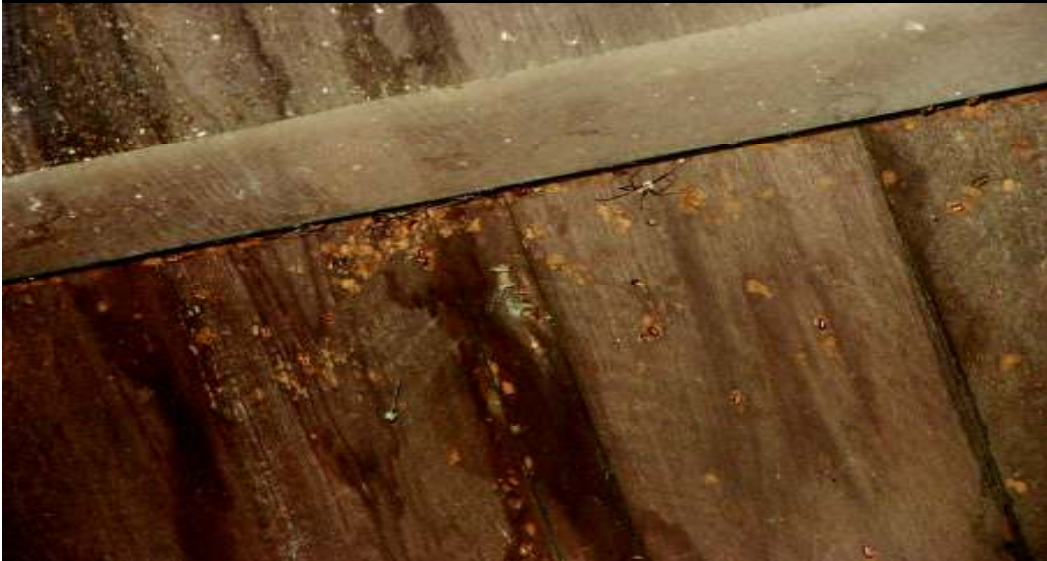
Timber boarding affected by white ants

Repair and structural strengthening of trusses & timber boarding

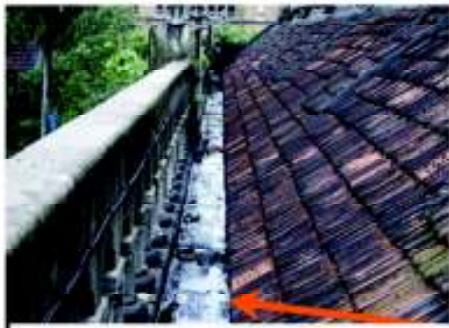
6

- 1 Gable end over Rose Window
- 2. Roof tiles over timber truss
- 3. Upper verandah cluttered
- 4. Extensive damp & termite seen along flying buttress
- 5. Incremental layers of tar felt have choked the water outlets
- 6. Vault and stone ribs under wooden truss roof

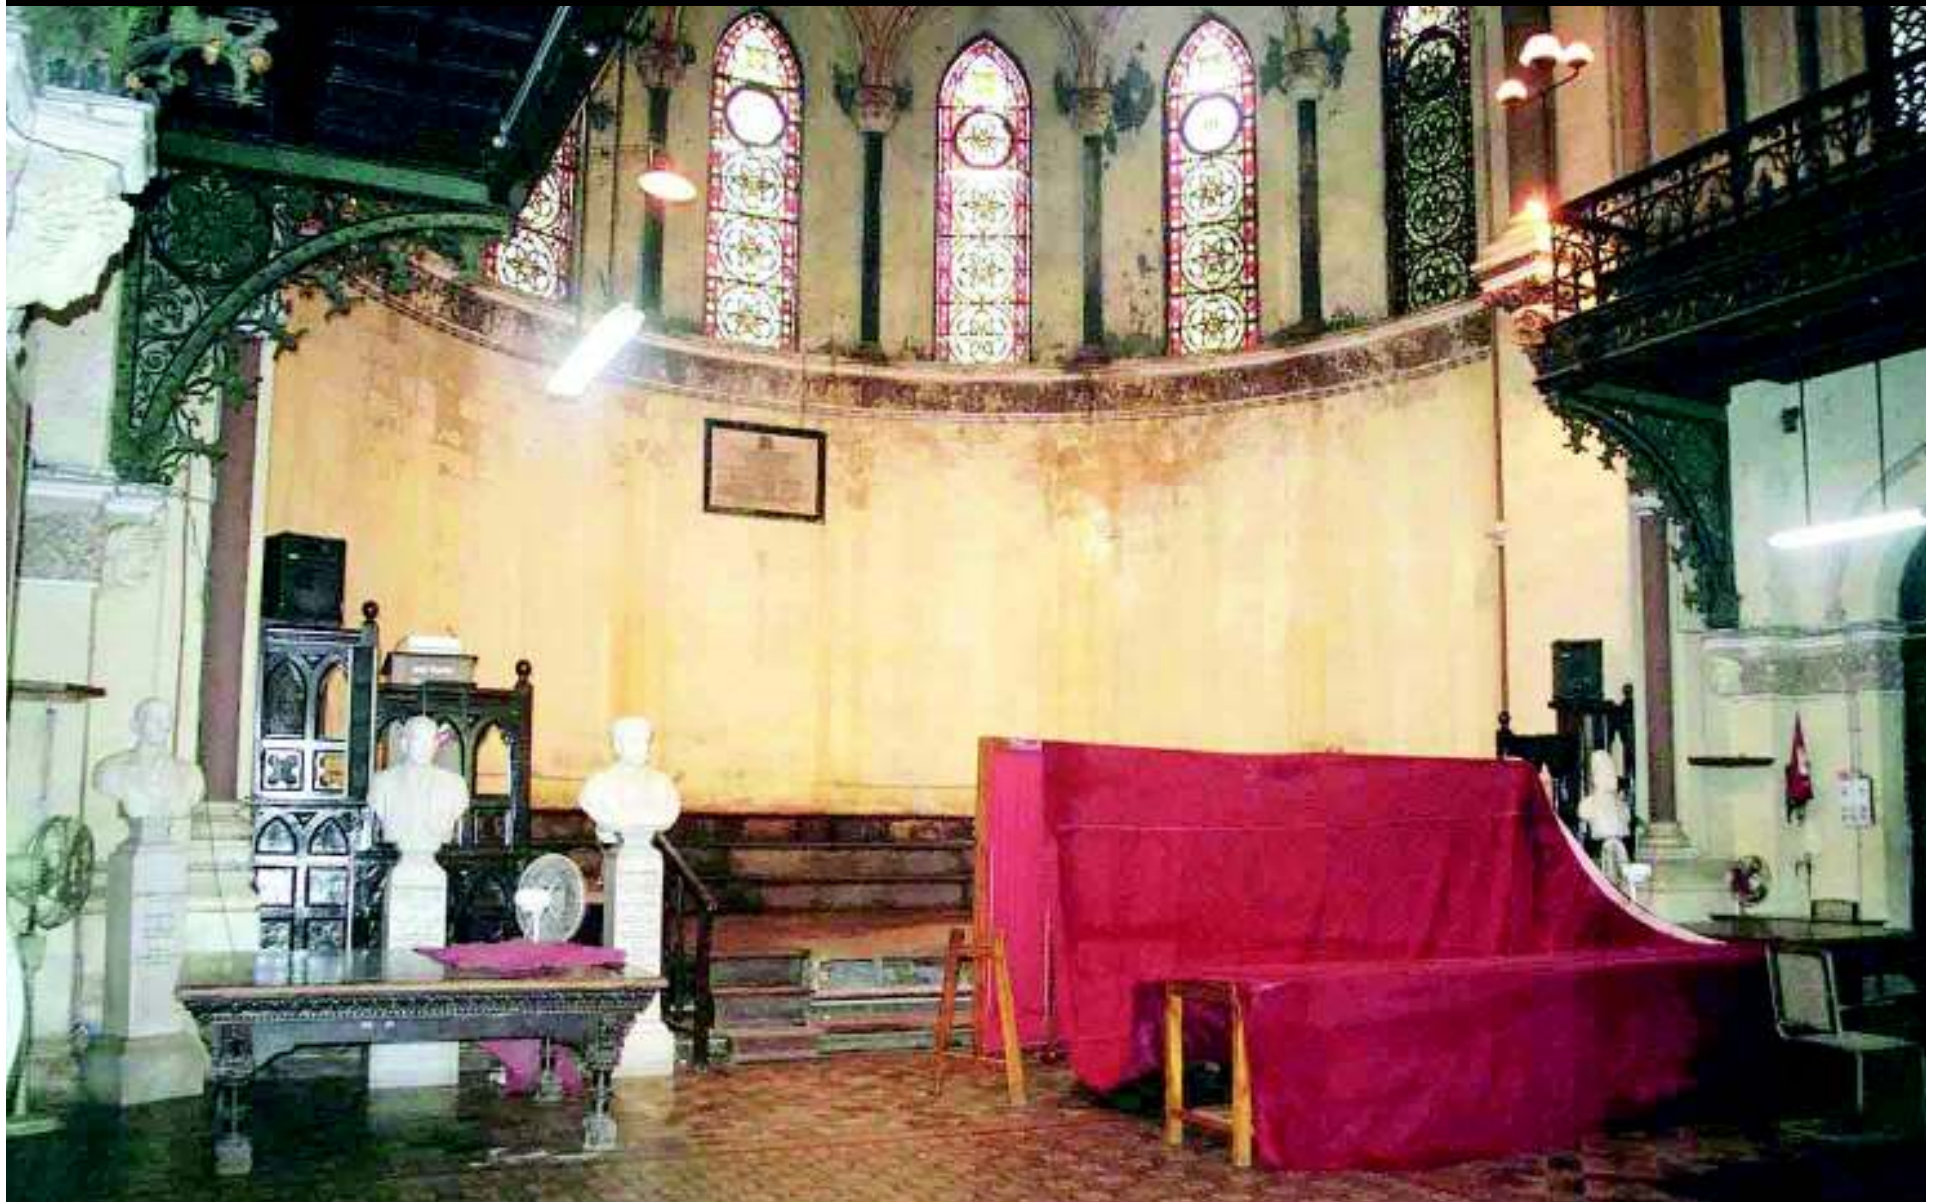
STRUCTURAL ISSUES: LEAKAGE AT APSE

Removal of bitumen layers, damaged planks from apse roof

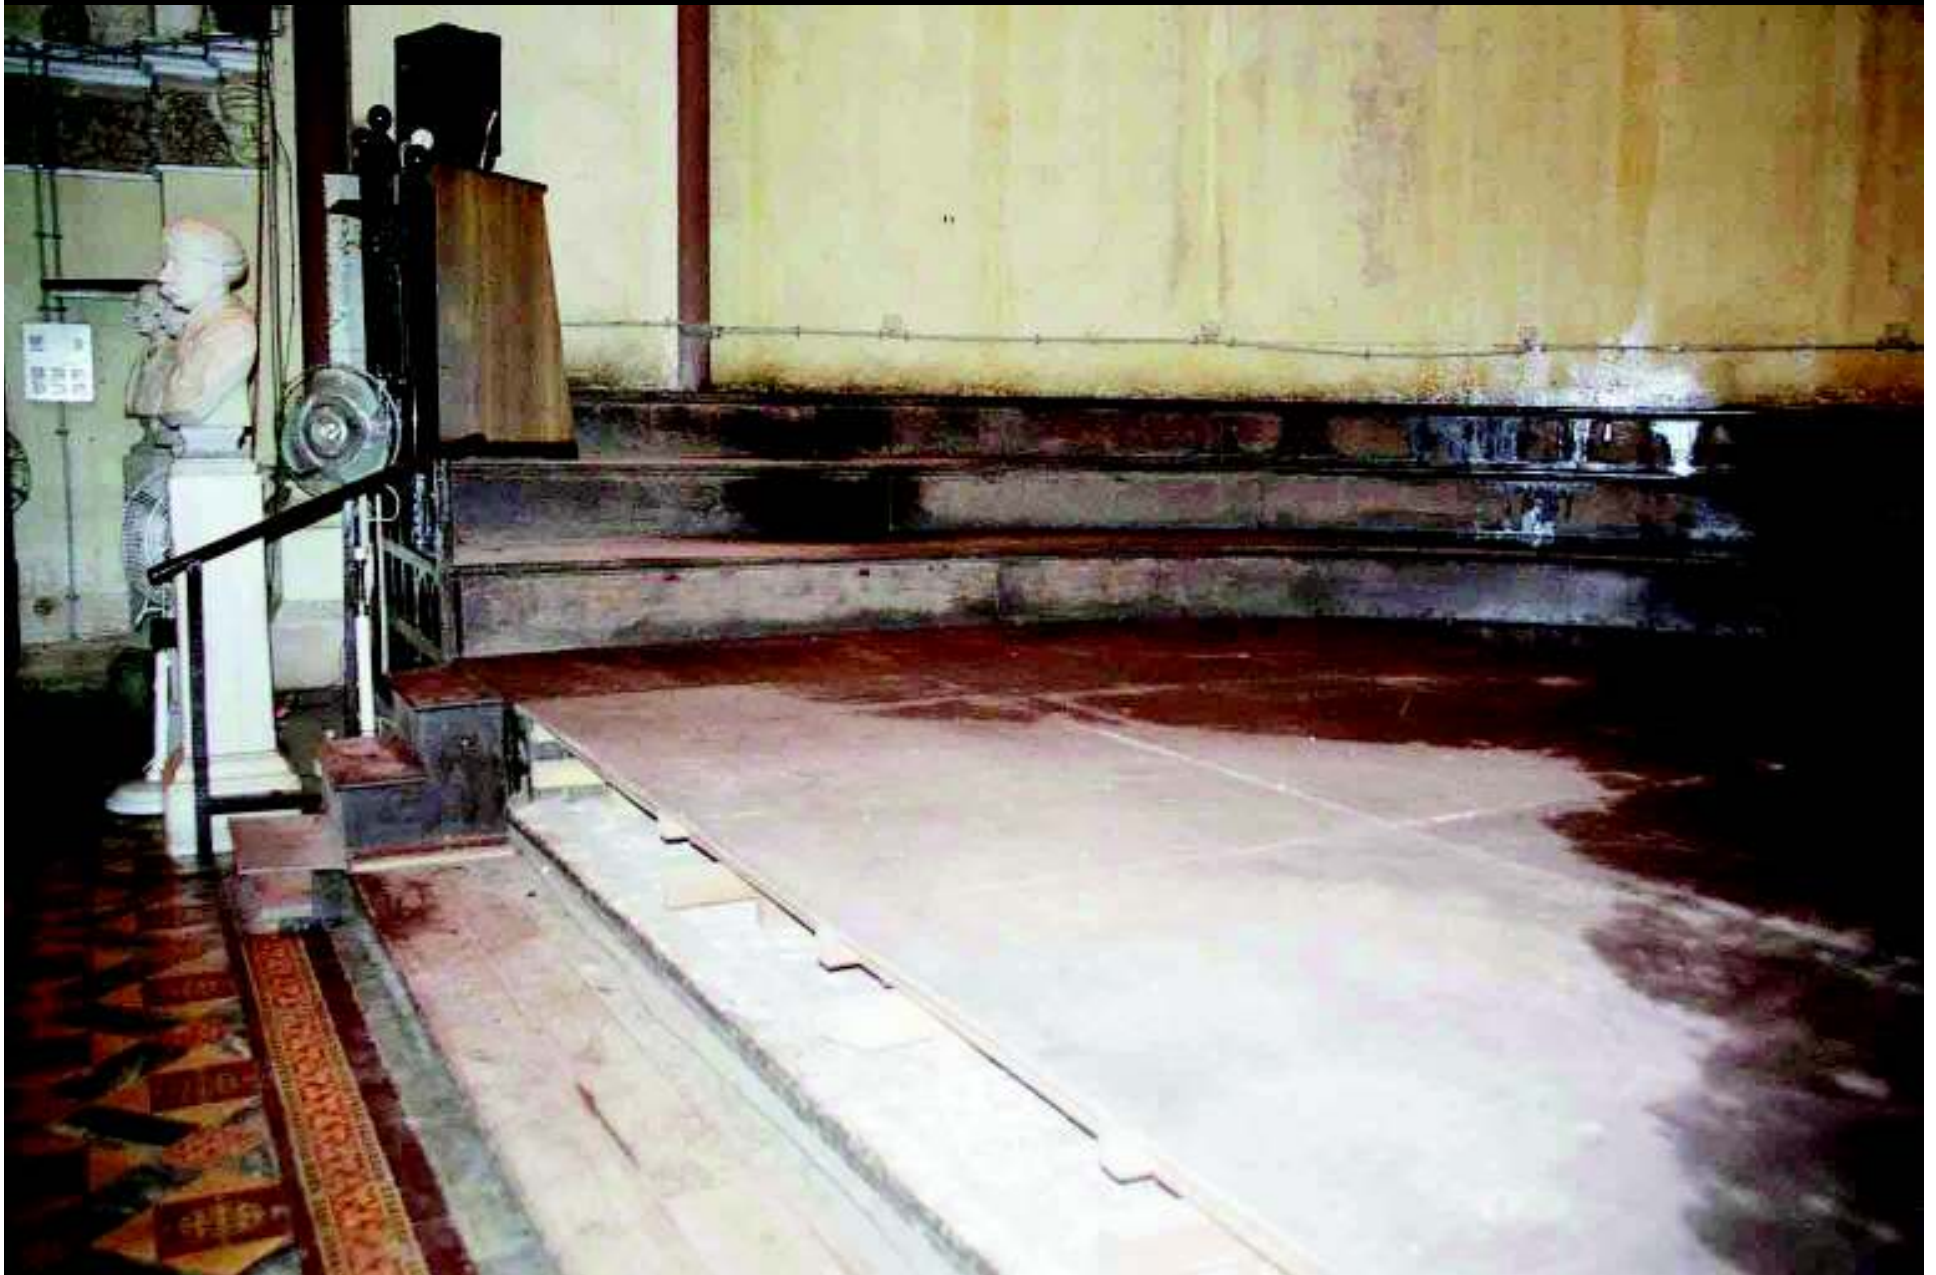
STRUCTURAL ISSUES: LEAKAGE AT APSE

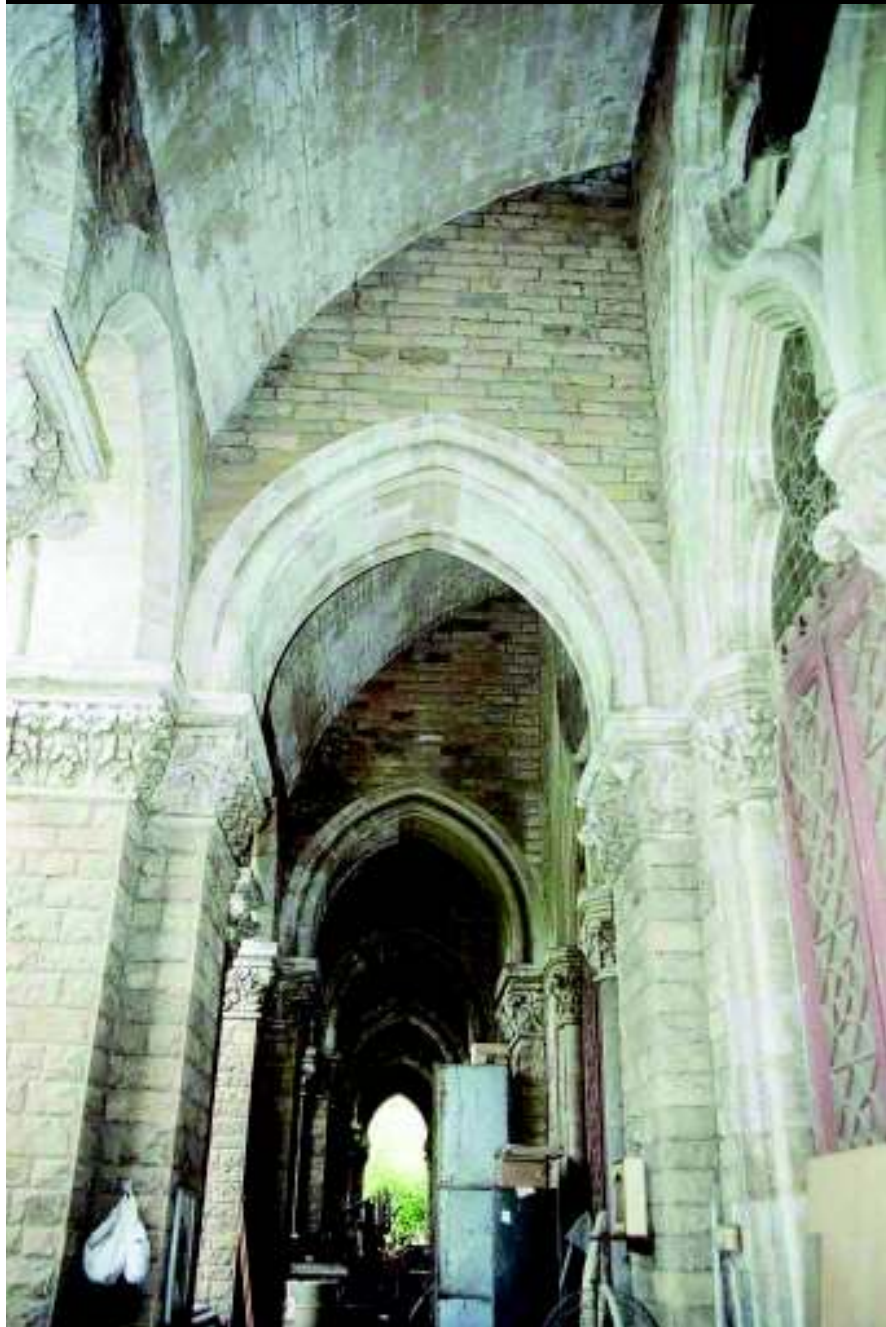
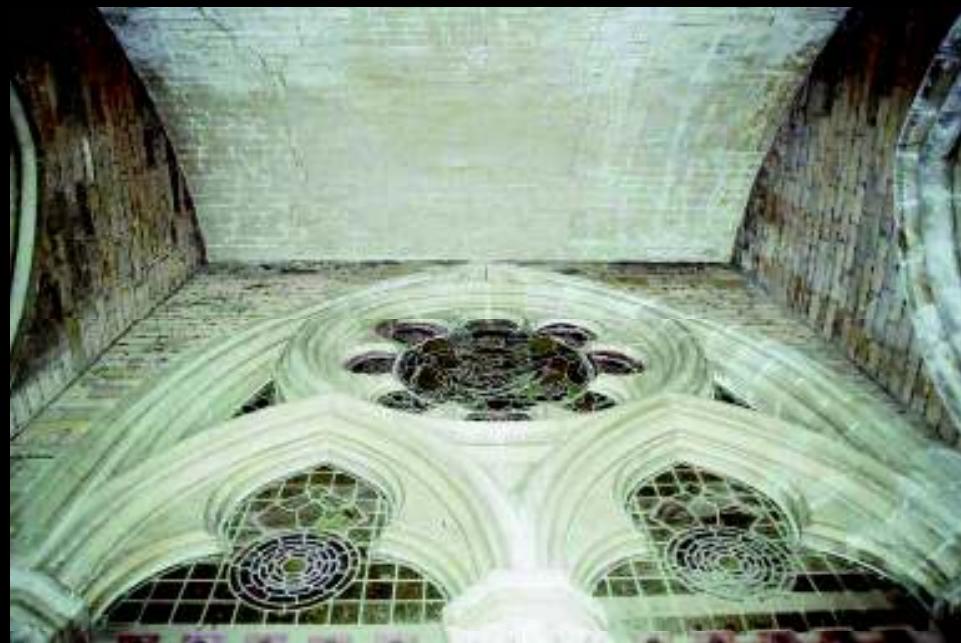
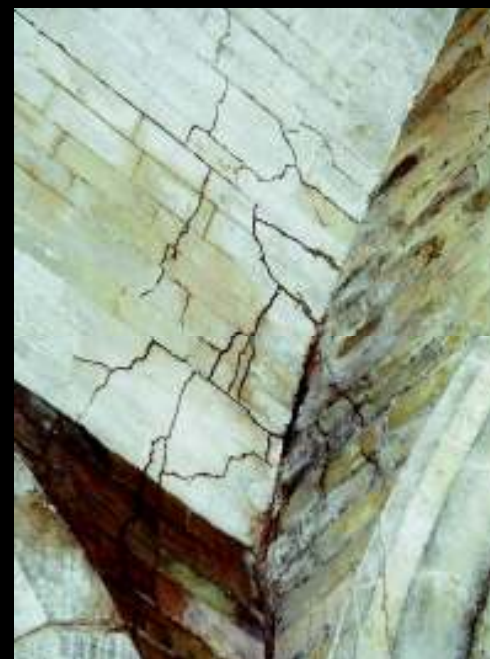
STRUCTURAL ISSUES: CONDITION OF BUTTRESS LEAKAGE & TERMITE RUNS

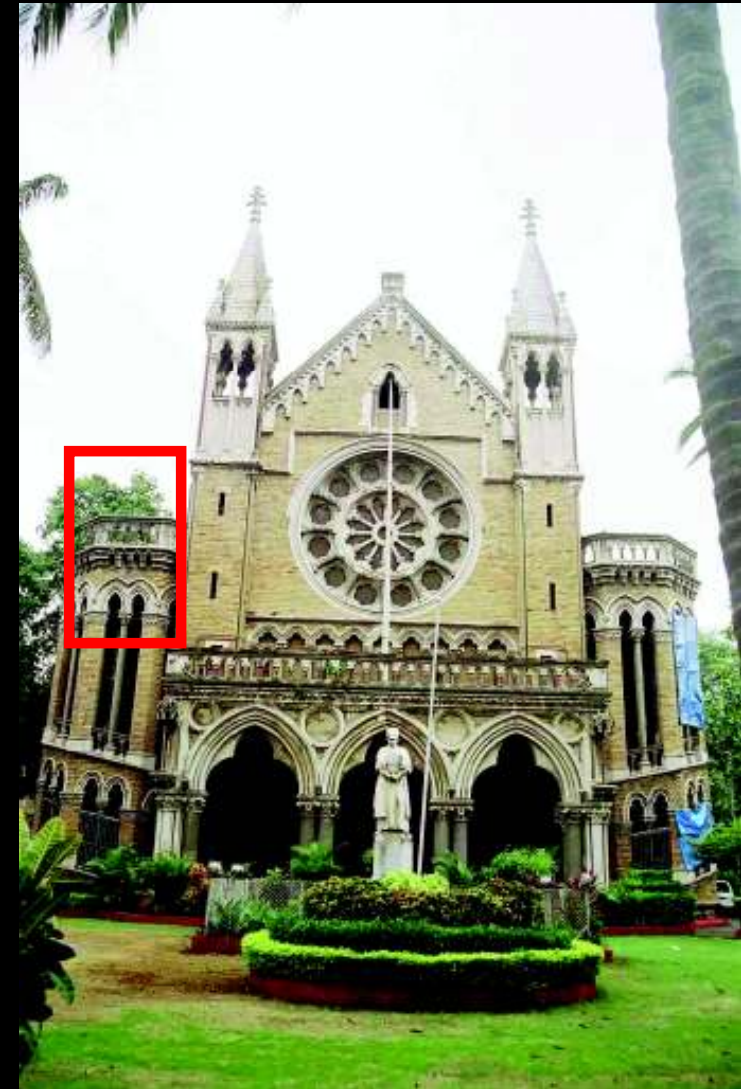
STRUCTURAL ISSUES: CRACKS, SETTLEMENT & DISPLACEMENT

Resetting cracks / settlement in parapets and other cracks

Grouting of cracks and fissures

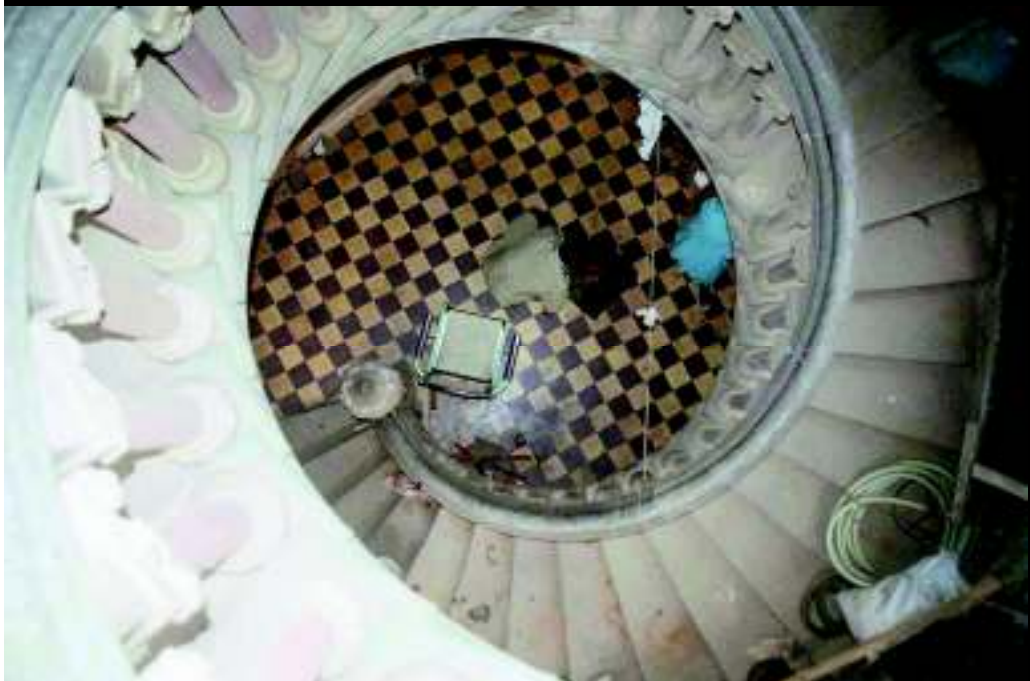
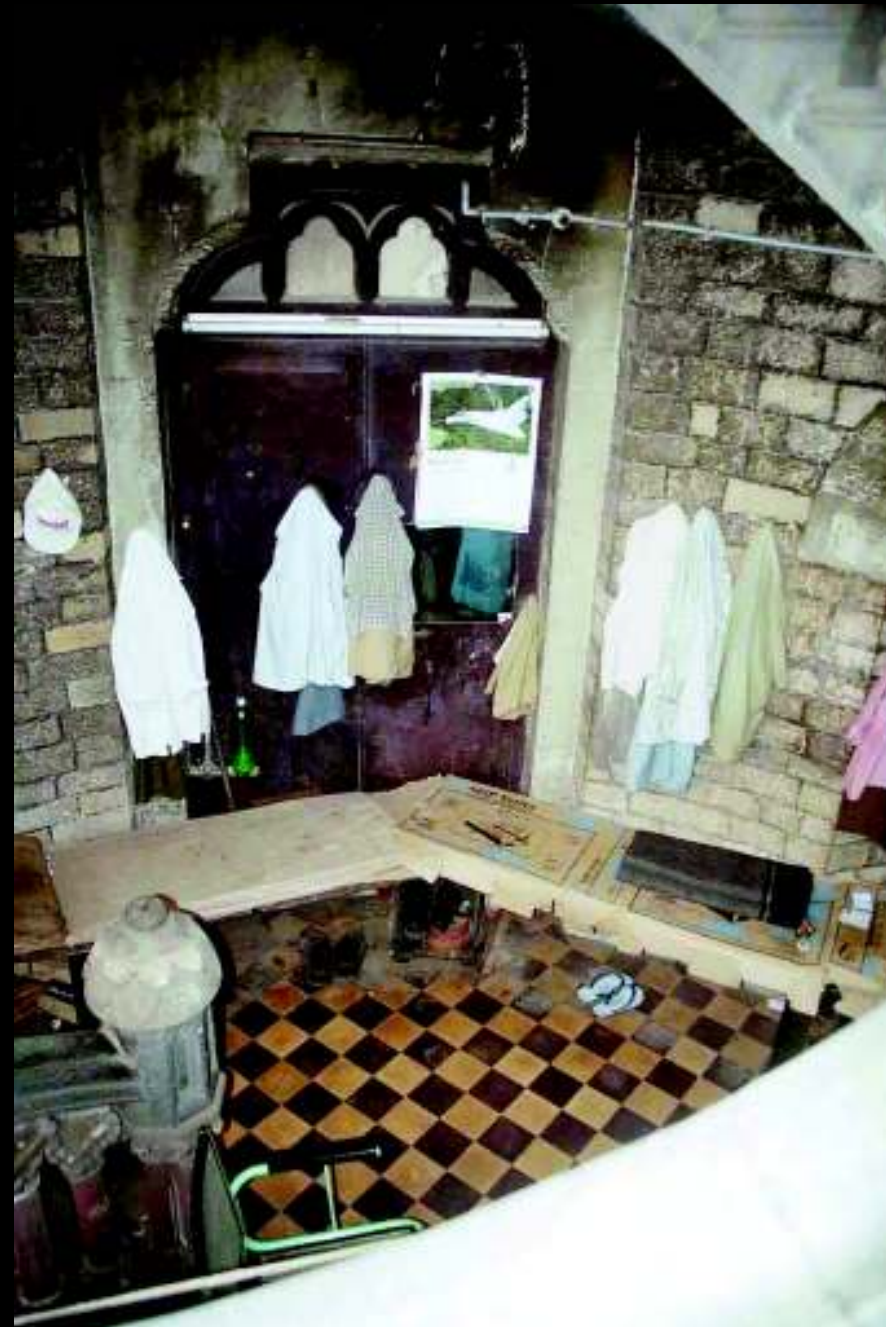
ARCHITECTURAL ISSUES: STAIRCASE

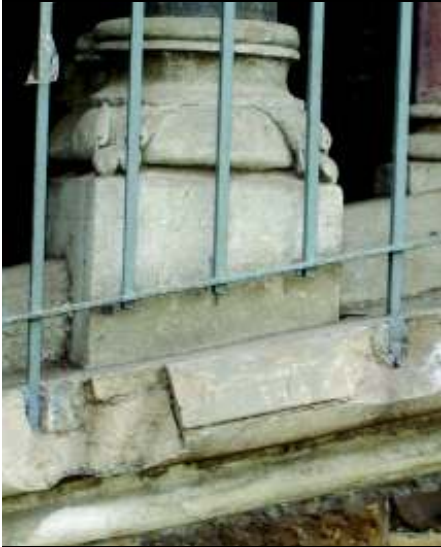
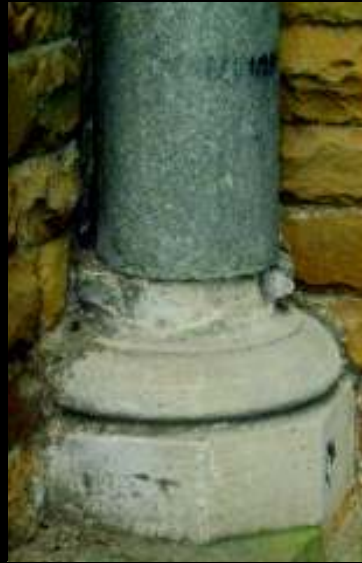
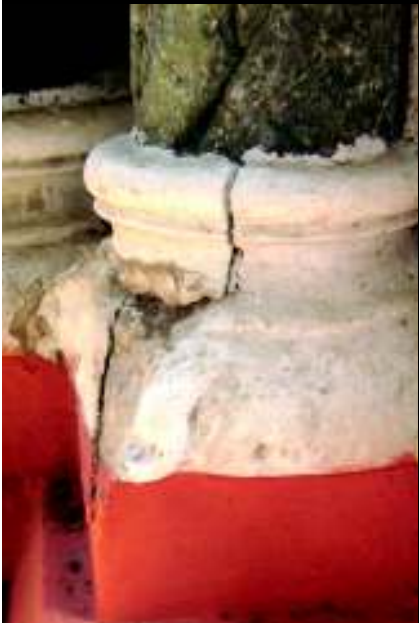
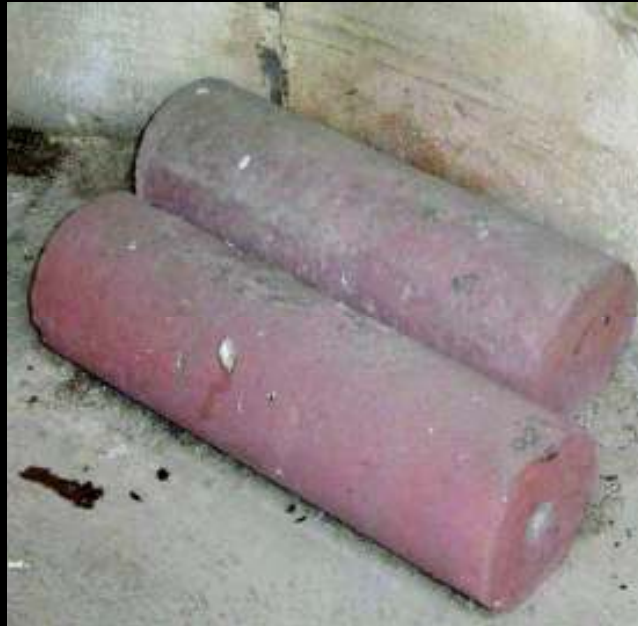
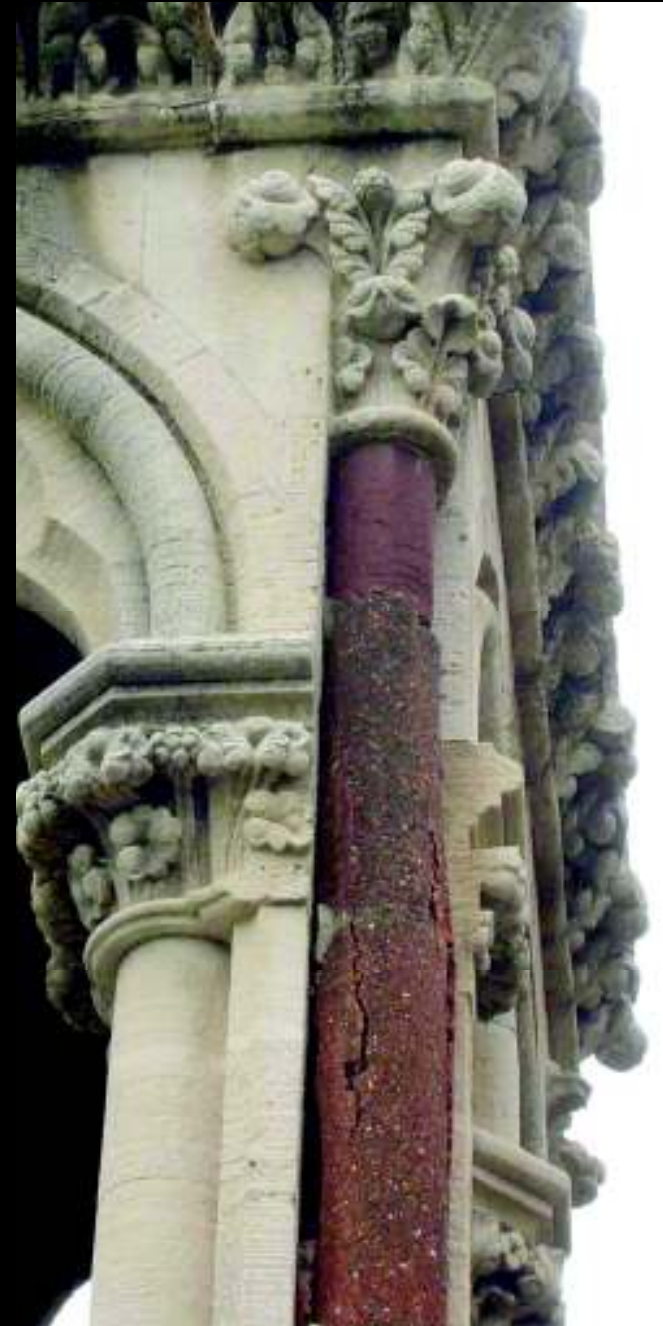
ARCHITECTURAL ISSUES: RESTORATION & DUTCHMAN REPAIR OF STONE

- Replacement of sandstone cylindrical sections (balusters and upper turrets) in like material with non corrosive SS or phosphor bronze dowels and epoxy plugs
- Replacement of missing sections of cylindrical dark grey stone column shaft in like material with non corrosive SS or phosphor bronze dowels and epoxy plugs & green stone columns in Porch area
- Replacement of carved Porebunder limestone sections of decorative carved details of column capitals, mouldings, bases etc in like material with non corrosive SS or phosphor bronze dowels and epoxy plugs
- Plastic repair of damaged Porebunder limestone carvings in lime mortar

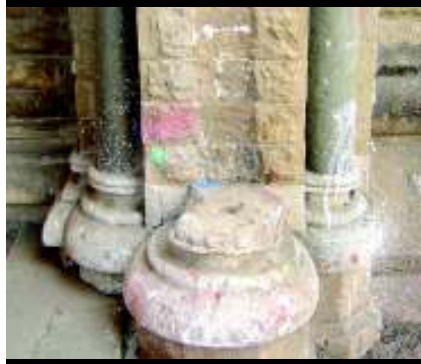
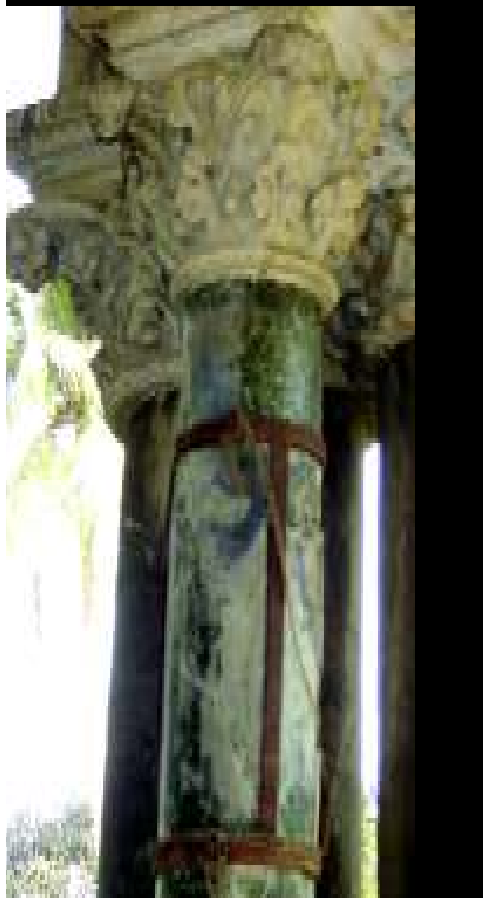
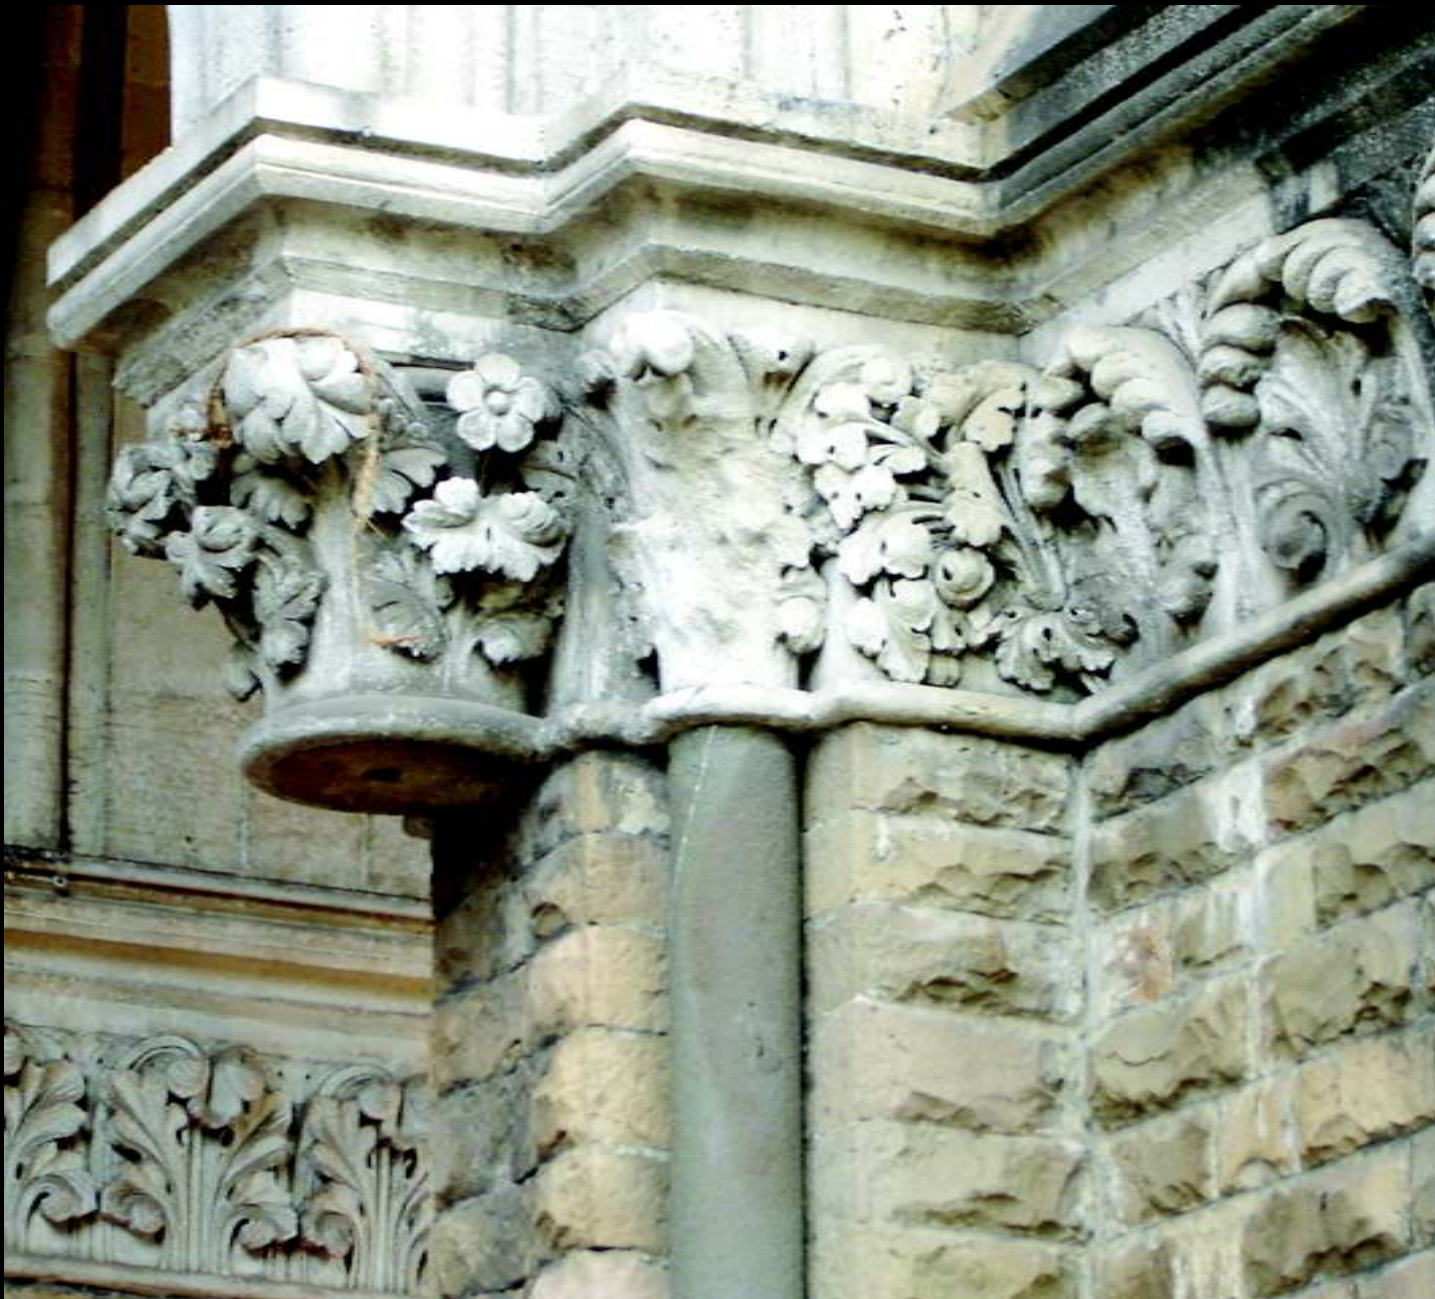
ARCHITECTURAL ISSUES: RECONSTITUTION OF MISSING STONE SHAFTS

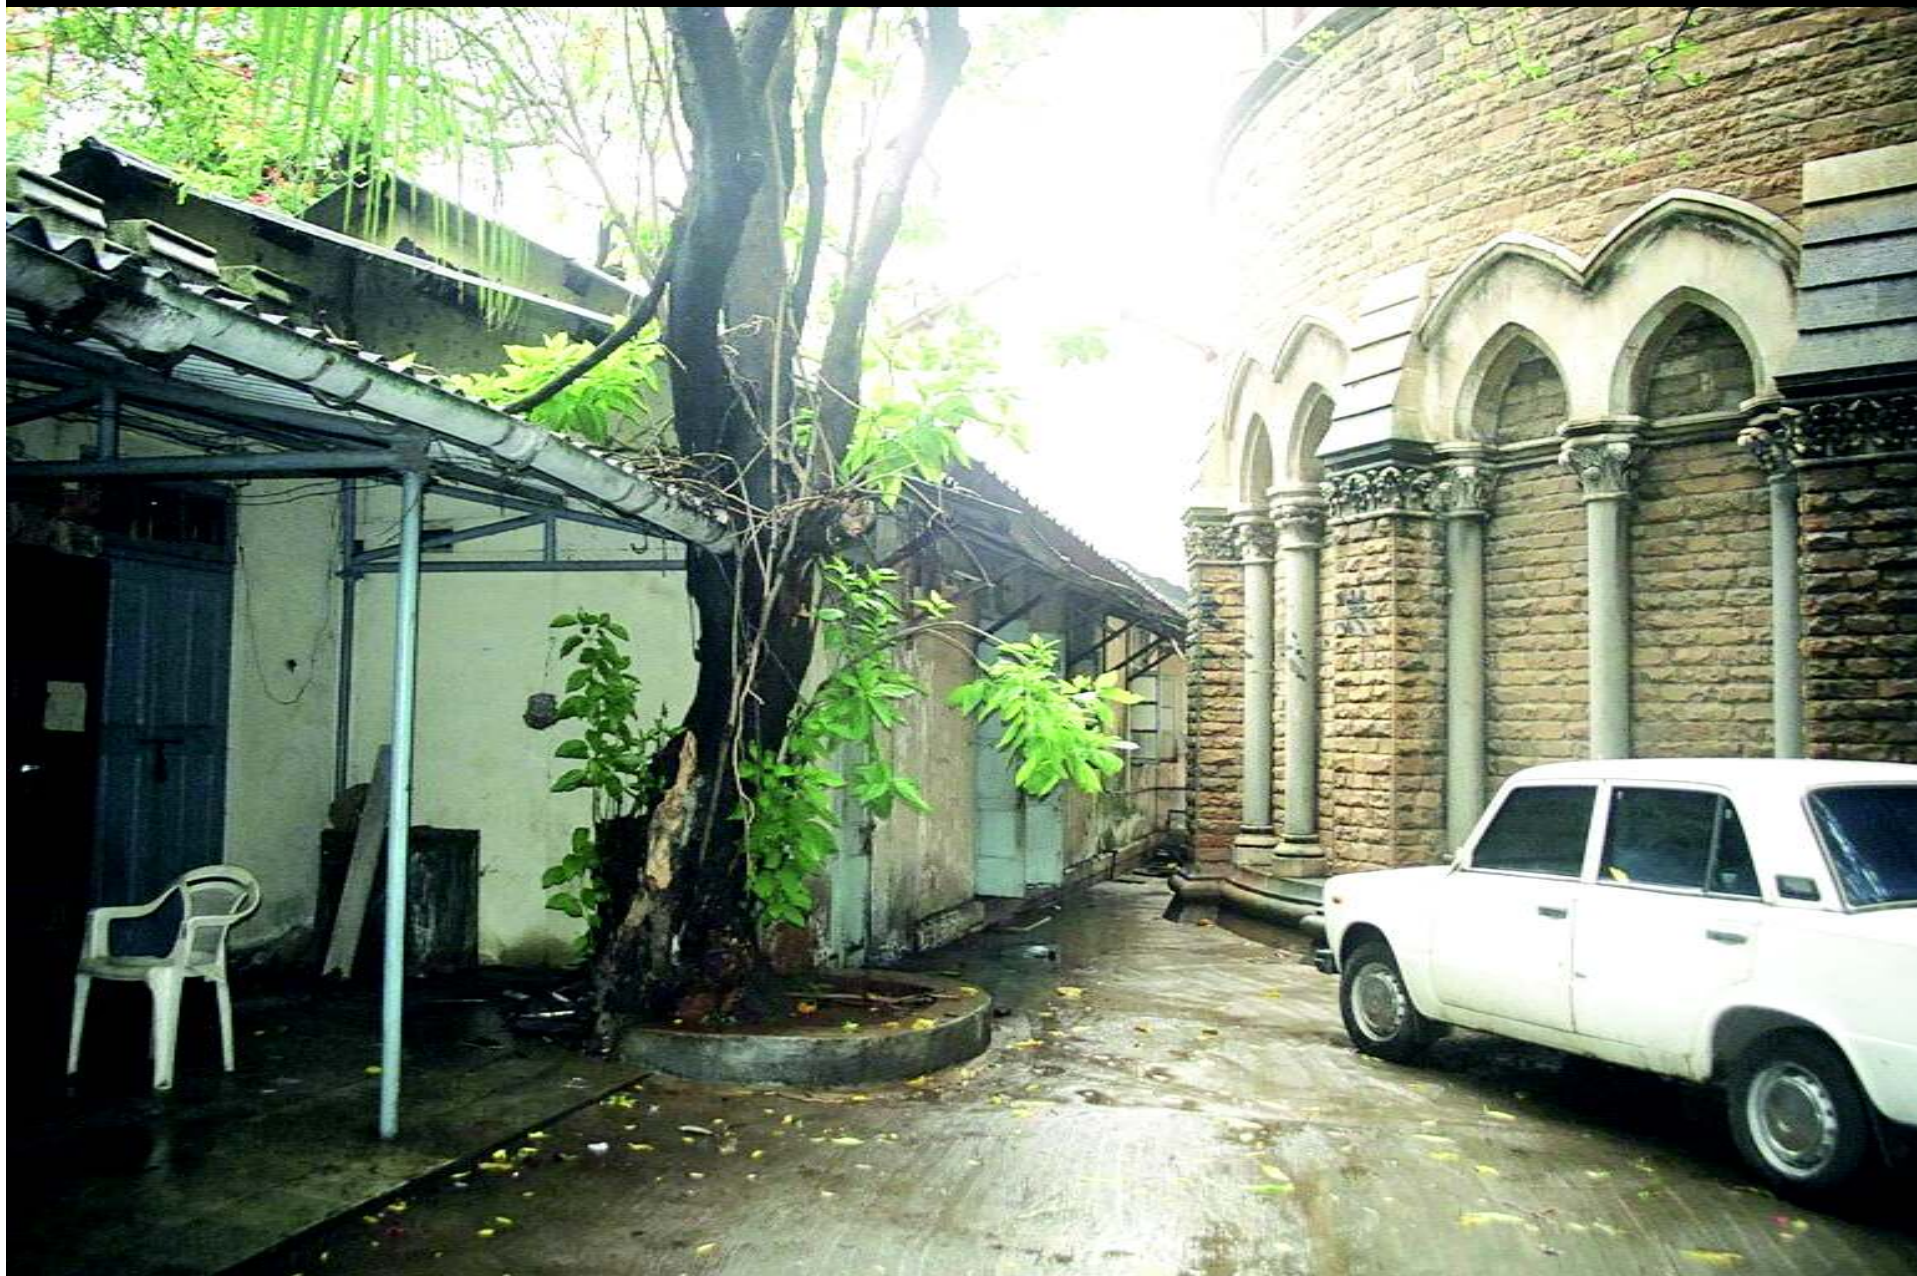
ARCHITECTURAL ISSUES: INSENSITIVE ADDITIONS & SITE ACCRETIONS

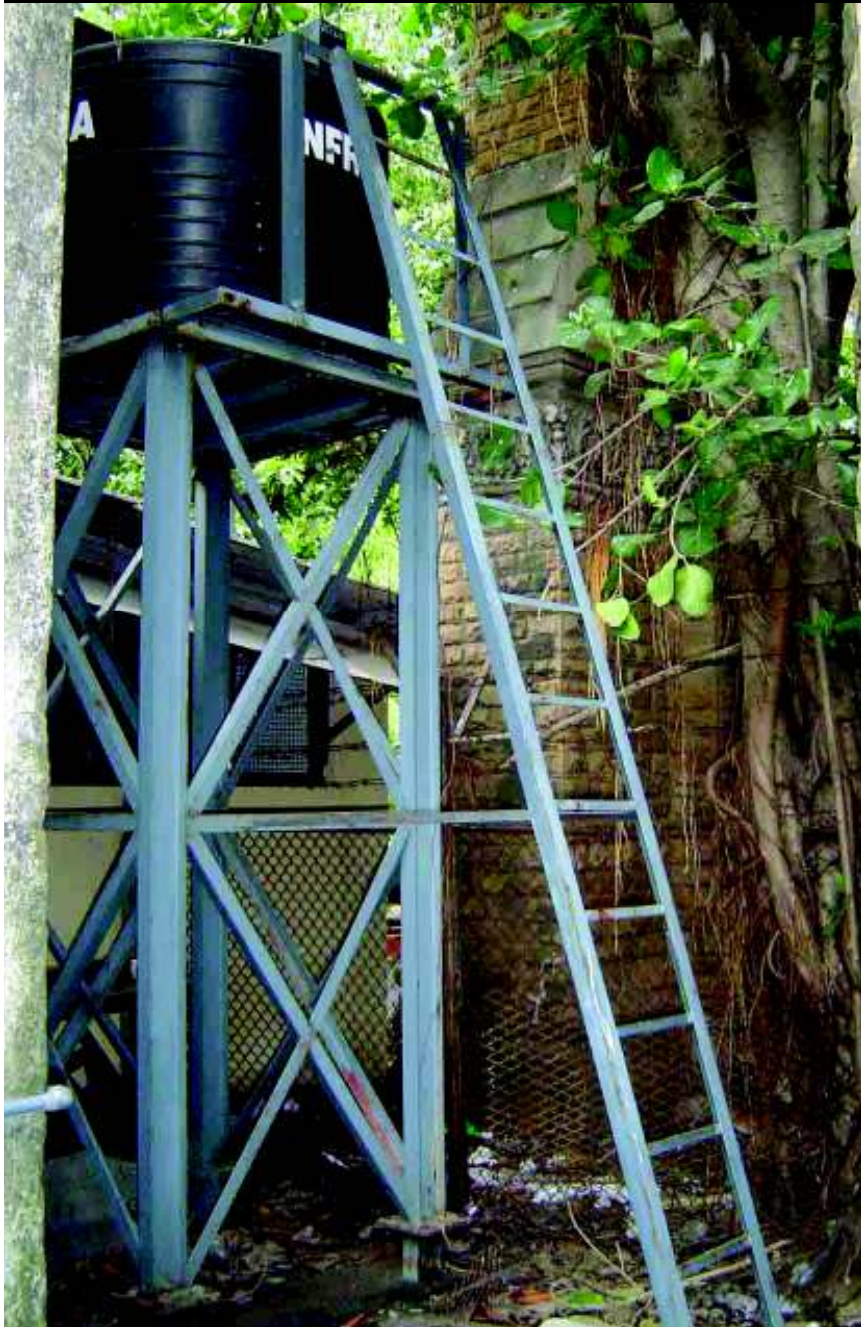
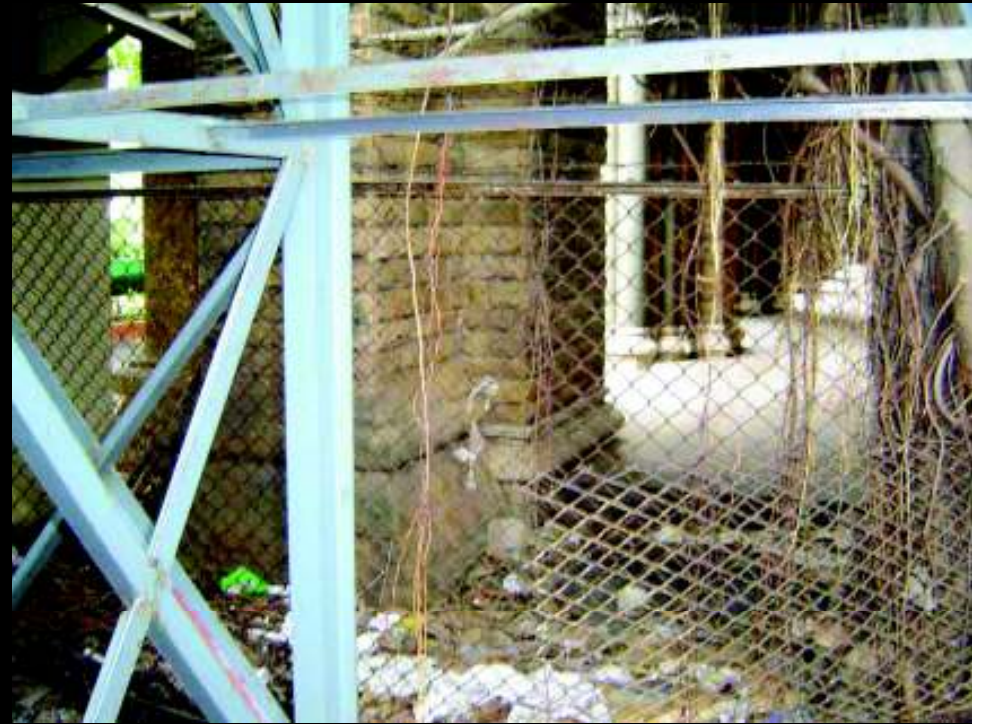
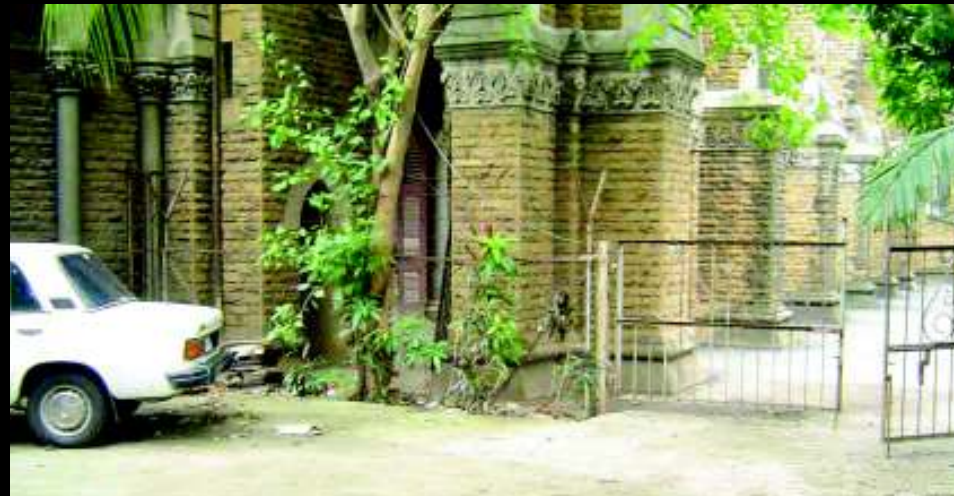
ARCHITECTURAL ISSUES: INSENSITIVE ADDITIONS & SITE ACCRETIONS
