Mumbai University Convocation Hall

Scheme for Restoration

Abha Narain Lambah Associates – Conservation Architects & Historic Building Consultants

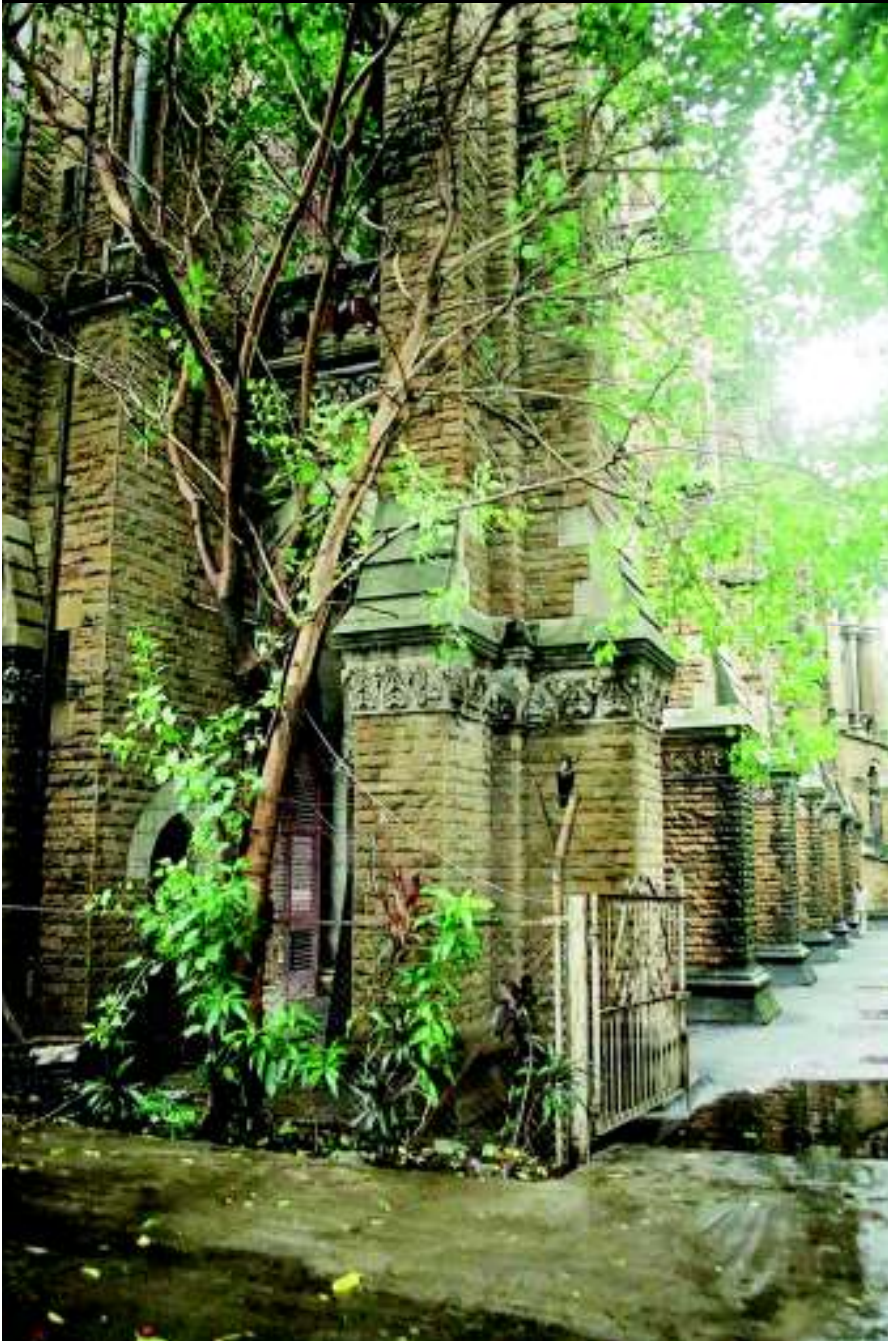
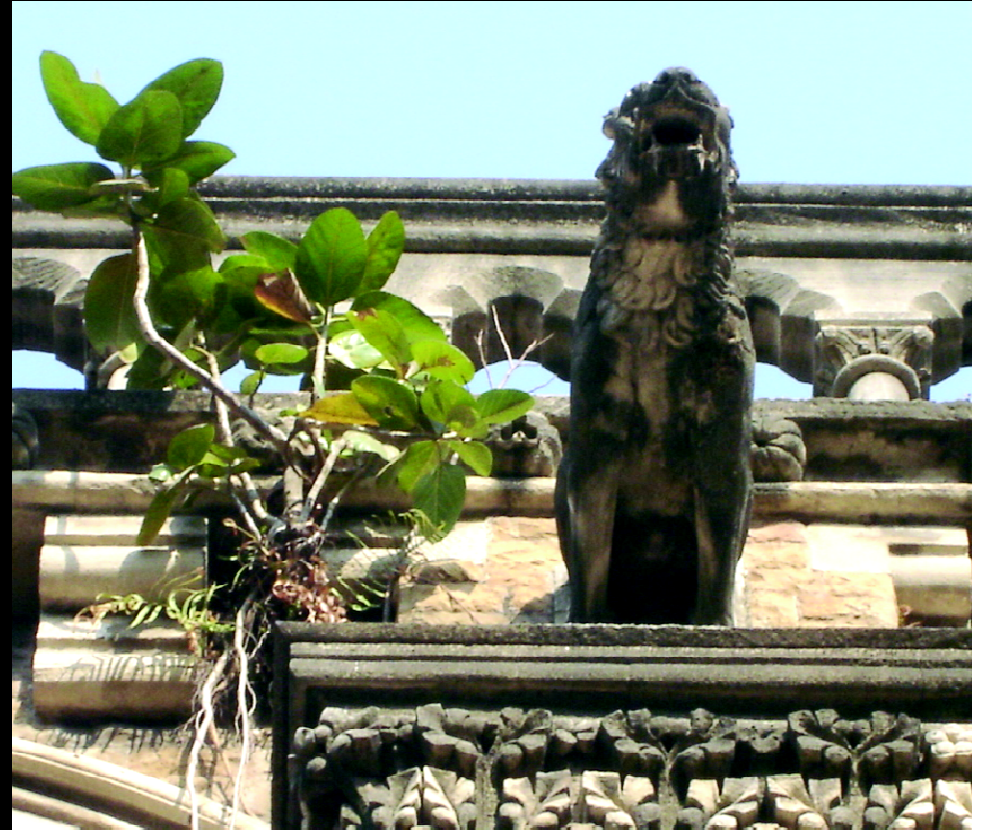
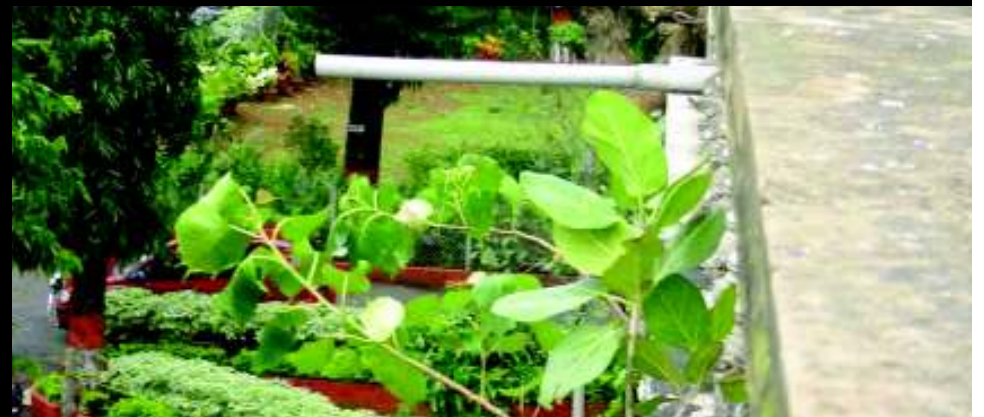
ARCHITECTURAL ISSUES: STONE STAINING/ ALGAE, FICUS

- Removal of bitumen stains in South face and along all gargoyle ends E&W façade
- Removal of algae, staining etc by water misting and anti algae treatment
- Repointing of rear south stairwell and rear south gable in lime mortar with masking tape
- Removal of old pointing in hard cement on north gable end and repointing in lime
- Removal of red paint along north and west façade base
- Stitching of cracks/Resetting of parapet stones on south east corner and south terrace
- Poulting and specialised cleaning of Stringer courses, mouldings, carvings and underside of vaults to remove residues and sulphate encrustations

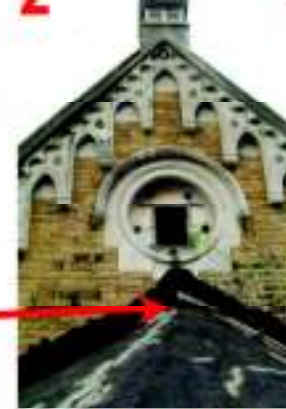
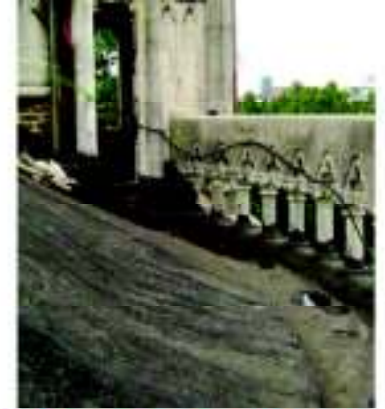
2 Roof over Apse distressed

Removal of bitumen layers, damaged planks from apse roof

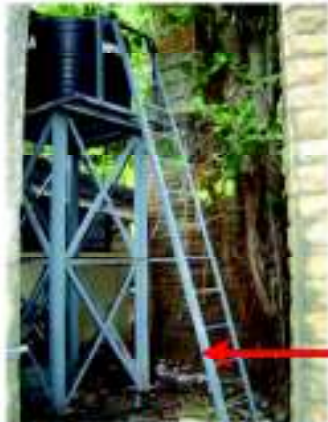
Stairwell masonry in need of pointing

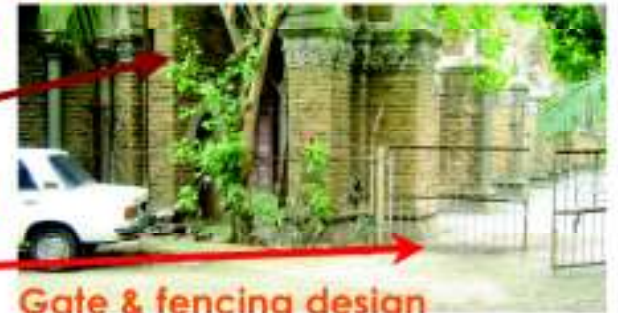
Gate & fencing design

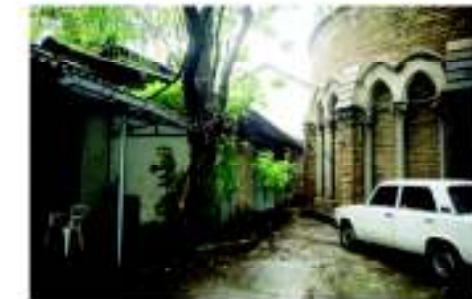
Incongruous Sheds

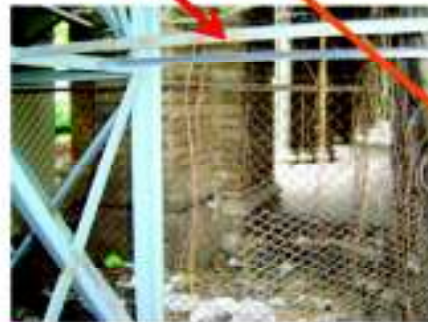
6 Ugly Wire mesh

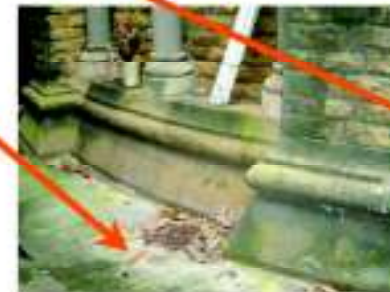
Stone Staining & Damaged Mouldings

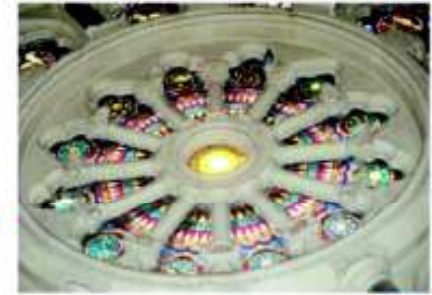
- 1 Zodiac Rose Window with damp on north gable end. Acoustic felt de-lamination
- 2. Centre piece of Rose Window by Heaton Butler & Bayne
- 3. Detail of Rose window showing Cancer and Leo
- 4. Iron Brackets designed by George Twigge Molecey
- 5. Insensitive installation of Tube lights

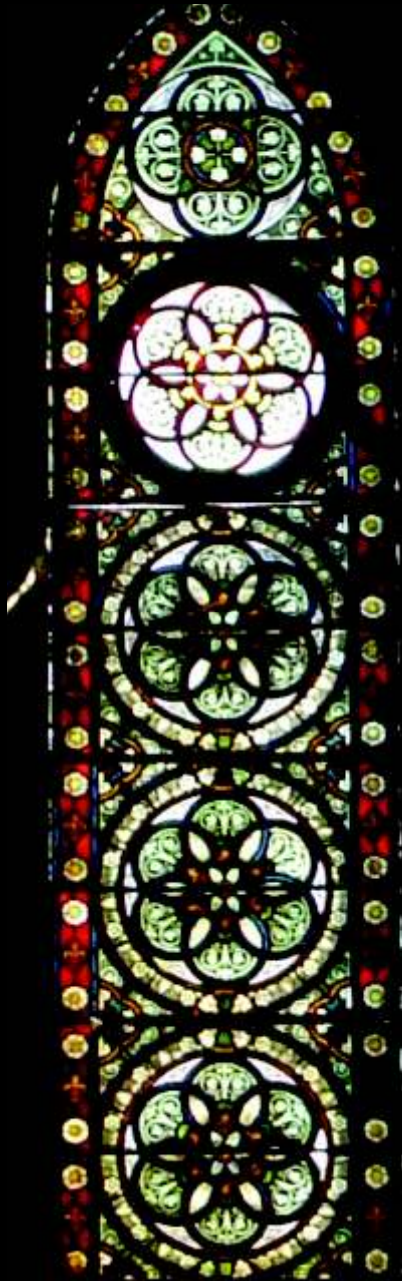
From the Studio of Heaton Butler & Bayne
