DOCUMENTATION AND PREPARATION OF CONSERVATION GUIDELINES
for
HERITAGE BUILDINGS AND PRECINCTS IN VASAI - VIRAR SUB - REGION
VOLUME IV: HERITAGE ASSETS IN THE GREEN ZONE

Final Report of the
DOCUMENTATION AND PREPARATION OF CONSERVATION GUIDELINES
for
HERITAGE BUILDINGS AND PRECINCTS IN VASAI – VIRAR SUB – REGION

VOLUME IV: APPENDICES
LIST OF HERITAGE ASSETS IN THE GREEN ZONE

December 2008

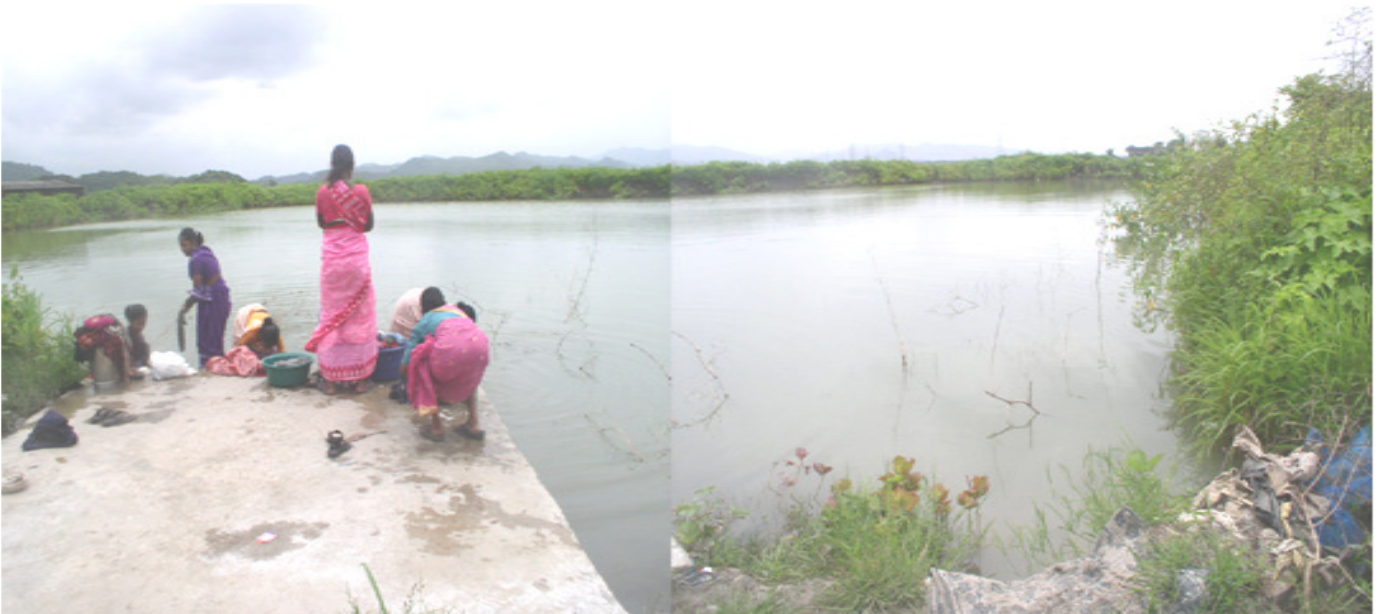
Washing platform along one of the edges of the talav

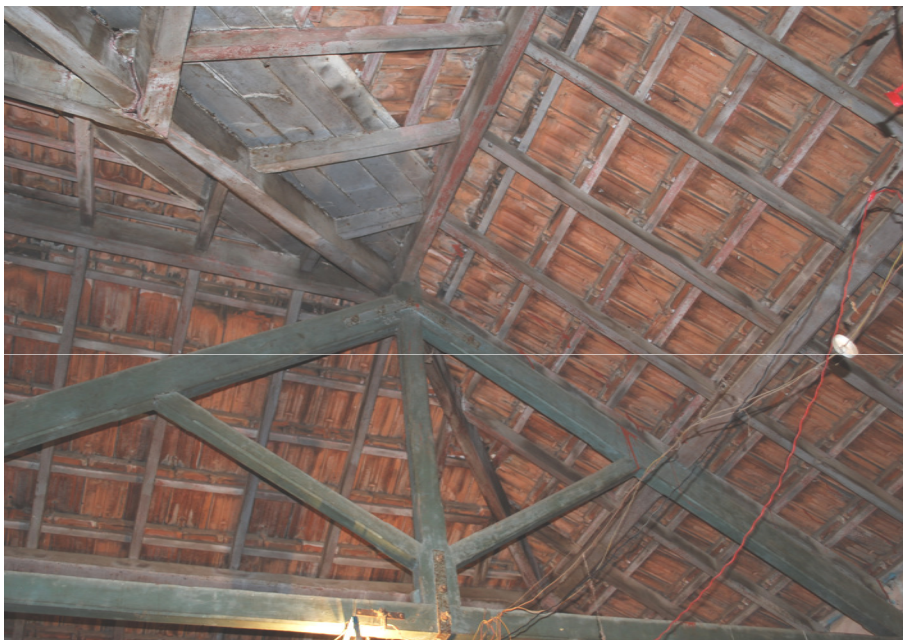
Details of roof construction

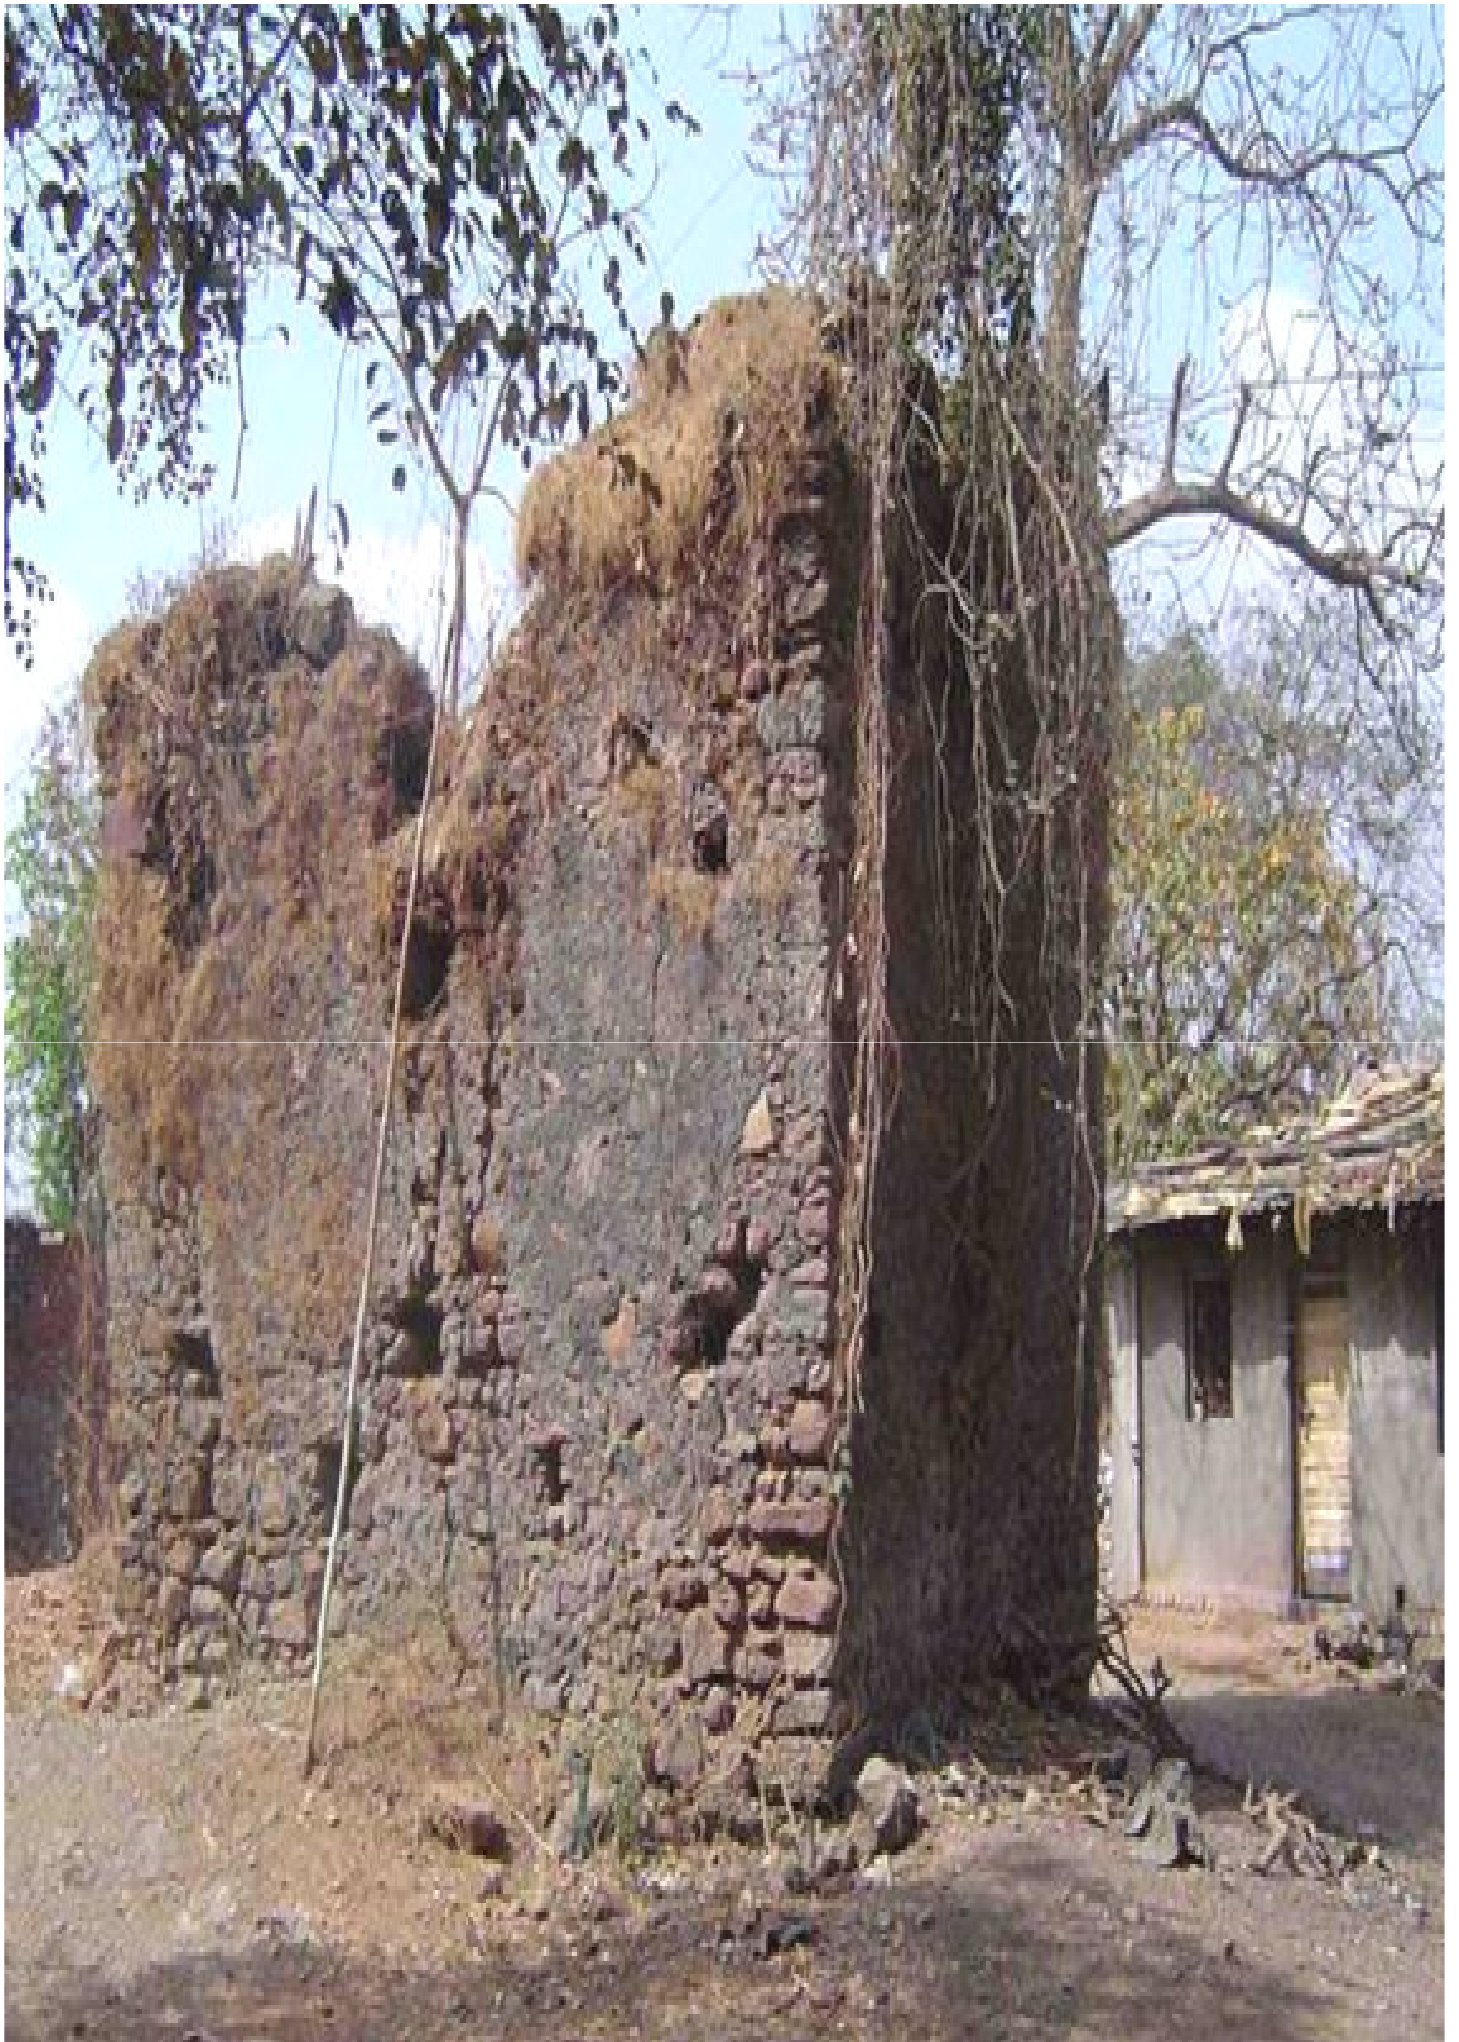
4	VALUE CLASSIFICATION								GRADE	
	B(his)	B(cul)	B(seh)	B(arch)	B(tech)	B(lm)	B(ev)	B(bio)	B(reus)	III
5	CONDITION ASSESMENT									
5.1	Structural System and Materials									Assessment
	Foundation: Stone Foundation.									Cannot be assessed
	Plinth: Stone plinth. Signs of rising dampness are seen along the plinth.									Ruin
	Walls: Load bearing stone masonry walls, which are the only remnants of the structure. The walls show cracks as well as severe wear and tear. In addition, the growth of plants, creepers and trees on the structure is observed.									Ruin
	Roofing: The roof of the structure has collapsed.									Ruin
	Fenestration / Openings: The four existing walls of the structure do not have any openings.									Ruin
	Finishes: The plaster / paint has worn off leaving the stone exposed.									Ruin
	Compound / Fence / Gate: The fort wall is broken at several places and only its ruins can be observed.									Ruin

5.4	Overall Condition Assessment (based on 5.1, 5.2 and 5.3): This structure is in complete ruin.	RUIN
	0: RUIN / NON EXISTENT 1: POOR 2: FAIR 3: GOOD	
6	FUTURE RELEVANCE

The ruin of the hambara showing growth of creepers

6.1	DP Remarks: None.	
	Perceived Threats: If not maintained the structure could collapse in the near future.	
6.2	Owners / Tenants / Occupants / Community / Organizational Aspirations: None identified.	
7	MISCELLANEOUS	
	Additional Notes / References and Documents Available: Records and information gathered from the Sasunavghar Grampanchayat.	
8	RECOMMENDATIONS & SUGGESTIONS FOR IMPLEMENTATION	
	The ASI or the State Archaeology Department need to be made aware of this important heritage asset and Immediate steps for the restoration of this heritage asset should be taken.

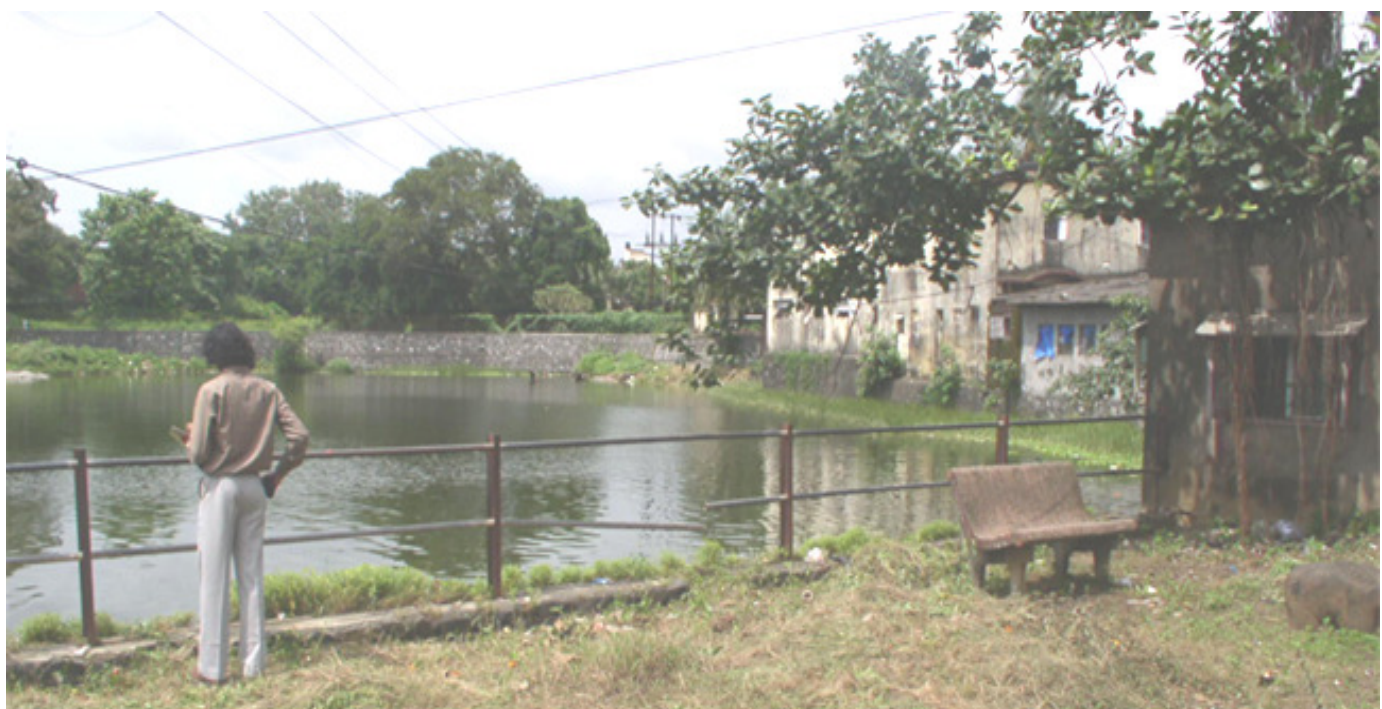
One of the sides has buildings built right on the edge

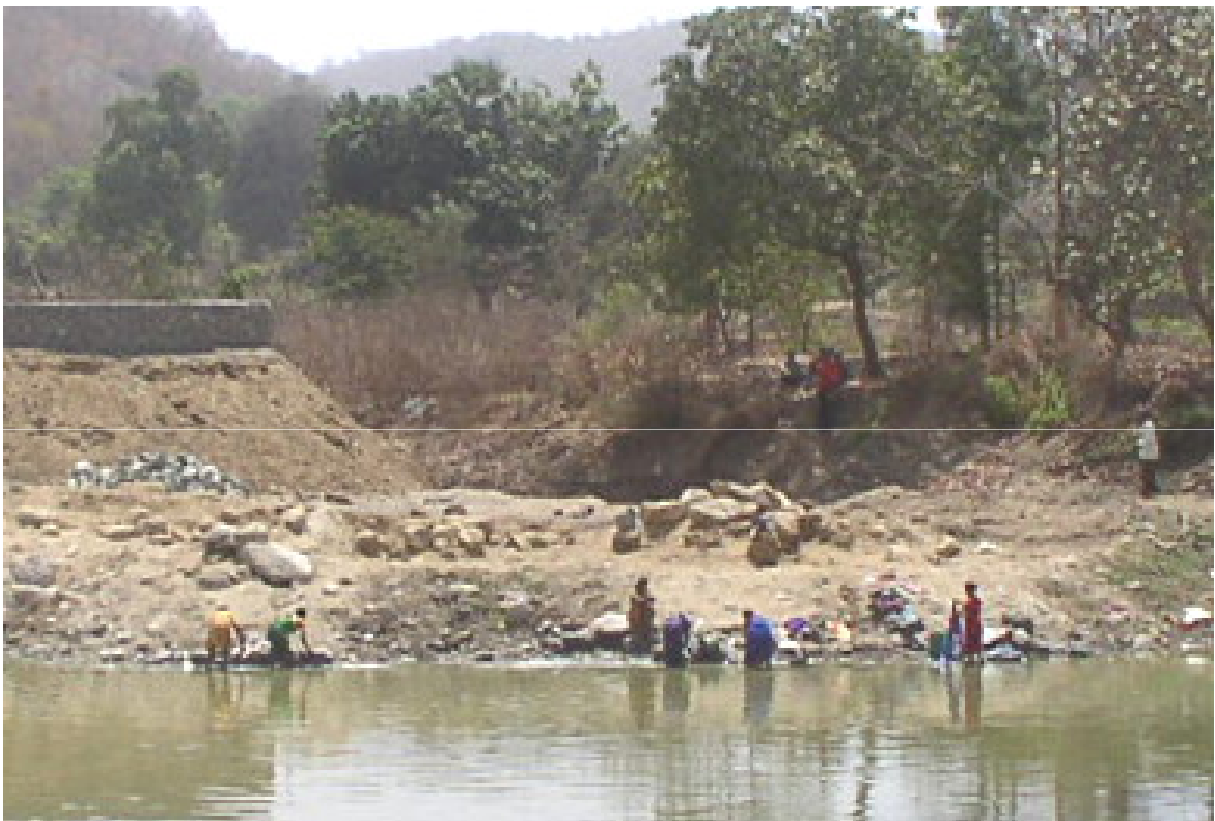
Washing activities along the edge of the talav

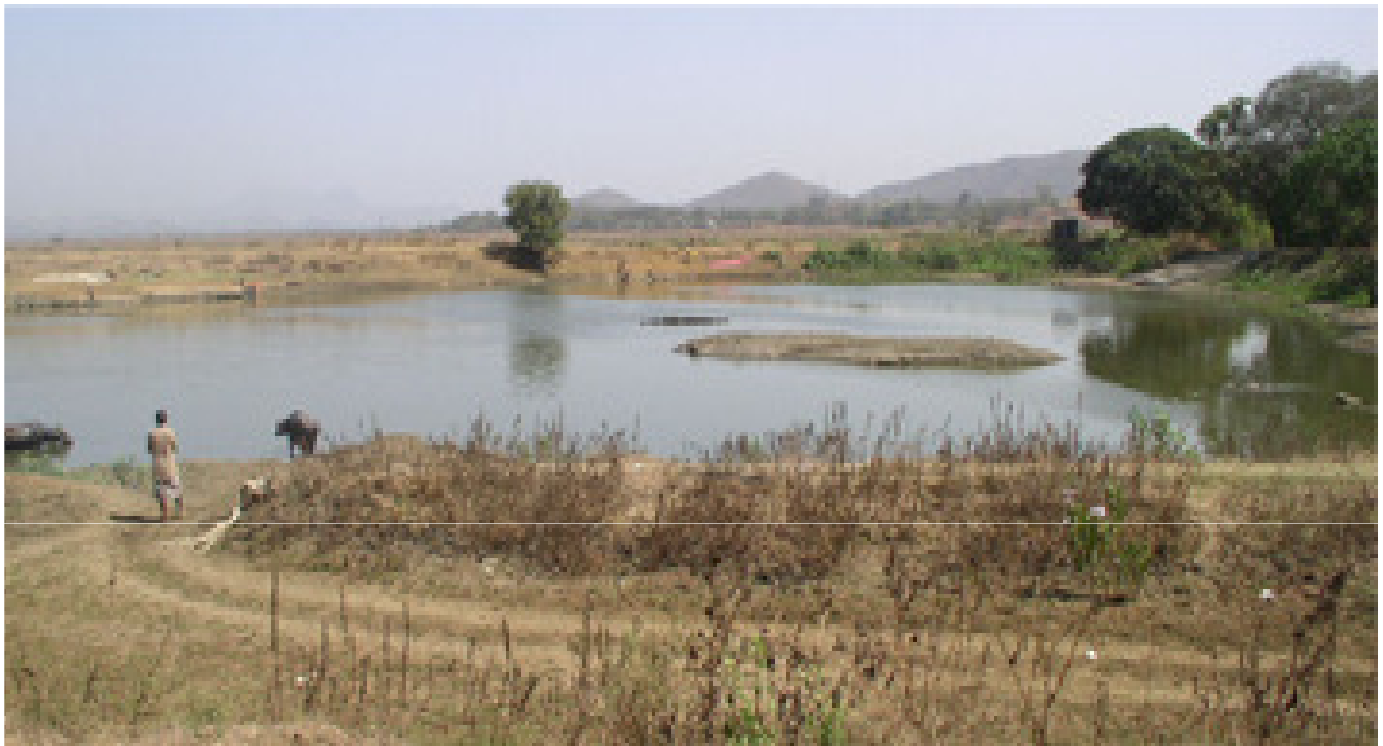
Soft landscape around the edge of the talav

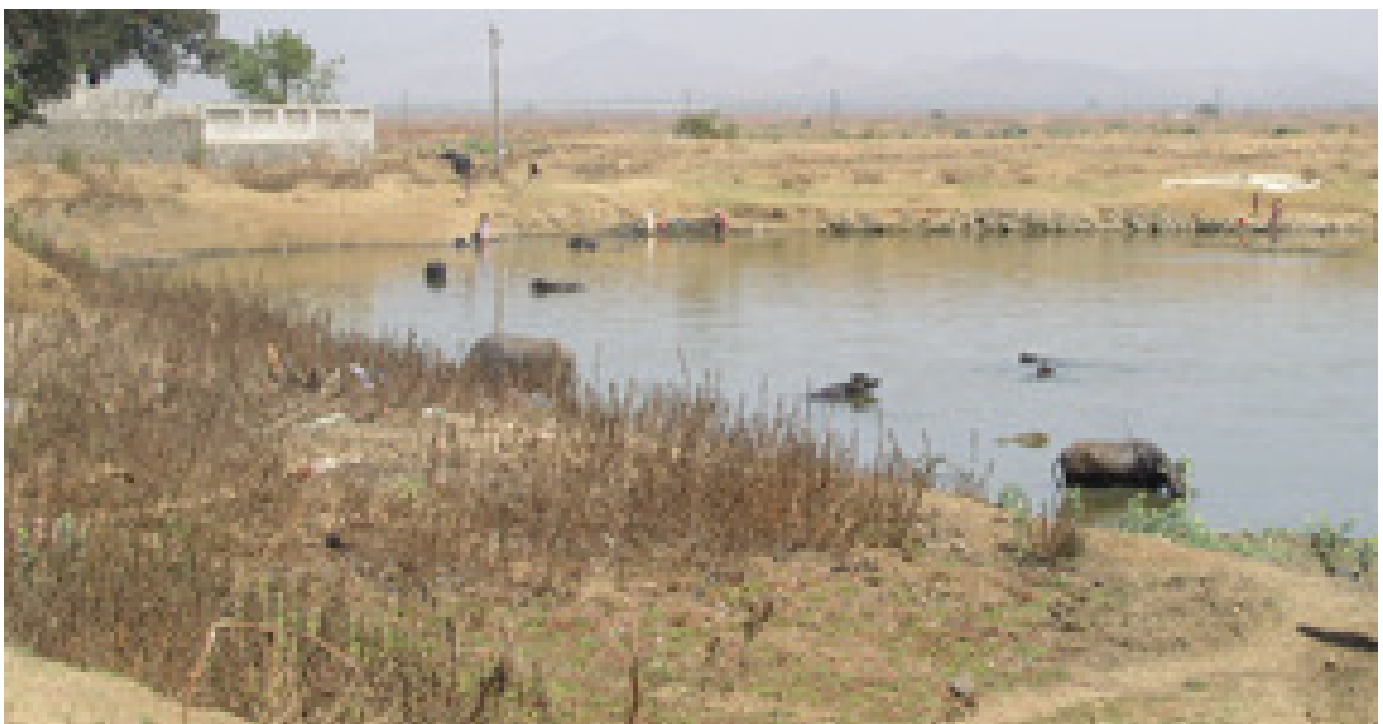
0: RUIN / NON EXISTENT 1: POOR 2: FAIR 3: GOOD	
6	FUTURE RELEVANCE	
6.1	DP Remarks: Reserved as a Water Body.	
	Perceived Threats: The increase in the surrounding cattle sheds has lead to deterioration of the water within the talav. This needs to be safeguarded against.

Washing of cattle within the talav

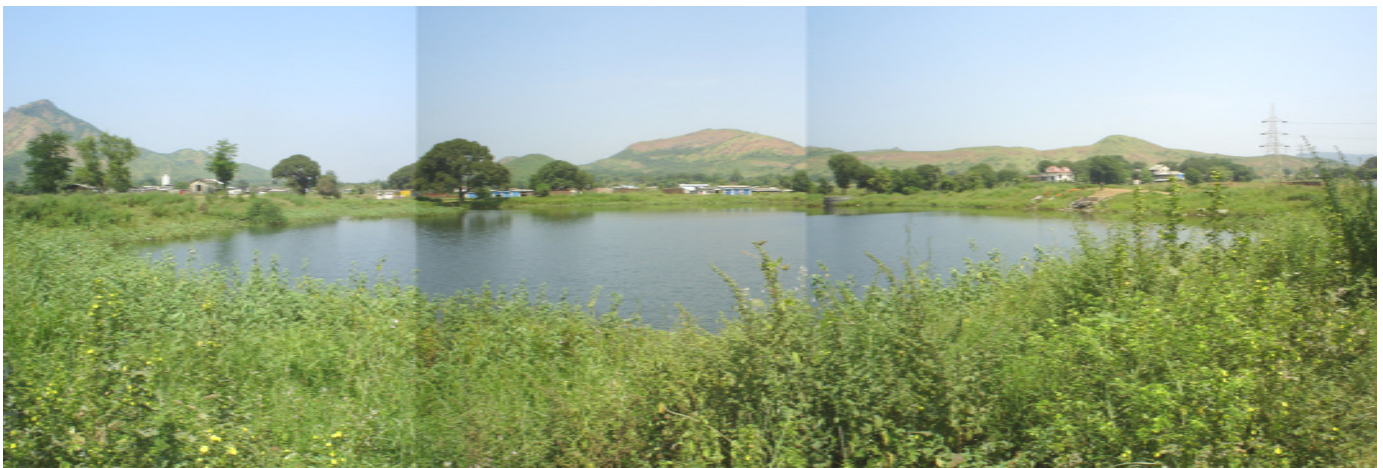
Soft landscape around the edge of the talav

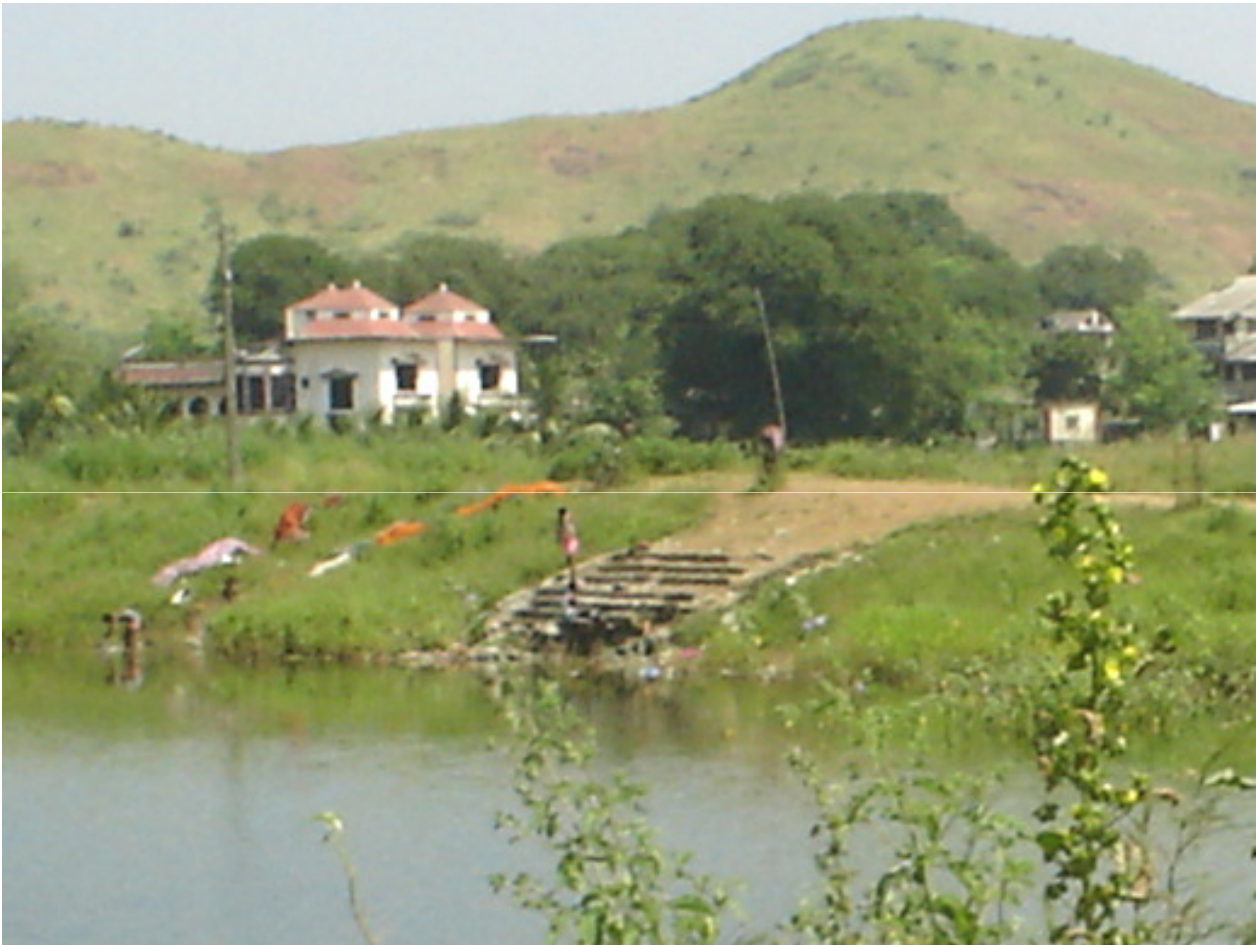
Steps for washing along one of the edges

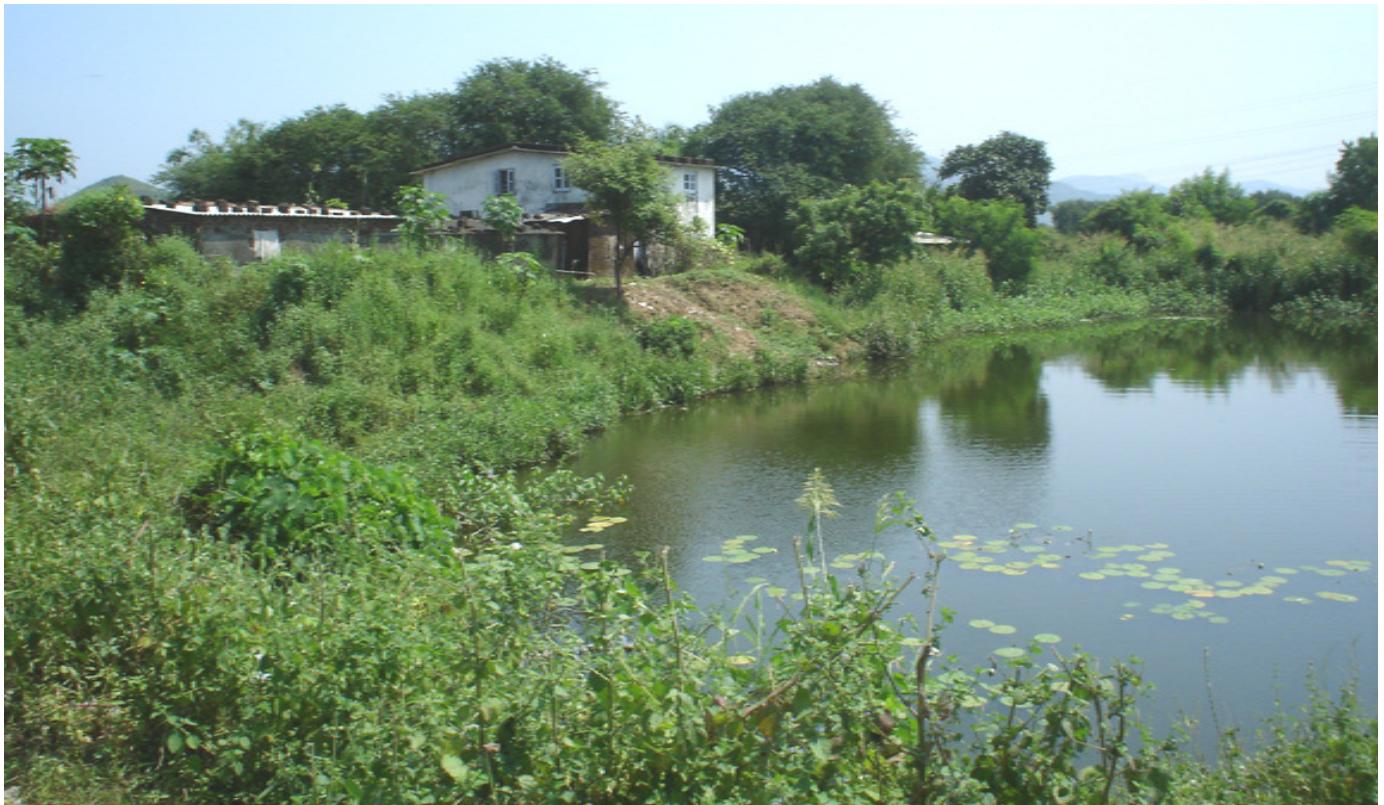
Adivasipada around one of the edges of the talav

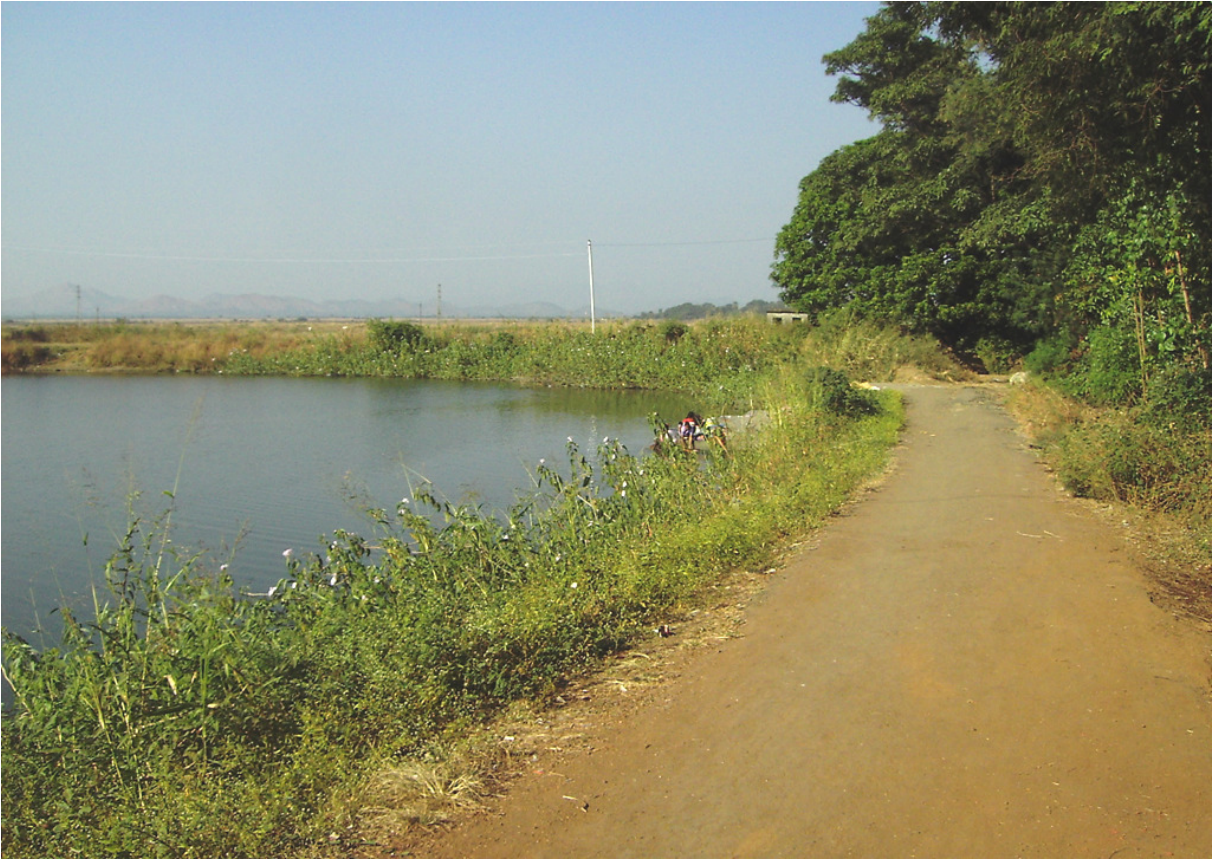
Road along the edge of the talav

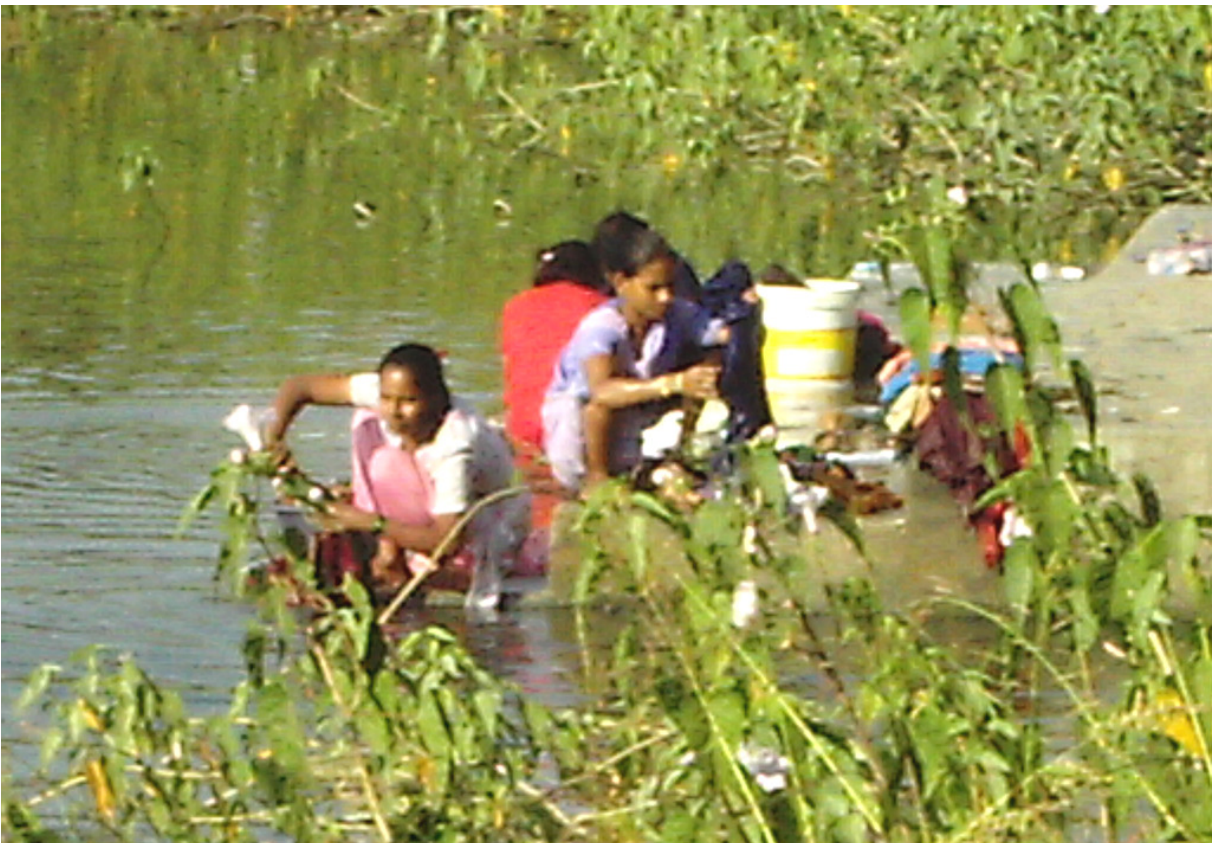
Washing activities on steps along the edge

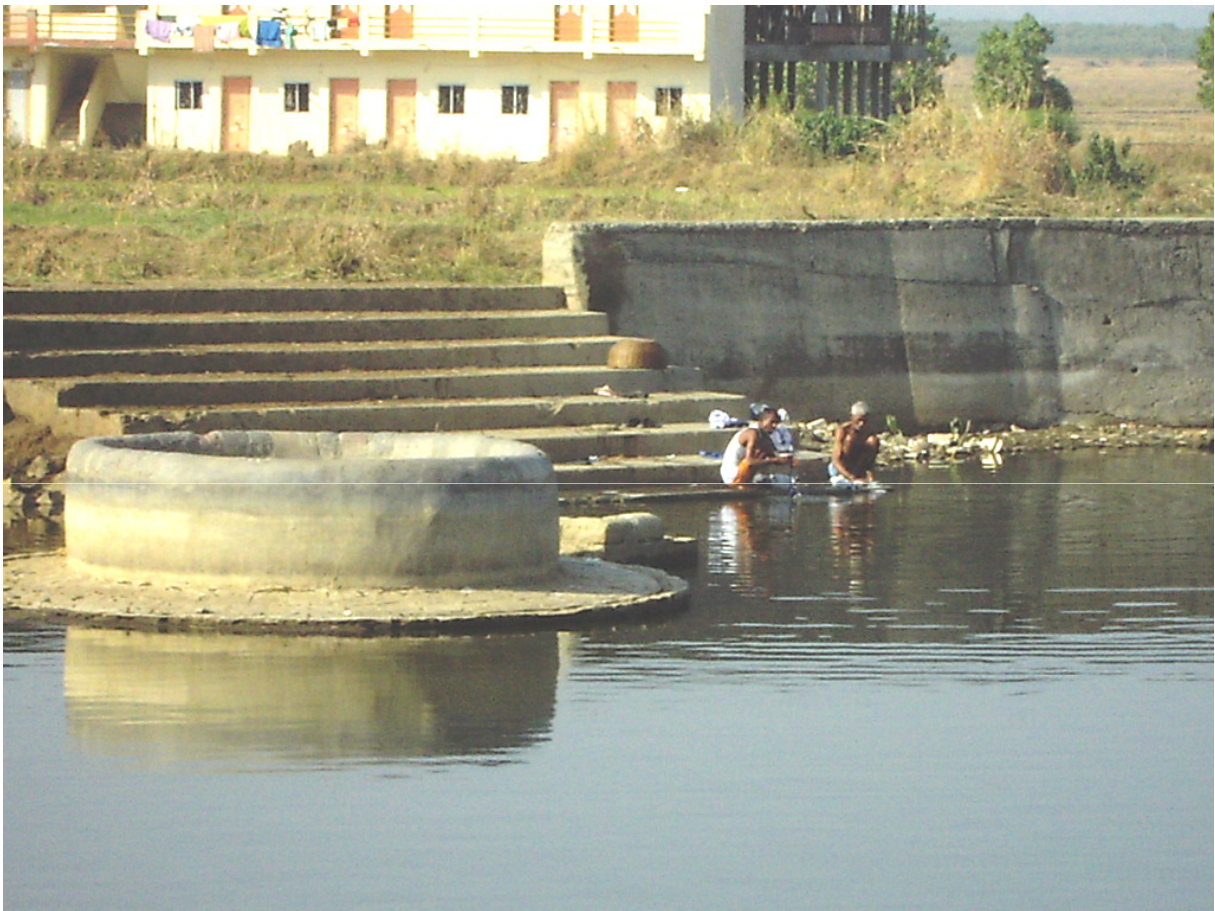
Steps for washing and a well near the edge

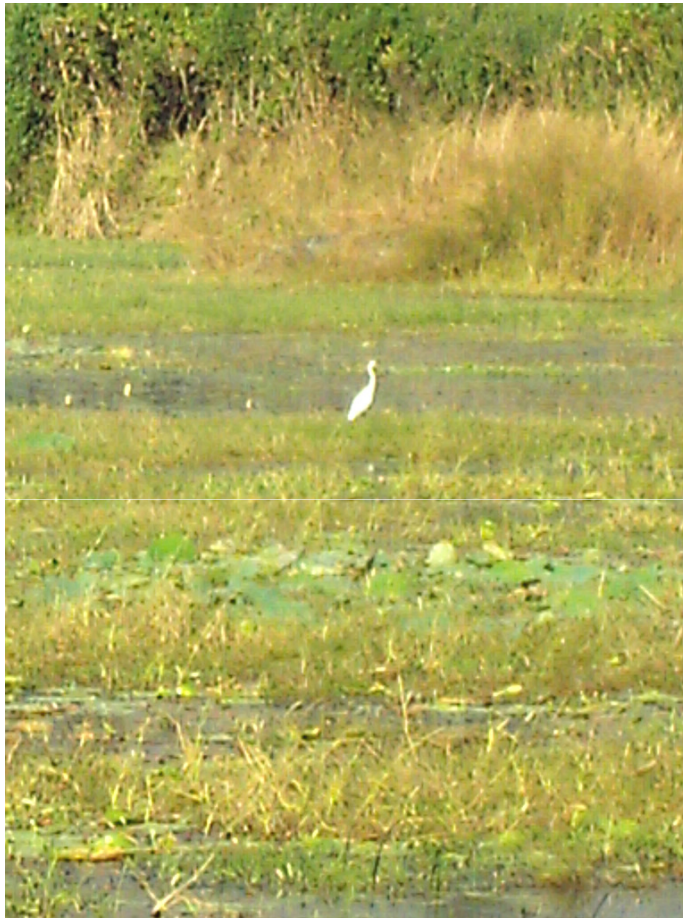
Presence of migratory birds in the talav

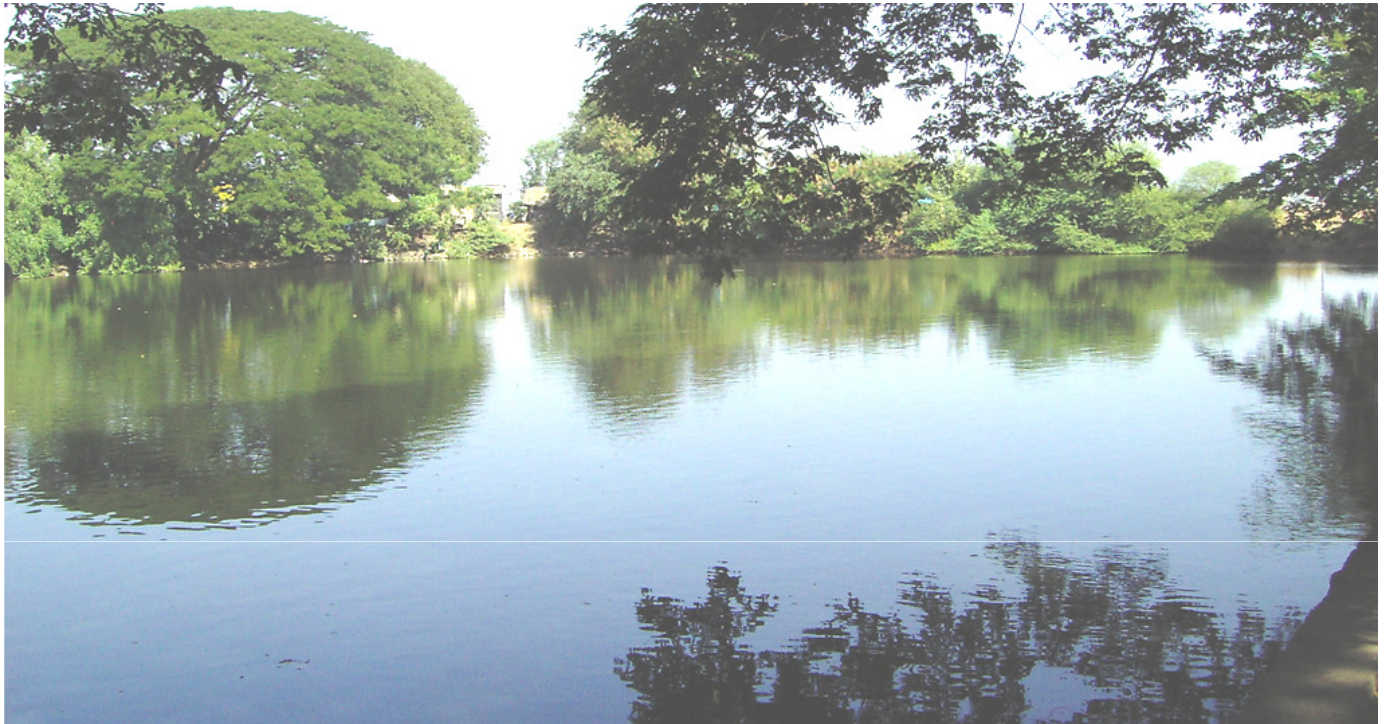
Soft landscape around the edge of the talav

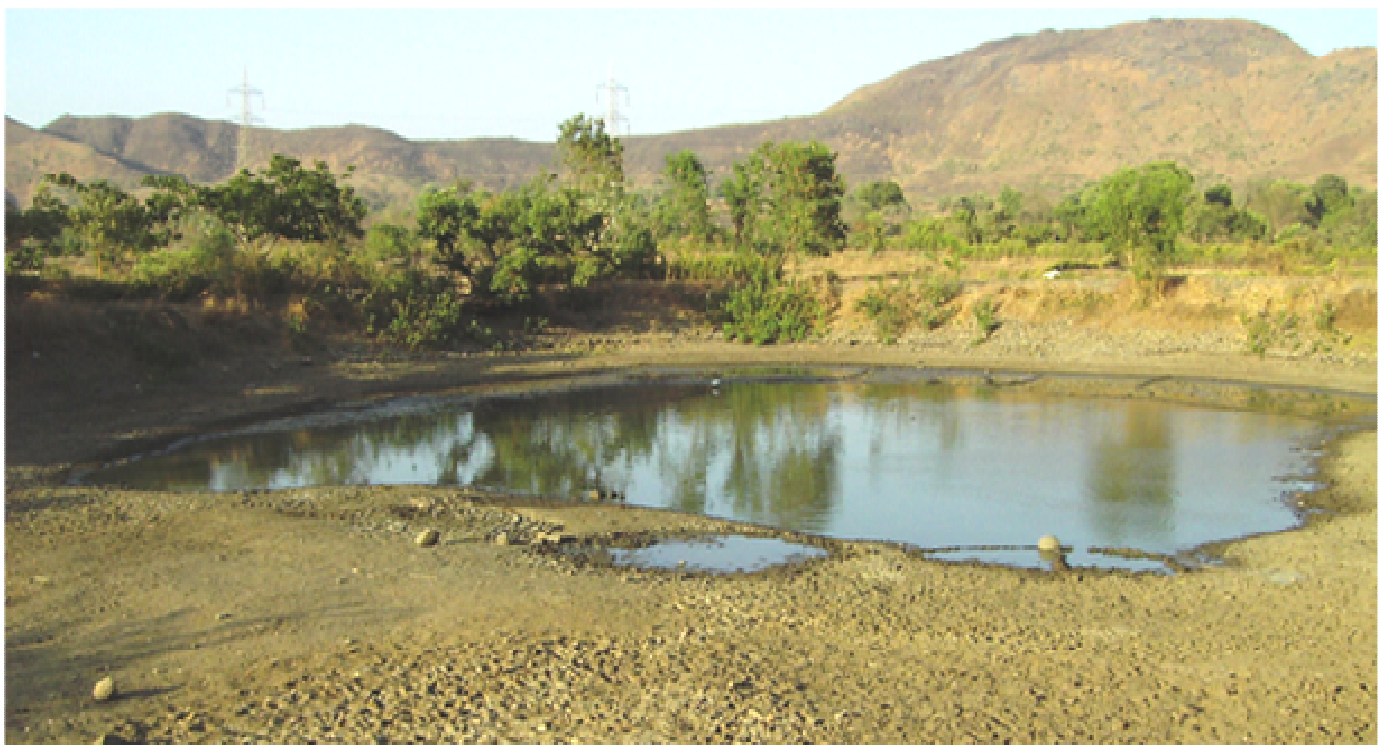
The talav dried up during summer

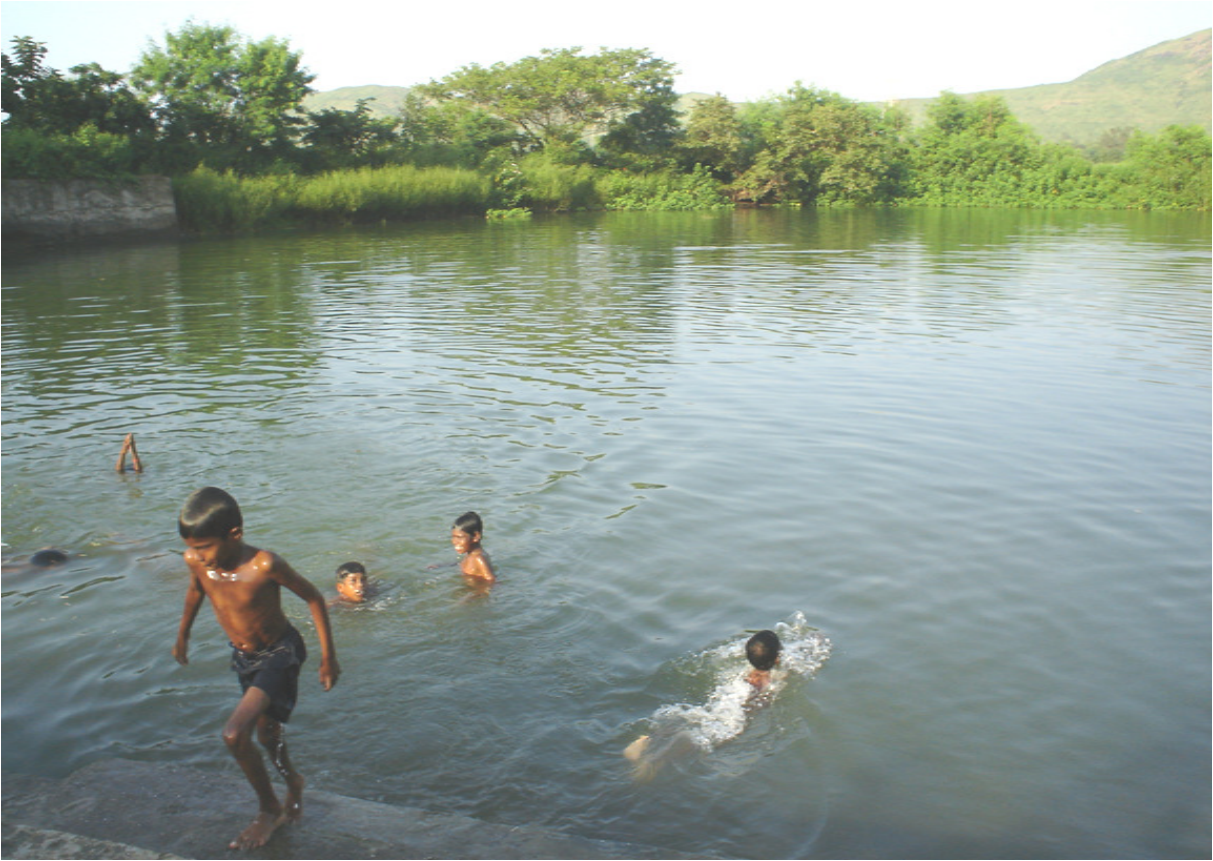
Children bathing in the talav

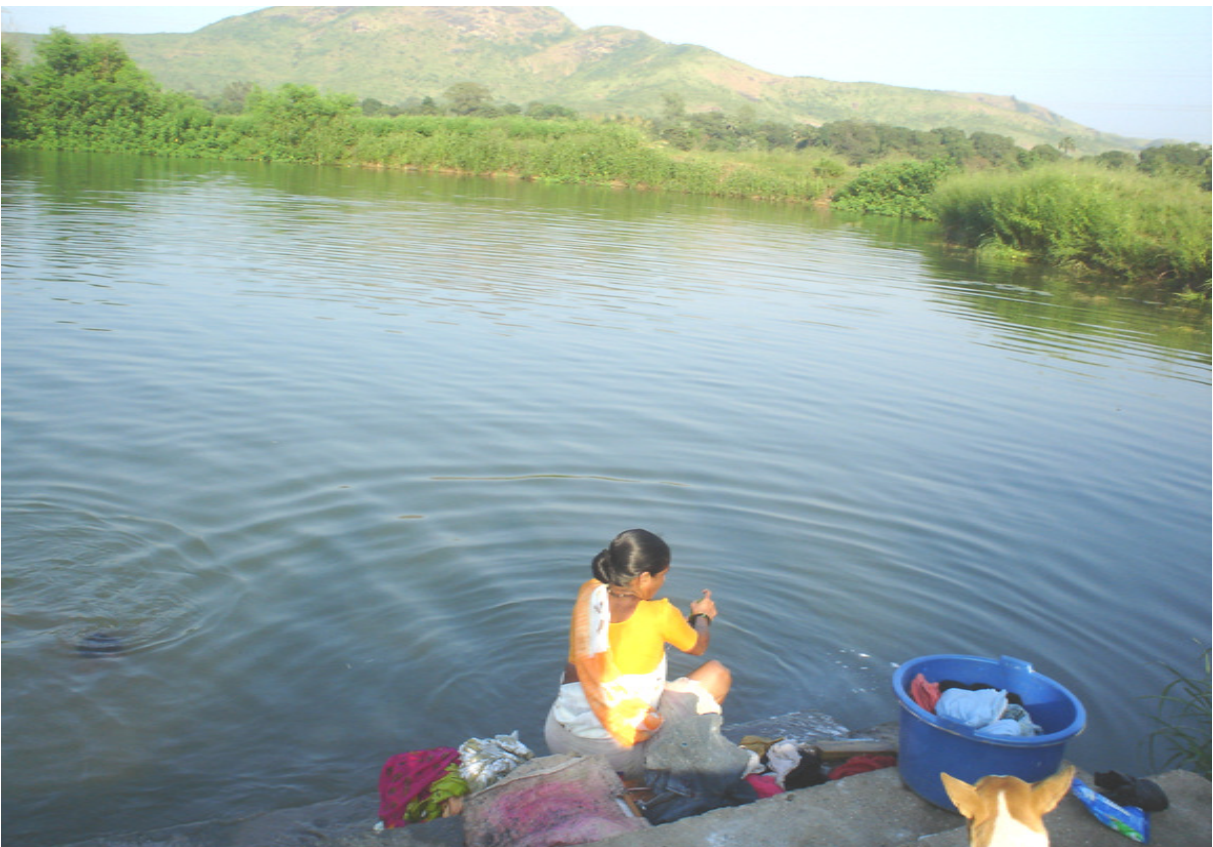
Washing activities on steps along the edge

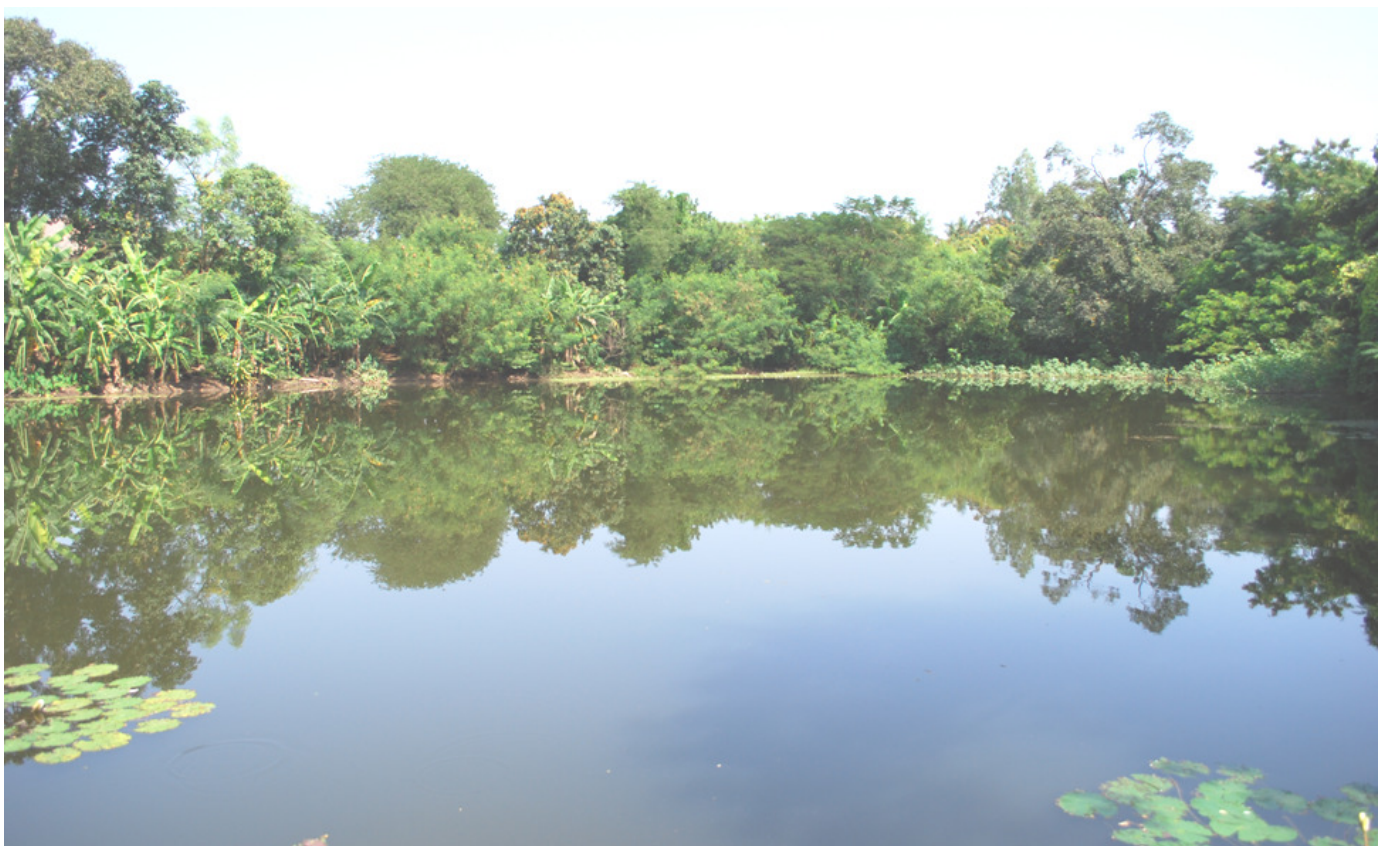
Soft landscape along the edge

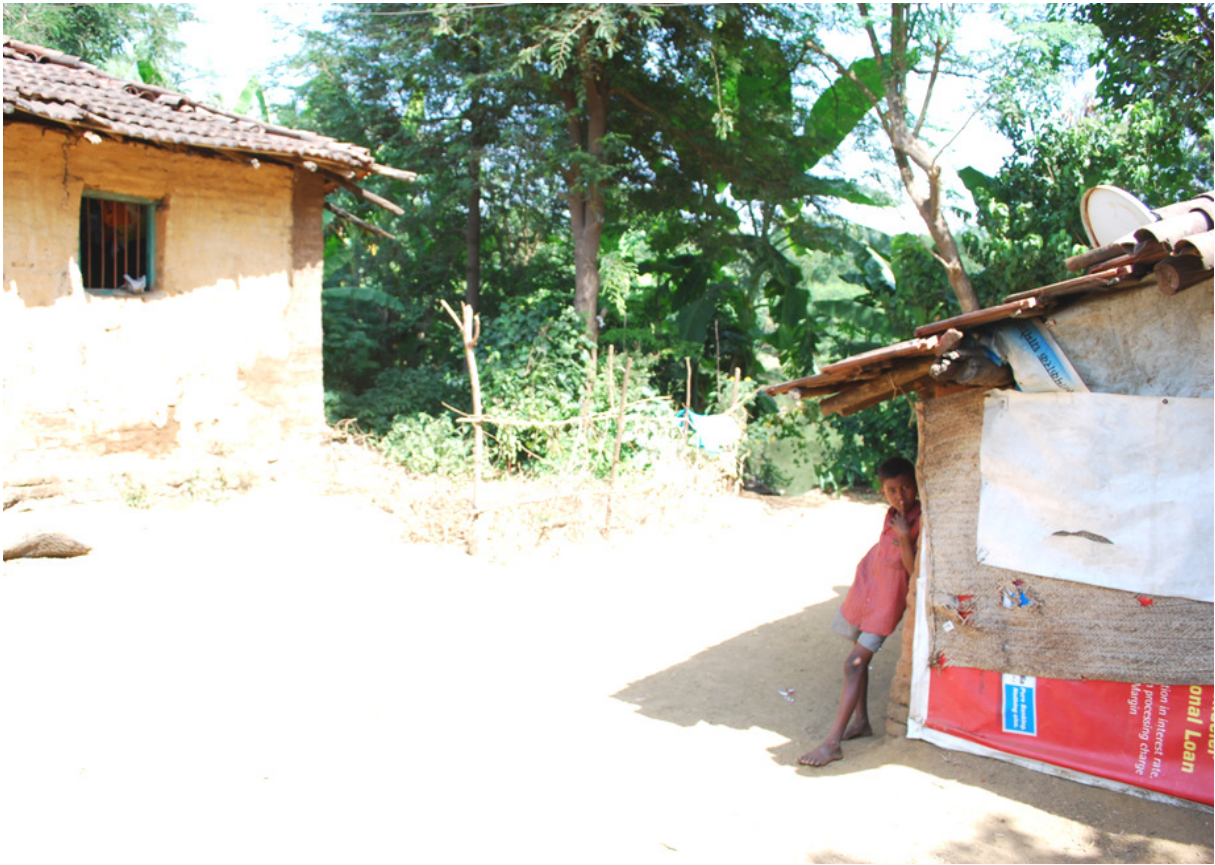
Adivasipada around the edge of the talav
