DOCUMENTATION AND PREPARATION OF CONSERVATION GUIDELINES
for
HERITAGE BUILDINGS AND PRECINCTS IN VASAI - VIRAR SUB - REGION
VOLUME IV: HERITAGE ASSETS IN THE GREEN ZONE

Final Report of the
DOCUMENTATION AND PREPARATION OF CONSERVATION GUIDELINES
for
HERITAGE BUILDINGS AND PRECINCTS IN VASAI – VIRAR SUB – REGION

VOLUME IV: APPENDICES
LIST OF HERITAGE ASSETS IN THE GREEN ZONE

December 2008

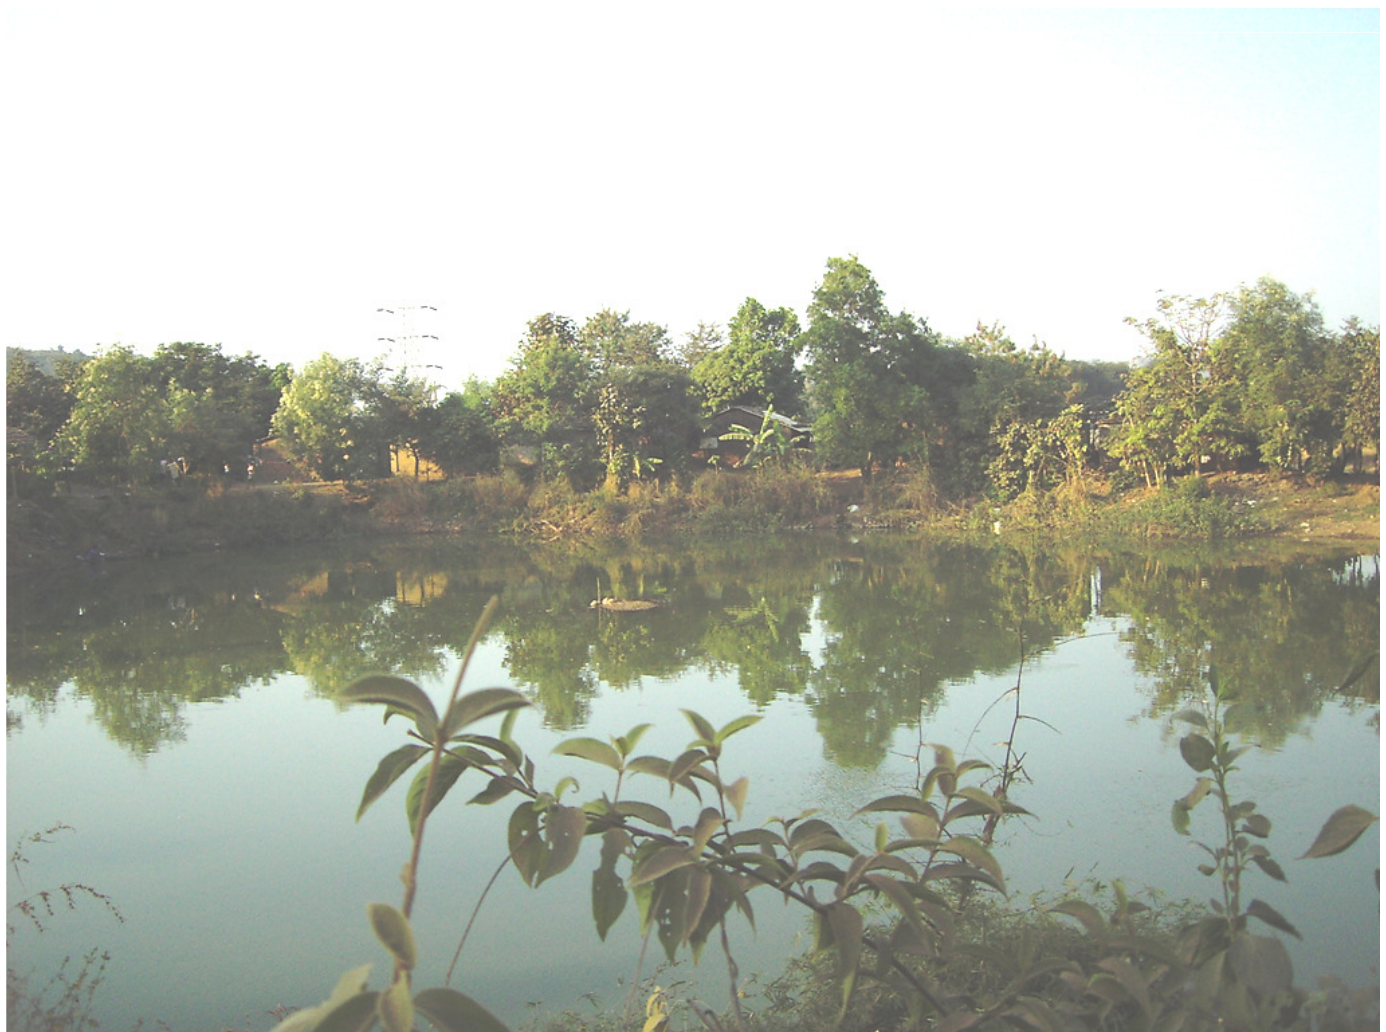
Soft landscape along the edge intersperse with adivasi houses

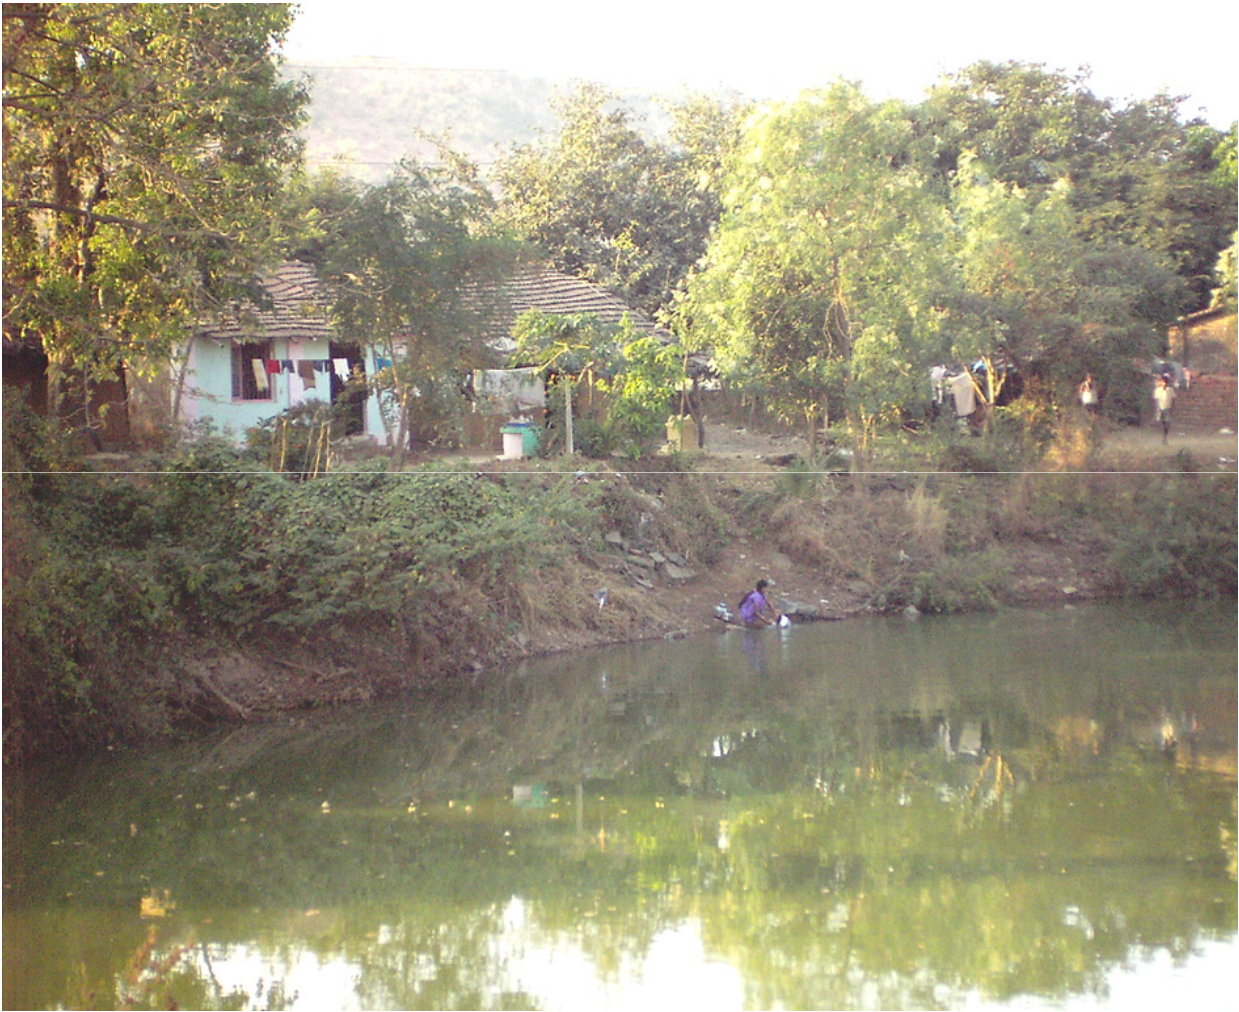
5.2	Physical Infrastructure						Assessment	
Lighting: Street lights have not been provided around the talav.						Non Existent		
Sanitation: No garbage or open defecation is observed on the edge of the talav. The edges of the talav have been maintained in a good condition.						Good		
Storm Water Drainage: Water from the surrounding flows into the talav.						Fair		
Public Facilities: No public facilities for washing or cleaning have been created.						Poor

Steep access to the water for washing along the edge

6.2	Owners / Tenants / Occupants / Community / Organizational Aspirations: None identified.	
7	MISCELLANEOUS	
	Additional Notes / References and Documents Available: Information gathered from the Kaner Shirsad Grampanchayat. Area details verified from the Land Records and Revenue Department (Vasai Taluka).	
8	RECOMMENDATIONS & SUGGESTIONS FOR IMPLEMENTATION	
	Small infrastructural improvements need to be undertaken in the form of providing washing platforms or steps to access the water.

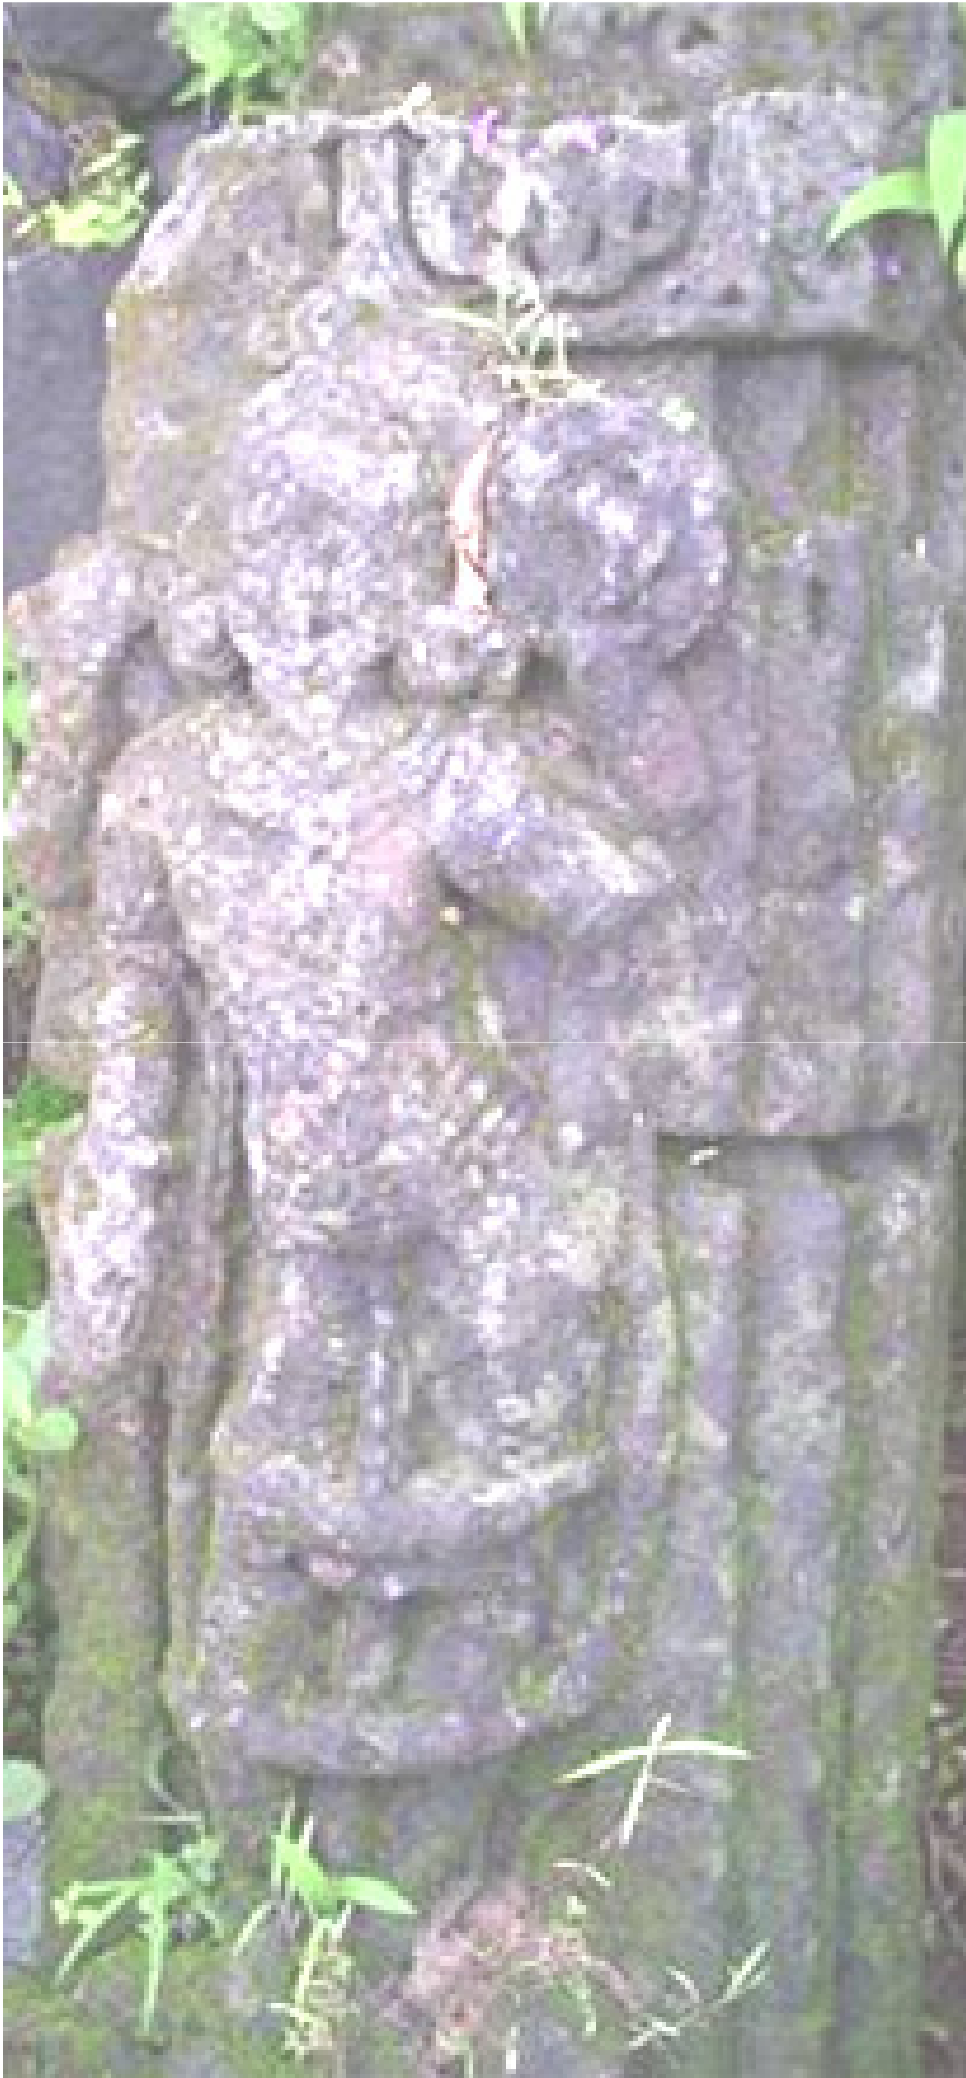
Stone sculpture found along the talav edge

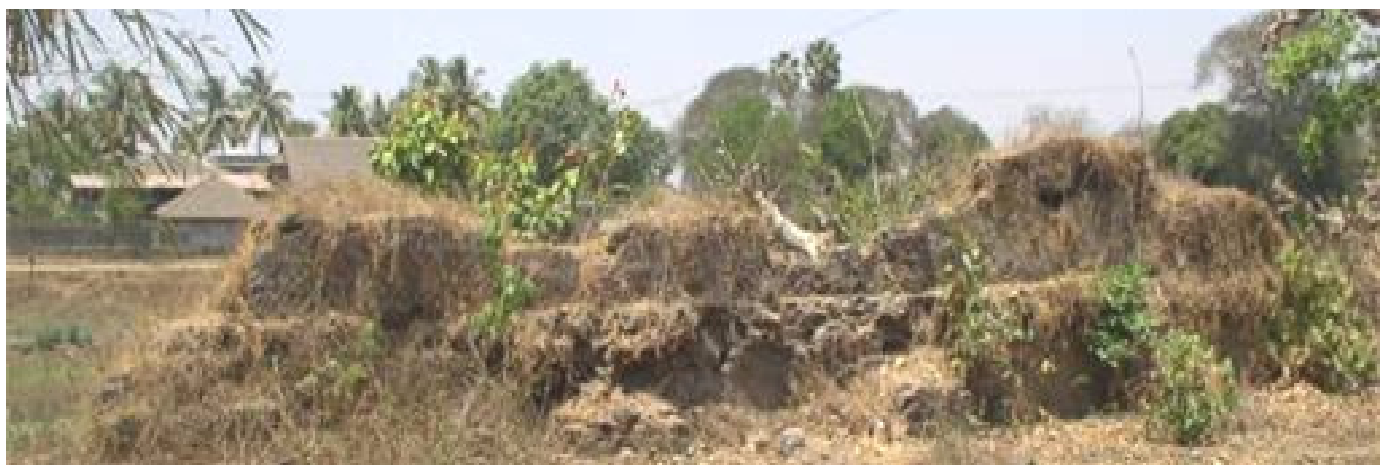
5.1	Structural System and Materials							Assessment		
	Foundation: Stone Foundation.							Cannot be assessed		
	Plinth: Stone plinth.							Ruin		
	Walls: Load bearing stone masonry walls, which are the only remnants of the structure. The walls show cracks as well as severe wear and tear. In addition, the growth of plants, creepers and trees on the structure is observed.							Ruin		
	Roofing: The roof of the structure has collapsed.							Ruin		
	Fenestration / Openings: The existing walls of the structure do not have any openings.							Cannot be assessed		
	Finishes: Stone walls are exposed.							Cannot be assessed		
	Compound / Fence / Gate: The fort wall is made of load bearing stone masonry.							Ruin		
	Curtilege / Unbuilt Space/ Out buildings / Landscape: The open space has an adivasipada located along the fort wall. The path to access the fort has overgrown shrubs and weeds.							Poor

5.4	Overall Condition Assessment (based on 5.1, 5.2 and 5.3): The heritage asset is in ruin.			RUIN	
	<div style="text-align: center;"> </div>				
		0: RUIN / NON EXISTENT	1: POOR	2: FAIR	3: GOOD
6	FUTURE RELEVANCE

Ruins of the fort

6.2	Owners / Tenants / Occupants / Community / Organizational Aspirations: None identified.				
7	MISCELLANEOUS				
	Additional Notes / References and Documents Available: Records and information gathered from the Mandvi Grampanchayat.				
8	RECOMMENDATIONS & SUGGESTIONS FOR IMPLEMENTATION				
	The ASI or the State Archaeology Department need to take immediate action for the preservation, restoration and management of this heritage asset. This relatively unknown fort has the potential to form an important node in the tourist circuits for the entire VVSR.

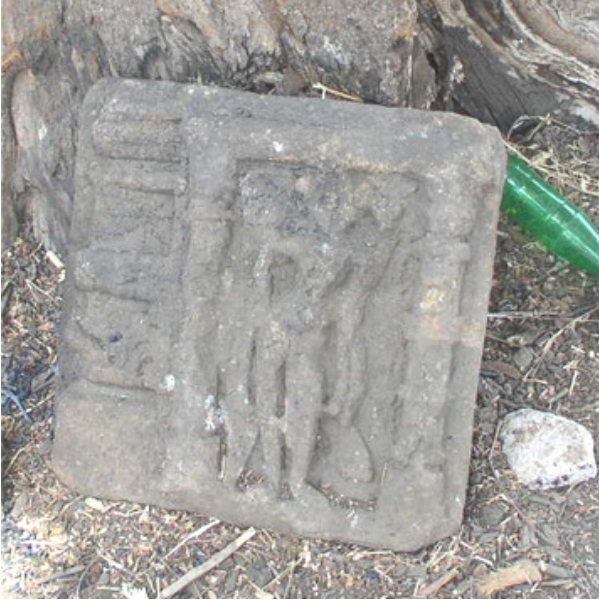
Stone sculpture lying along the fort wall

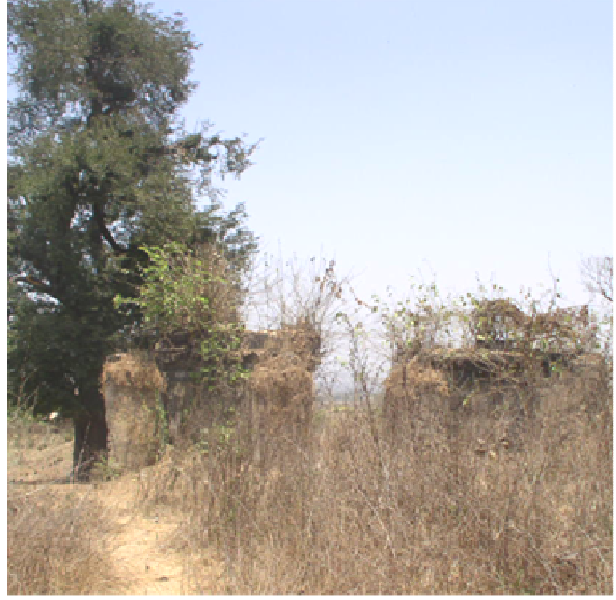
Ruins of the fort

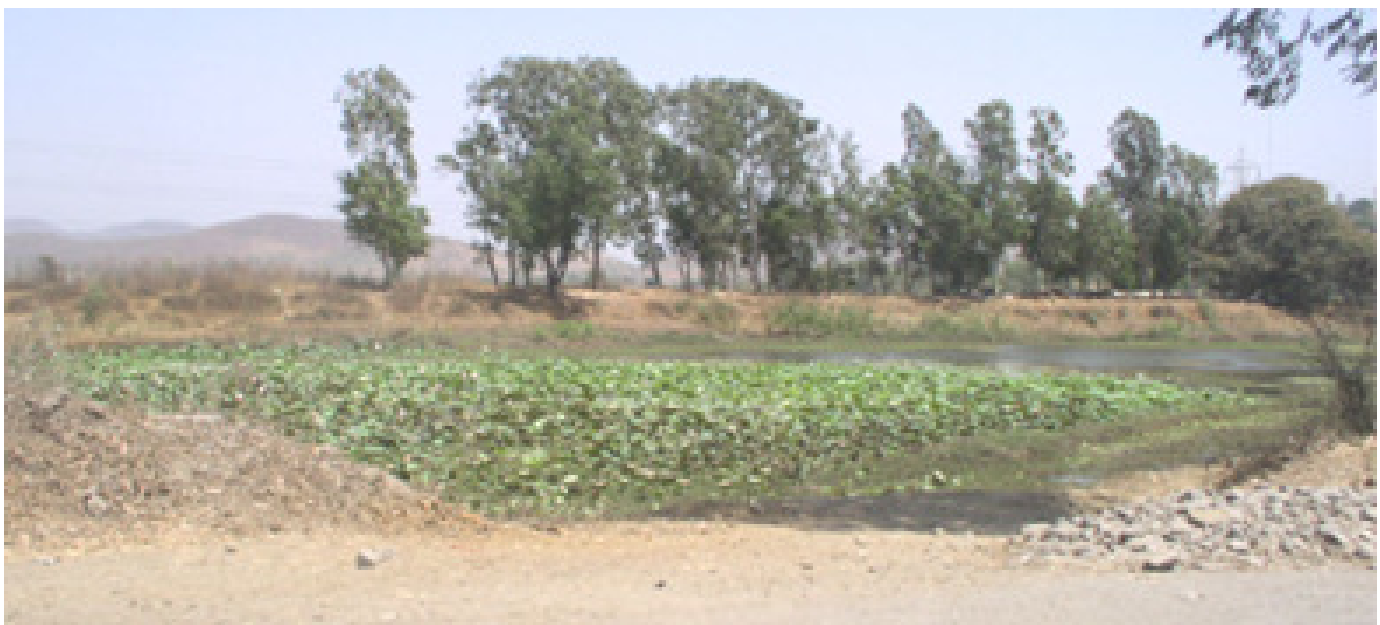
The talav dried up during summer
