Mahatma Education Society's
PILLAIS' COLLEGE OF ARCHITECTURE Research Cell
10, Sector 16, New Panvel (e) 410206
Telephones: (022) 27456100, 27451700
e-mail: picapanvel@hotmail.com

Contents

Volume II

Area A- Villages

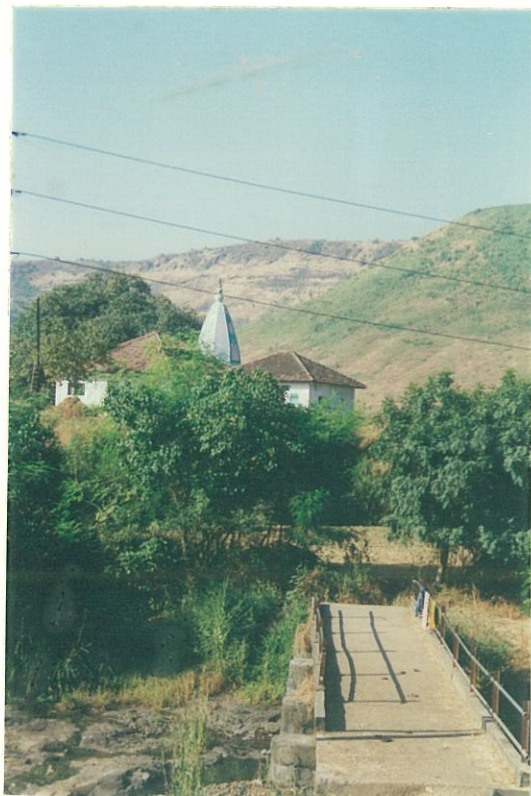
Scenic surroundings, access to temple by bridge

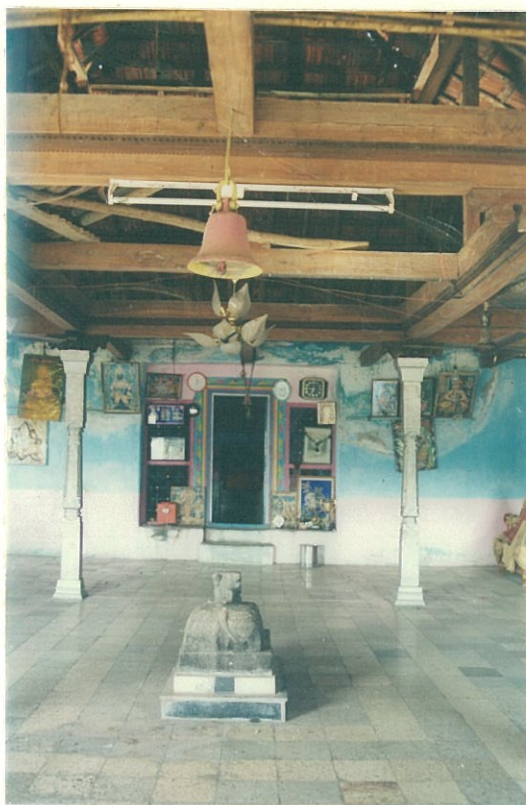
View from Sabha-mandapa looking towards the Garbagriha

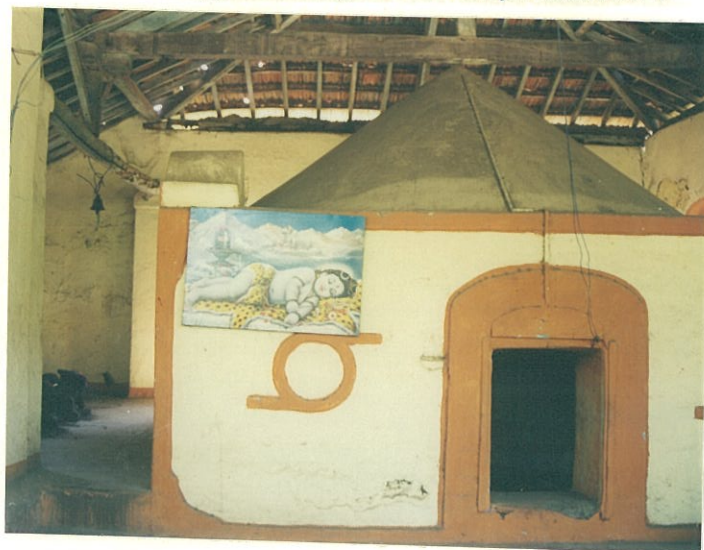
Original Garbagriha with temple built over it

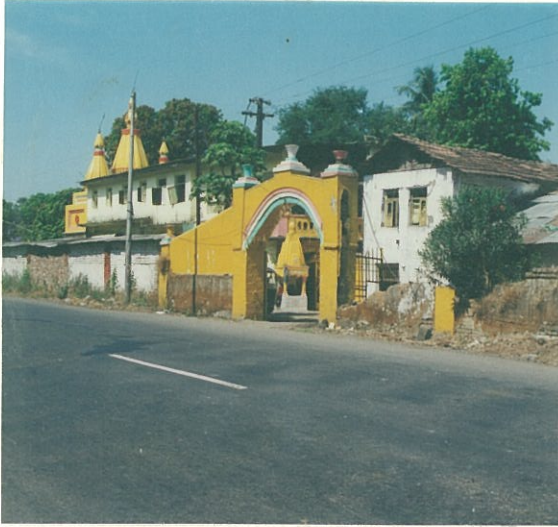
View of the entrance from Panvel- Uran Rd

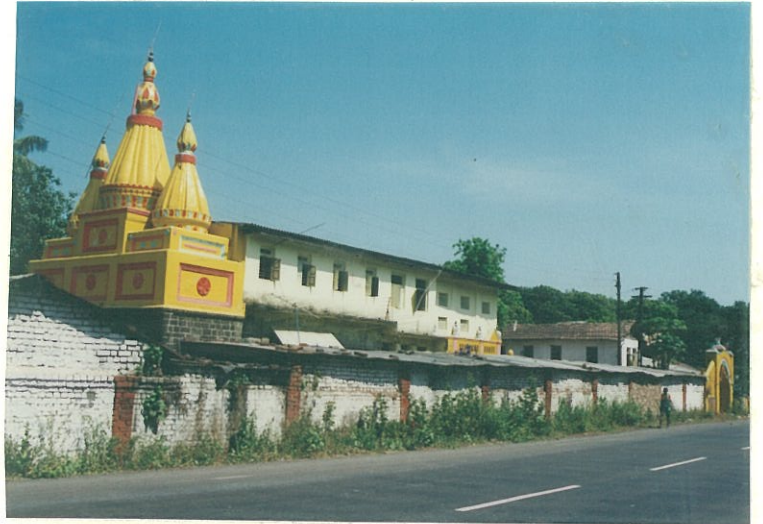
Rear view of the temple from Panvel- Uran Road

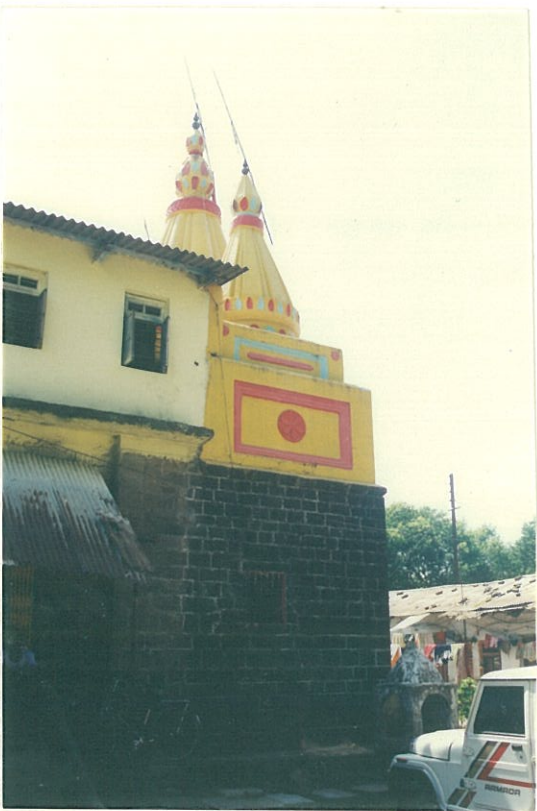
Ashlar walls of the garbhagriha and shikhara above

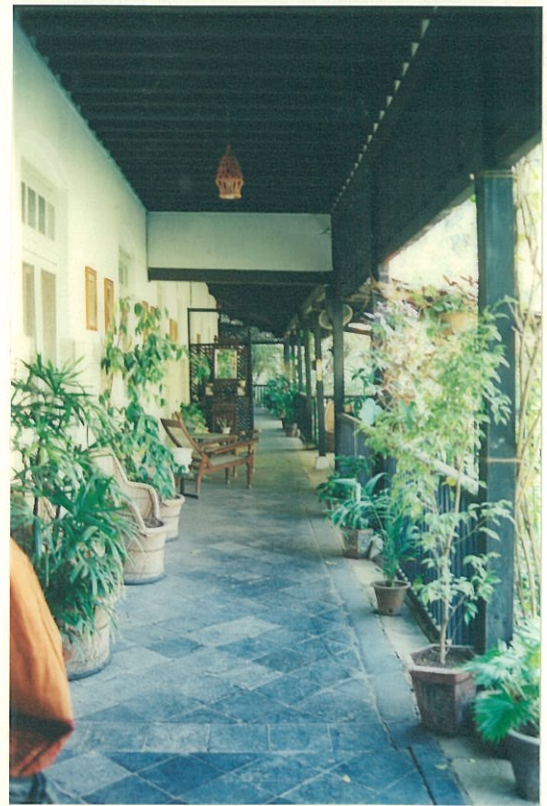
Long, continuous verandah fronts the landscaped garden

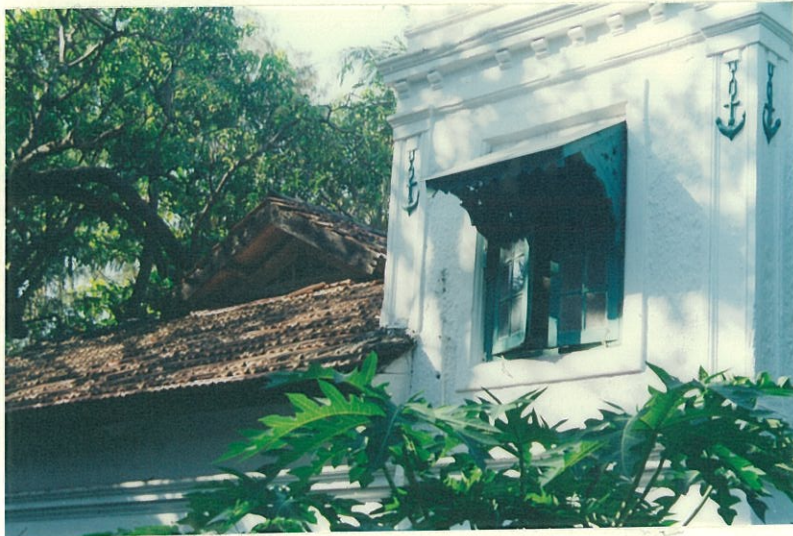
Side view

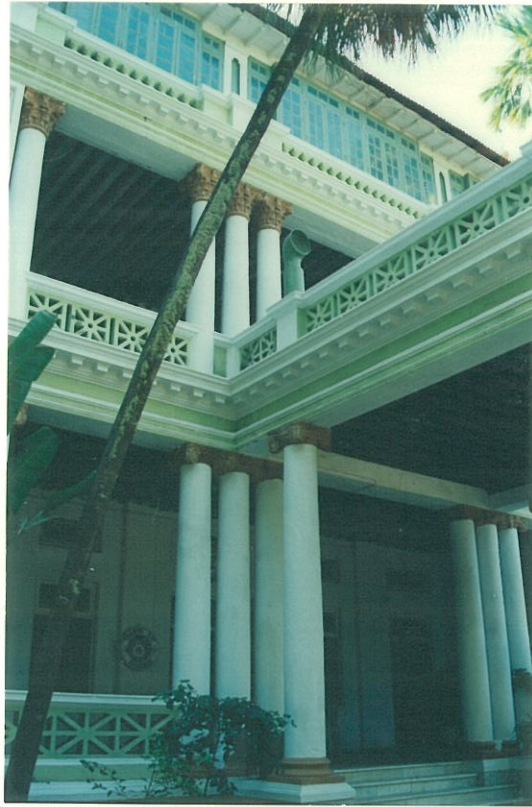
Common Reference No.	VL 12
Card No.	11
Name of Property	T. S. Rahaman, Nhava

Port Cochere with Neo-classical detailing

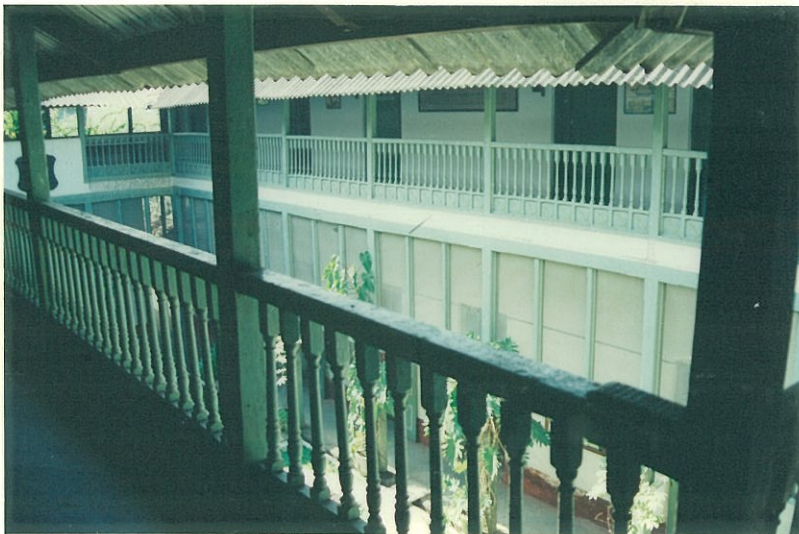
9.6	Roofing	Fair, the roofing around the cortile is in need of repair.
9.7	Articulation & Finishes	Good
9.8	Services	Fair
9.9	Outbuildings	NA
9.10	Overall condition	Good
		Maintenance level Good

View of the Courtile

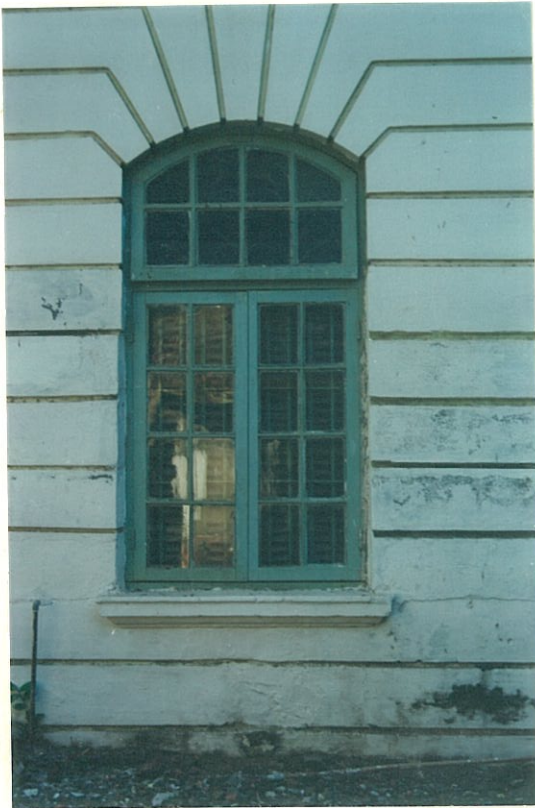
Common Reference No.	VL 12
Card No.	11
Name of Property	T. S. Rahaman, Nhava

Window detail in Neo-classical manner

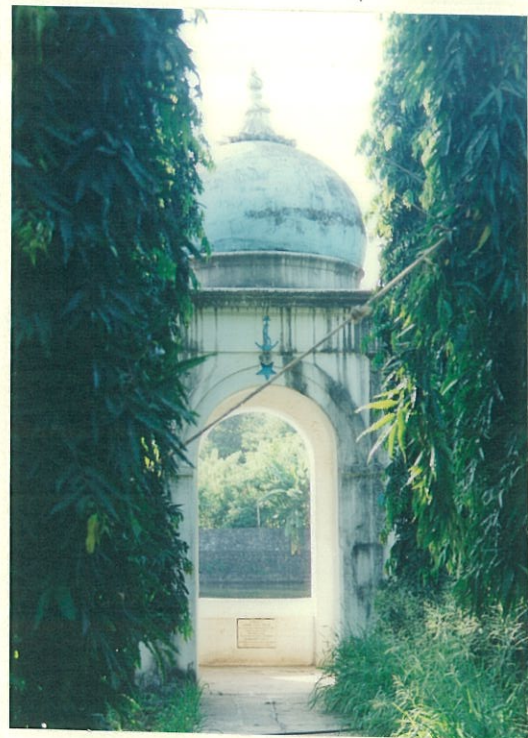
The memorial chhatri of Hashim Yusuf Sailor

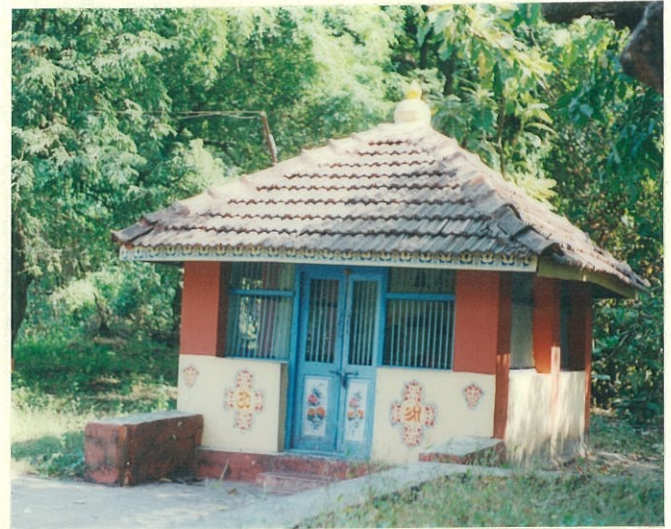
9.7	Articulation & Finishes	Recently maintained, without any alteration to the original structure.
9.8	Services	Good
9.9	Outbuildings	The Maruti shrine in the vicinity of the temple is in good condition.

A subsidiary shrine on the premises

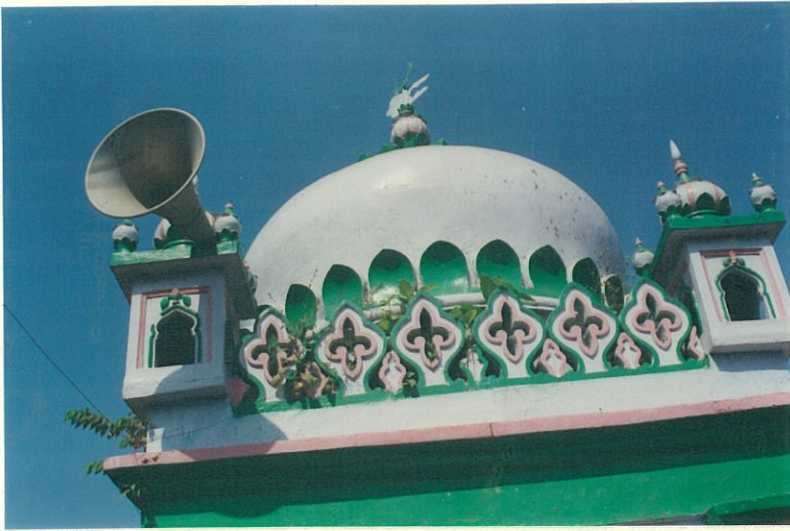
Common Reference No.	VL 16
Card No.	15
Name of Property	Muquimshababa Dargah, Phirwadi, Nagaon

Articulation of the dome showing Deccan features like arch head foliage at the base, merlons and guldastas

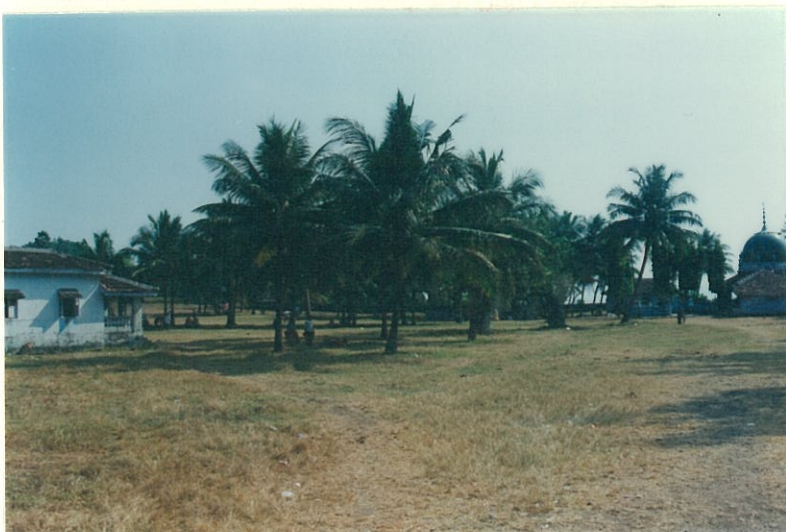
The tomb, at the back touches the sea face and fronts an open ground

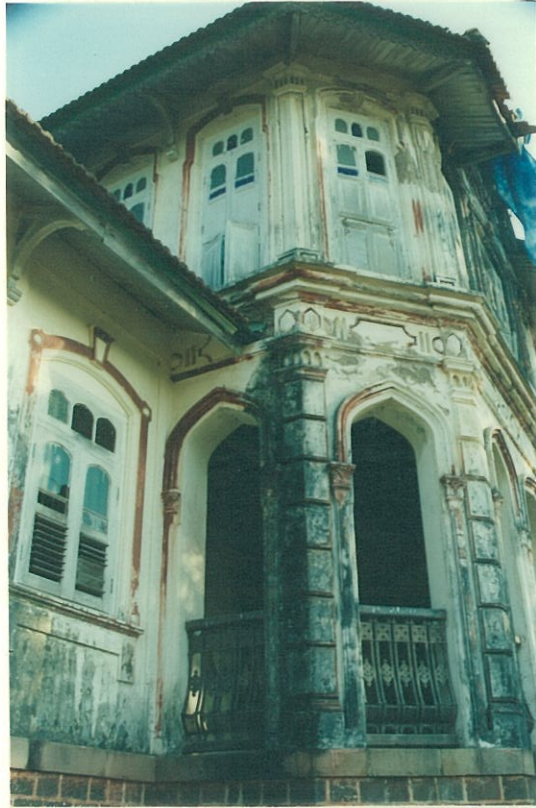
Common Reference No.	VL 17
Card No.	16
Name of Property	Tungekar House, Phirwadi, Nagaon

9.6	Roofing	The timber roofing has weathered and is in poor shape
9.7	Articulation & Finishes	The stucco work on the exterior is crumbling
9.8	Services	Interiors could not be observed

Close-up the central portion showing articulations of pilastered bays and overhanging roofs supported on timber brackets

10.3	Articulation & Finishes	Interiors could not be observed
11.0	DP Remarks / Perceived Threats	
	The building, which is by and large in a state of neglect and disuse, could deteriorate further into dilapidation if corrective measures are not immediately forthcoming.

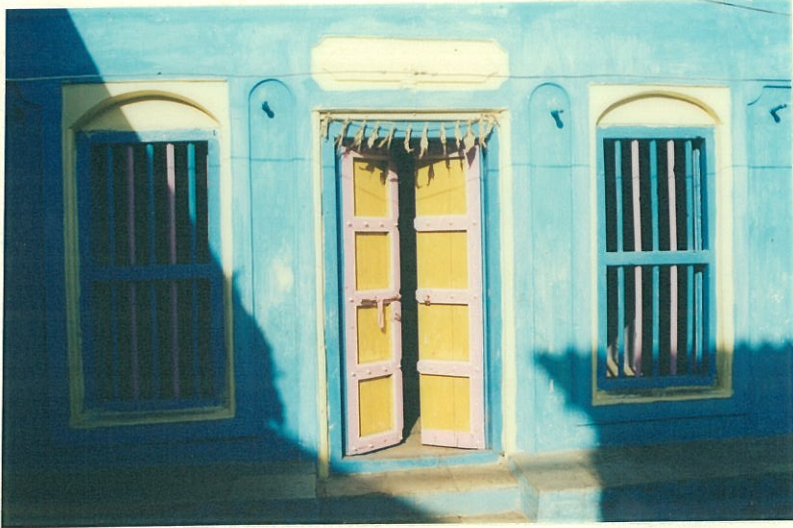
Common Reference No.	VL 18
Card No.	17
Name of Property	Vitthal Rakhumai Mandir, Owe

Entrance door in heavy timber flanked by arched windows. Wooden pegs on the wall

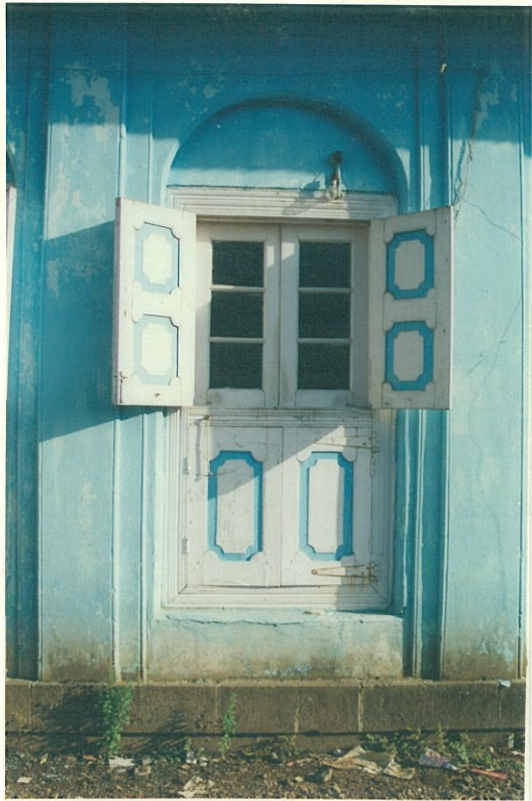
Common Reference No.	VL 19
Card No.	18
Name of Property	Jami Masjid, Owe

Detail of a bay showing an arched window with a low cill height, in two parts.

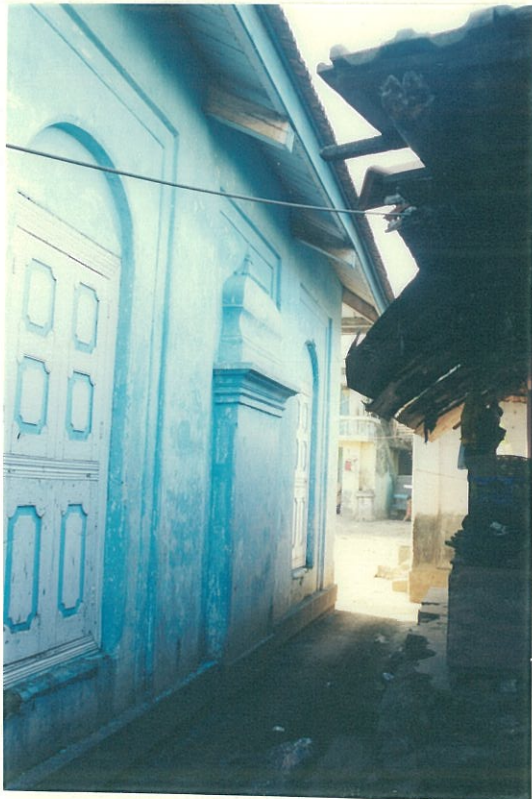
The mehrab is articulated as a decorative projection on the quibla wall
