BALLARD BUNDER GATEHOUSE

CONSERVATION REPORT

DOCUMENTATION, ANALYSIS & PROCESS

K.UNWALLA ARCHITECTS, MAY 2005

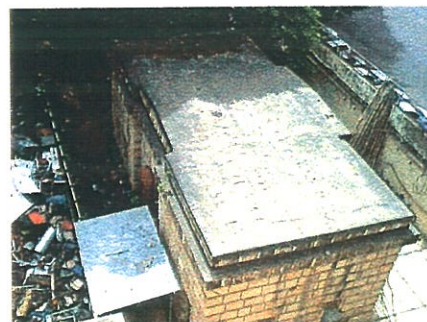
Chaotic setting of the gatehouse before restoration

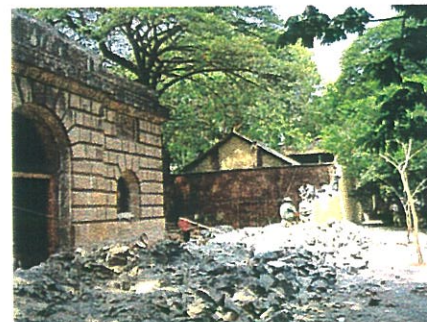
Security wall demolished to offer visibility to the structure and to re-establish the image of the node

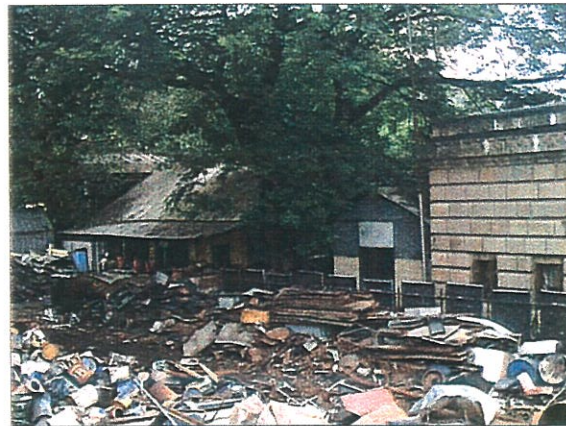
BALLARD BUNDER GATEHOUSE AMIDST CHAOS : BEFORE RESTORATION

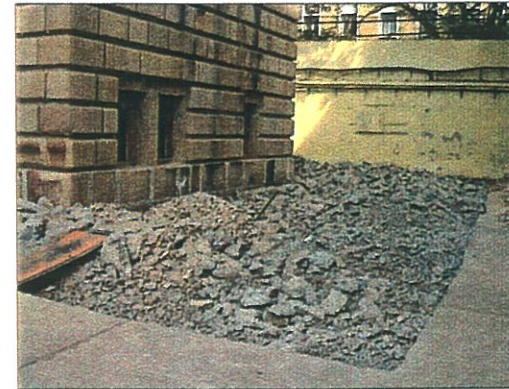
Layer of P.C.C. and murram around the structure was much deeper than estimated.

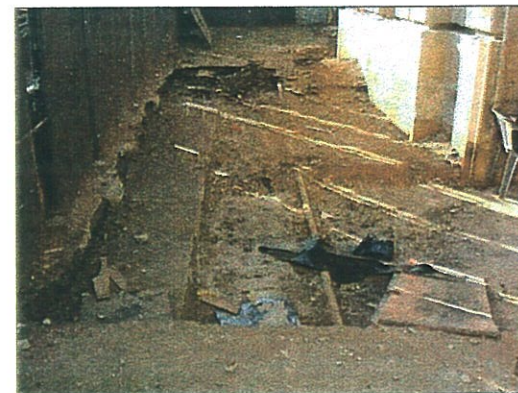
Cobbles laid in continuation with the main floor of the Gatehouse were unearthed from the rear open space.

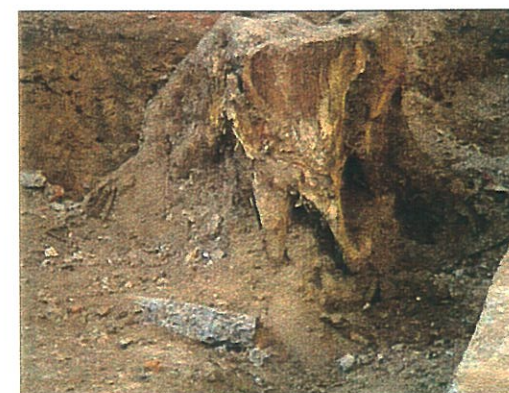
Dead tree trunk completely buried under the filling was restored and integrated in landscaped setting.

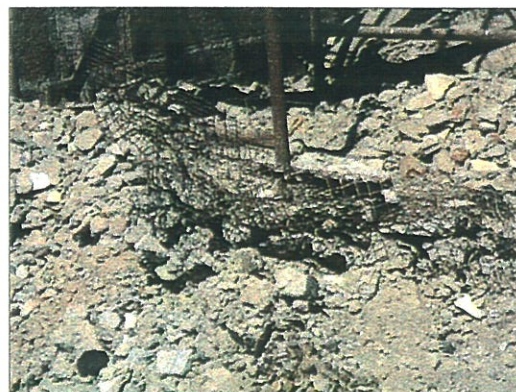
Layers of concrete (with wire mesh reinforcement) removed from roof slab

Interventions to the slab, in the past decade to afford a water proofing layer had been carried out. The interventions are of a superficial nature by an addition of a top concrete layer reinforced with steel wire mesh, covered with tar felt AND repair of the soffit concrete (reinforcement cover) of the slab.

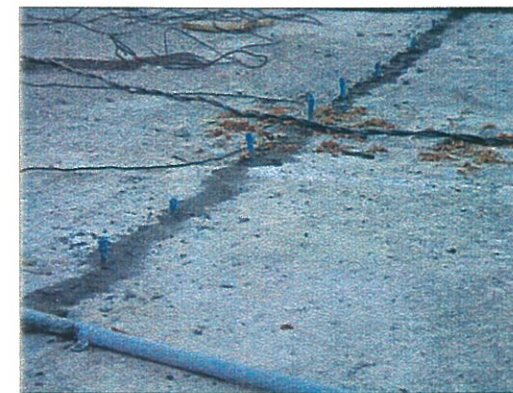
Roof slab prepared for polymer grouting

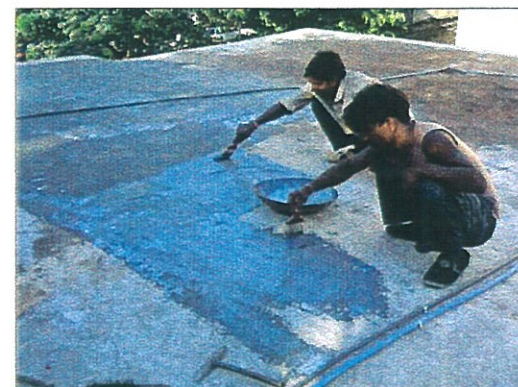
Application of polymer modified cement layer over prepared roof surface

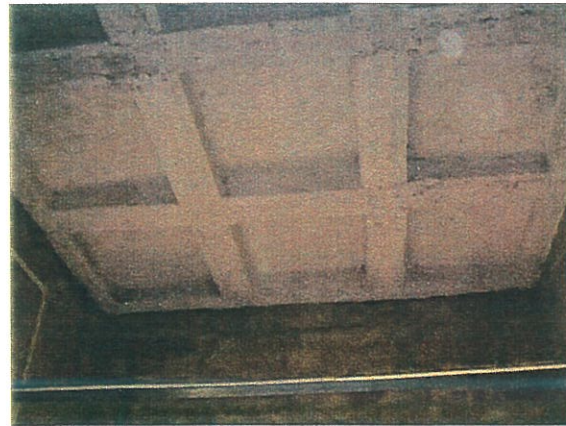
**COFFERED SLAB OF CENTRAL HALL
BEFORE RESTORATION**

Bulging of cover / loose cover at some locations inducing cracking of the cover, leakage stains indicating ingress of water, rusting / scaling of reinforcement. The reinforcement of an adequate design.

- Loose, disintegrated and cracked concrete broken and removed using chipping hammer and / or light chisel upto sound core concrete.
- Loose rust from reinforcement removed by light tapping, chipping, hammering and scrubbing

- Brush application of Rusticide to rusted steel
- Additional reinforcement placed at the bottom and secured to the new stirrups
- New stirrups provided by drilling holes and anchoring the same into the rib of existing RC beam with epoxy putty.

- Application of 2 coats of Polyalk Fixoprime and cement slurry
- Application of Polyalk EP + cement slurry as Bonding coat after 46 hours to entire broken surface

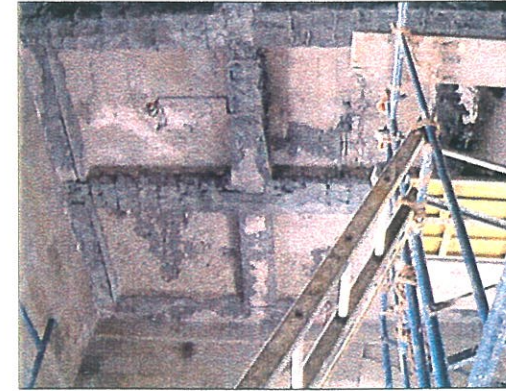
*Strengthened coffered slab before
application of Polymer modified mortar*

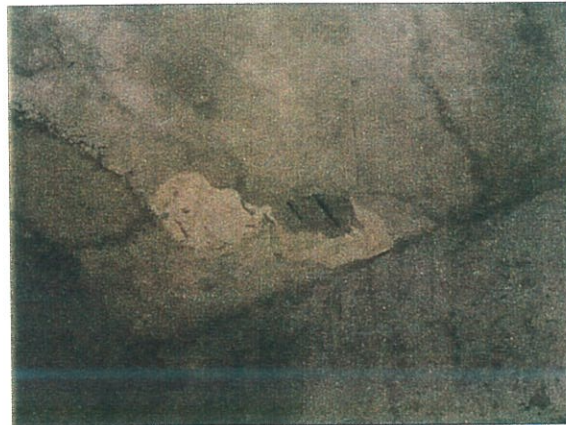
SLAB SOFFIT IN ROOMS BEFORE RESTORATION

Bulging of cover / loose cover at some locations inducing cracking of the cover, leakage stains indicating ingress of water, rusting / scaling of reinforcement. The reinforcement of an inadequate design.

- Loose, disintegrated and cracked concrete broken and removed using chipping hammer and / or light chisel upto sound core concrete.
- Loose rust from reinforcement removed by light tapping, chipping, hammering and scrubbing

- Application of 2 coats of Polyalk Fixoprime and cement slurry
- Application of Polyalk EP + cement slurry as Bonding coat after 46 hours to entire broken surface

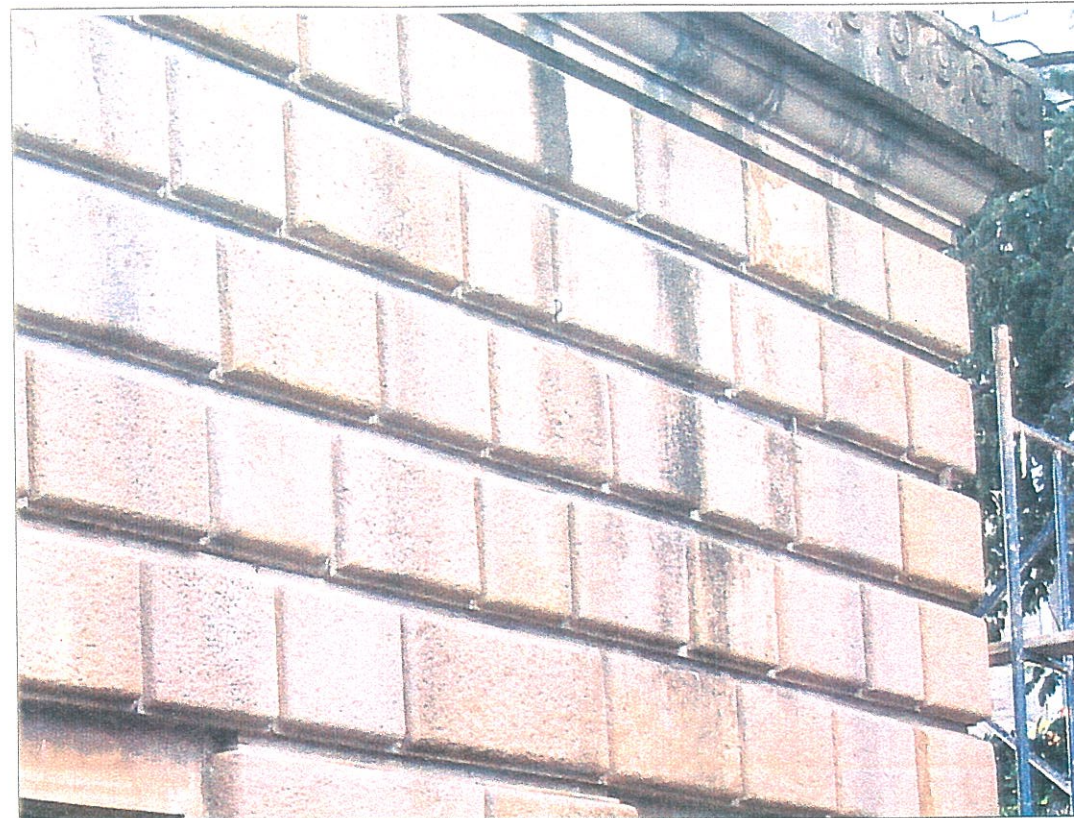
FACADE AFTER RESTORATION

- Removal of soiling by gentle mist spray and controlled pressure water jets.
- manual - light tapping / scrubbing / water application / Steam
- Tar stains removed by Steam / diluted Petrol
- Careful removal of Nails / wooden blocks etc and sealing the holes / depressions with lime mortar

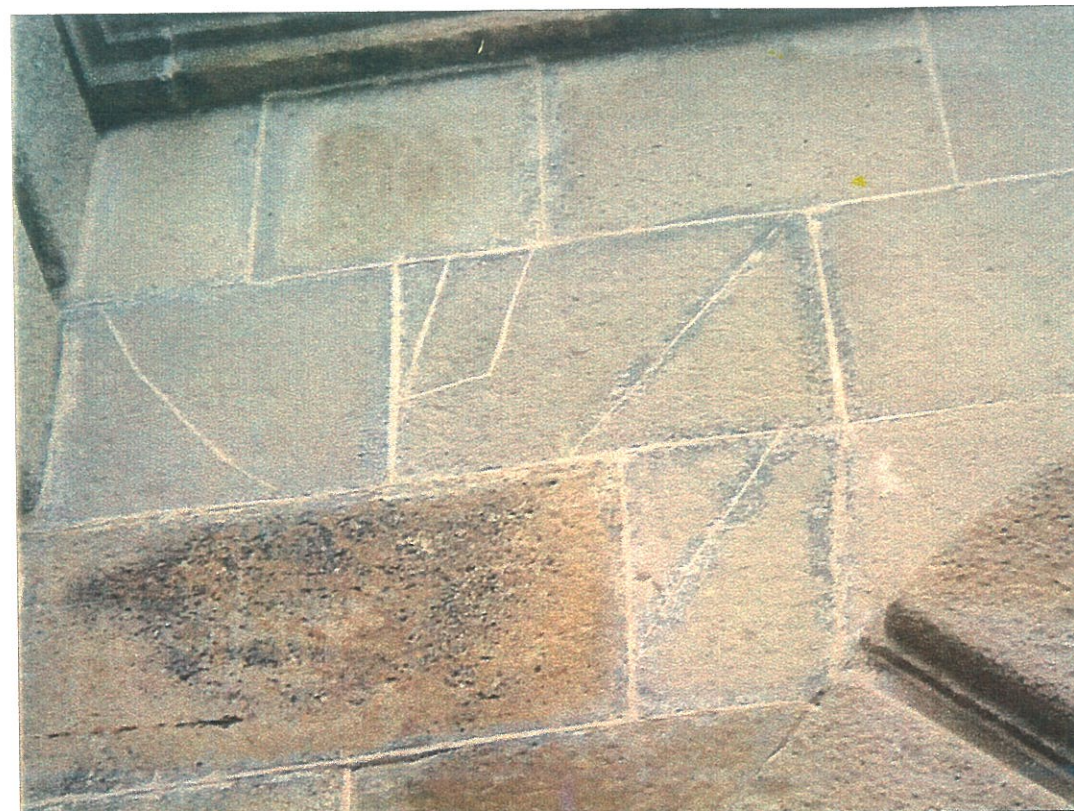
JOINTS AND CRACKS AFTER LIME POINTING

- Randomly located fine superficial cracks in the body of the stones
- The wide, depressed border profiles of the stones having been mistaken as wide open joints had been completely sealed,
- A complete fill of open joint profiles in the masonry

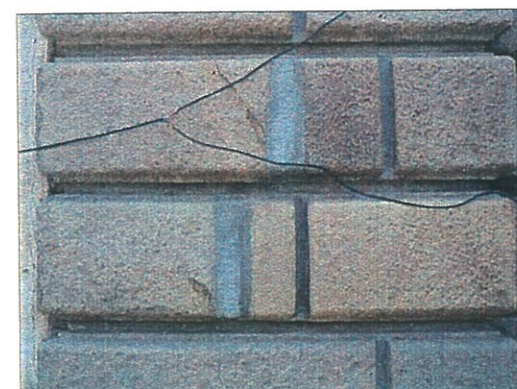
Deep recessed joints in stone masonry filled with cement mortar (before restoration)

- Stubborn cement application removed optimally by tapping and light abrasive hammering. At a few locations the attempt was abandoned for reasons of causing undue damage to the body parent stone.

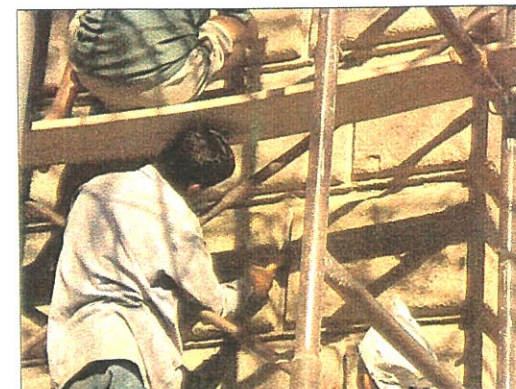
Removal of cement from recessed joints and dressed stone surfaces

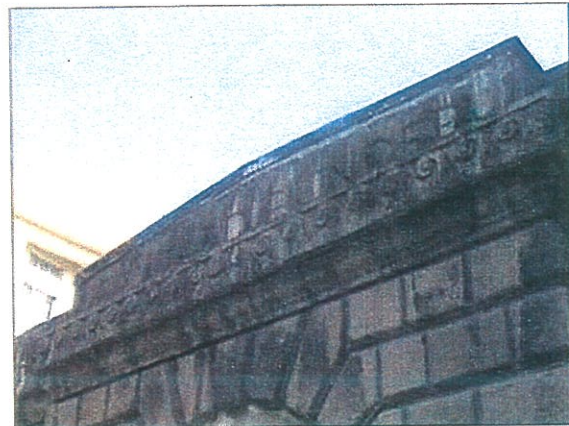
FRONT PEDIMENT BEFORE RESTORATION

- Weathering stains
- Stains due to water flow
- General atmospheric soiling
- Tar

- Attempt to fill cracks / repair damaged portions with cement mortar
- Recessed band, an integral component of façade design along the top of the pediment filled with cement mortar

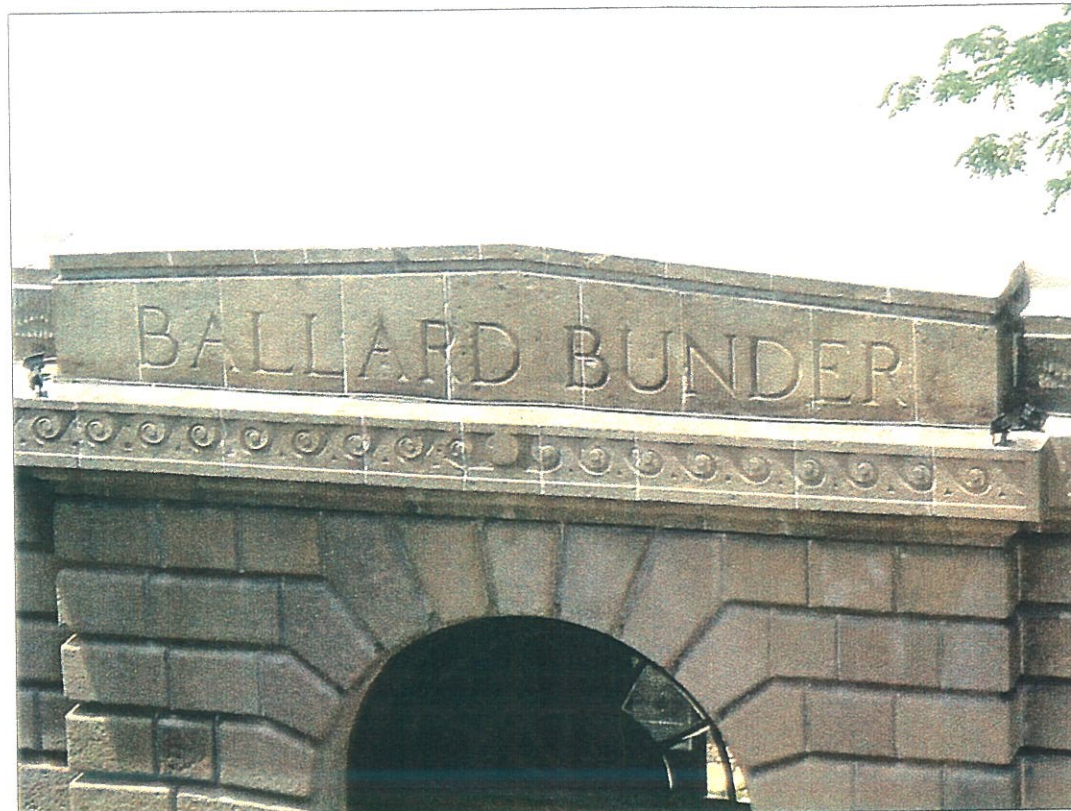
FRONT PEDIMENT WITH THE NAME TABLET AFTER RESTORATION

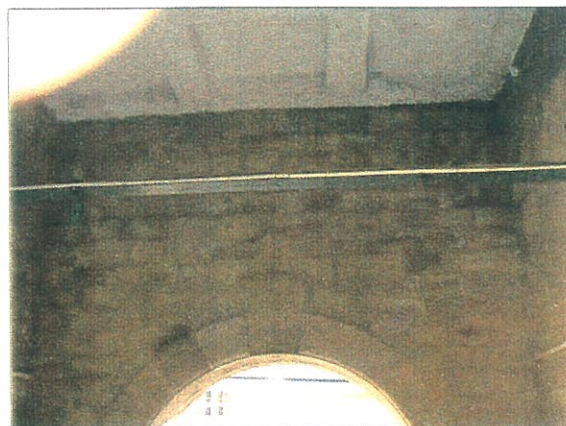
EXPOSED ASHLAR MASONRY IN THE CENTRAL HALL BEFORE RESTORATION

- Staining of stone surface due to water ingress from the roof and rising damp from the foundations is evident.
- Stains associated to adjoining filling / dump / P.C.C.
- Stains of cement applications on stone surface
- Several punctures / holes
- Electrical wiring without respecting the features and configuration of joints

- Cleaning of internal stone surfaces by appropriate method.
- Manual - light tapping / scrubbing / water application
- Careful removal of Nails / wooden blocks etc and sealing the holes / depressions with lime
- Jointing + flush pointing in lime mortar
- Sealing cracks with Lime mortar
- Minimum interventions and damage to stone walls while installing electric wiring / arranging display

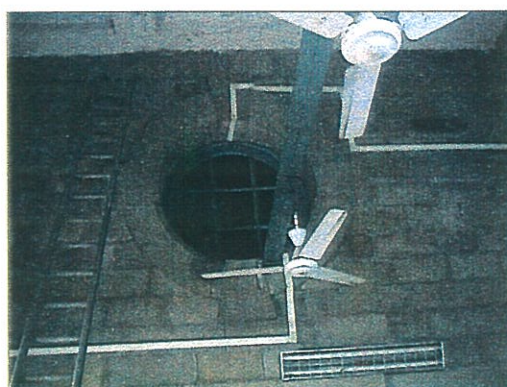
Fans suspended on steel beams, taking support on the voussoir of the intrados of the Bulls eye

Cause: Ceiling fans hung on steel angles, "L" shaped & Jointed back to back, forming a beam spanning across the Hall, supported at the intrados base of the "Bulls Eye" opening in the partition wall. The off-centre support, induced pin pointed, rotational action in the masonry, and a resultant vertical through crack, traveling the full height of the walls - both partition walls.

Treatment: The crack along its run is stitched using SS pins, grouted correctly into the parent wall structure and covered in lime plaster in the rooms.

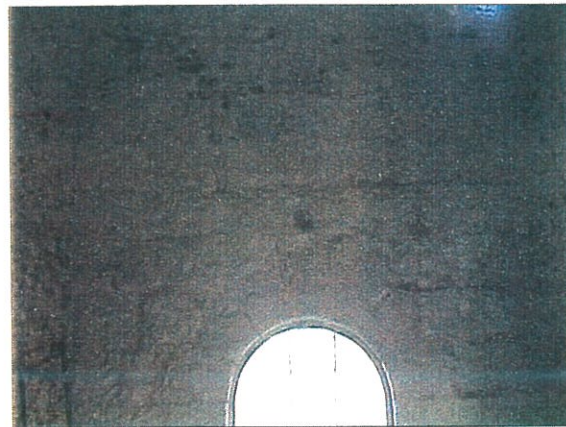
EXPOSED STONE MASONRY OF NORTH WALLS OF THE ROOMS DURING RESTORATION

- Cement plastered (later intervention, last decade)/ painted walls
- Stains of Leakage
- Opening up of cement plaster revealed composite stone (massive stones arranged in single thickness, stacked up in horizontal courses) and Brick masonry (1/2 brick thick) wall, except the north wall, which is devoid of the brick layer.

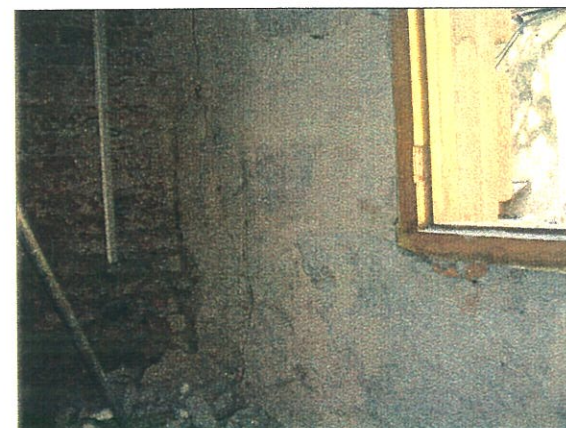
Composite stone walls with brick inner leaf along three sides of the ante-rooms. Note the north wall devoid of the brick leaf, constructed in massive stones, stacked up in a single pile

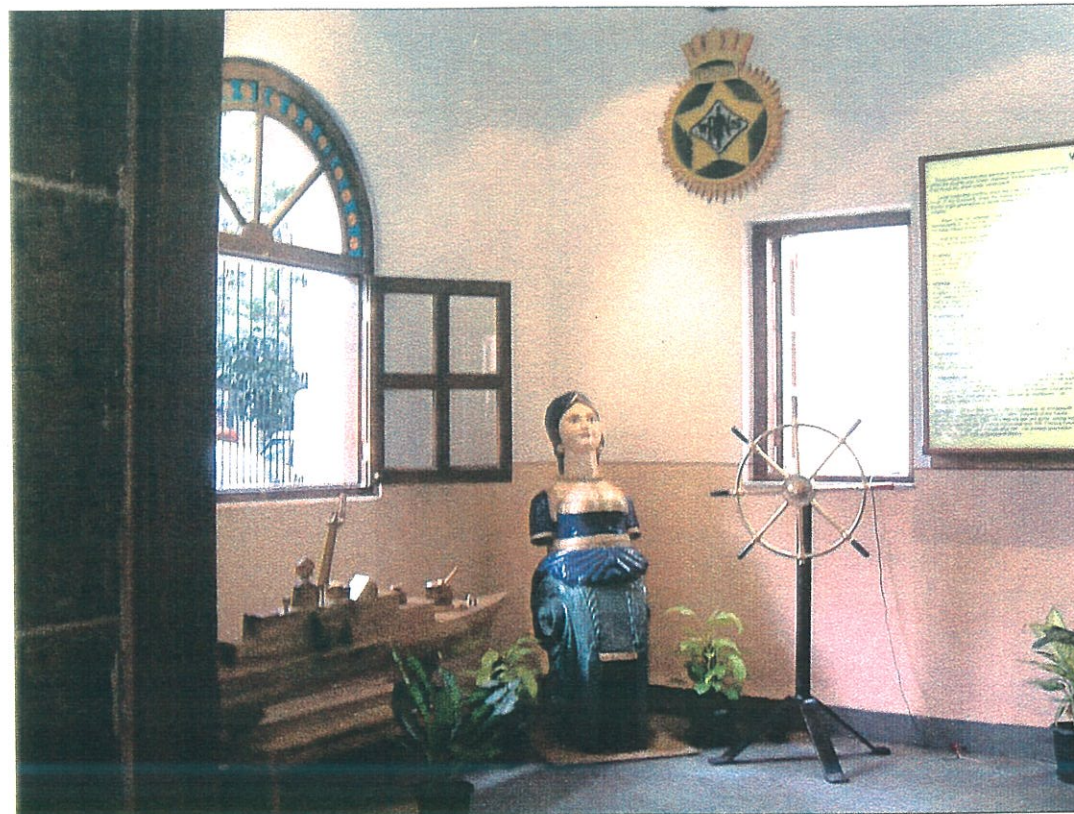
LIME PLASTERED WALLS AFTER RESTORATION

- Re-plaster brick leaf wall in lime mortar, subsequent to removal of all loose and disintegrated material, while consolidating the structure of the wall with brick bat packing.
- Stitching with Stainless Steel pins carefully designed and grouted into the parent stone wall along the line of fracture of the crack.
- Finish the surface in Lime wash (two shades).

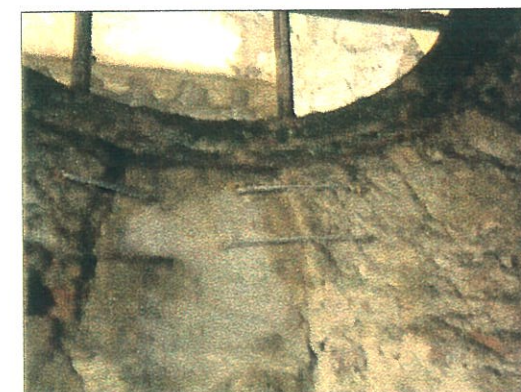
SS pins placed across opened joints of voussoirs of the ox-eye window.

- Vertical Cracks in walls induced by fan suspension system, as in the Hall.

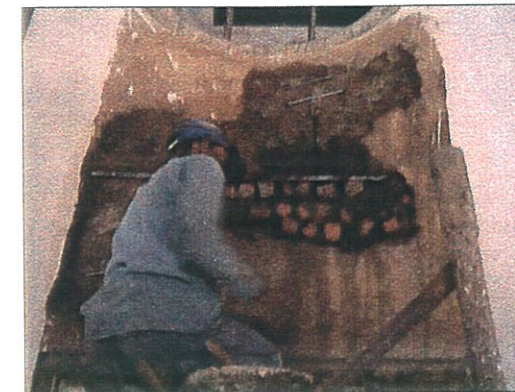
Consolidation / Leveling of masonry surface with brick bats in lime mortar.

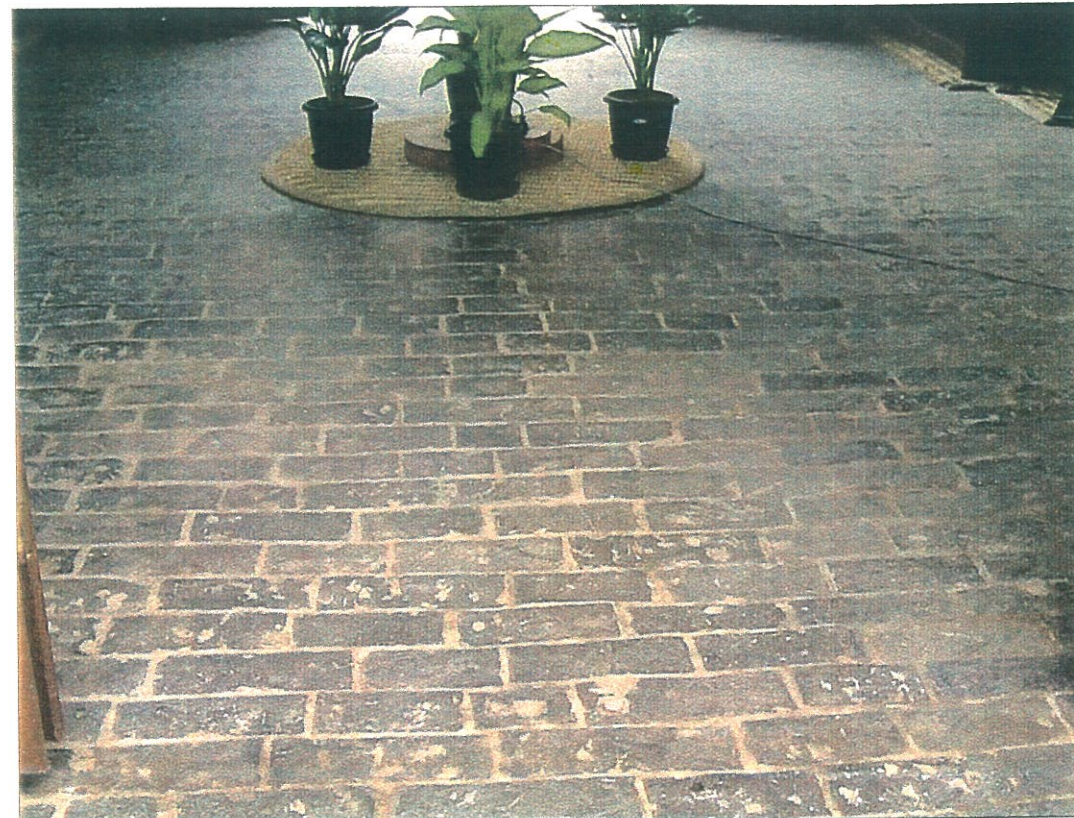
COBBLED FLOOR OF CENTRAL ROOM AFTER RESTORATION

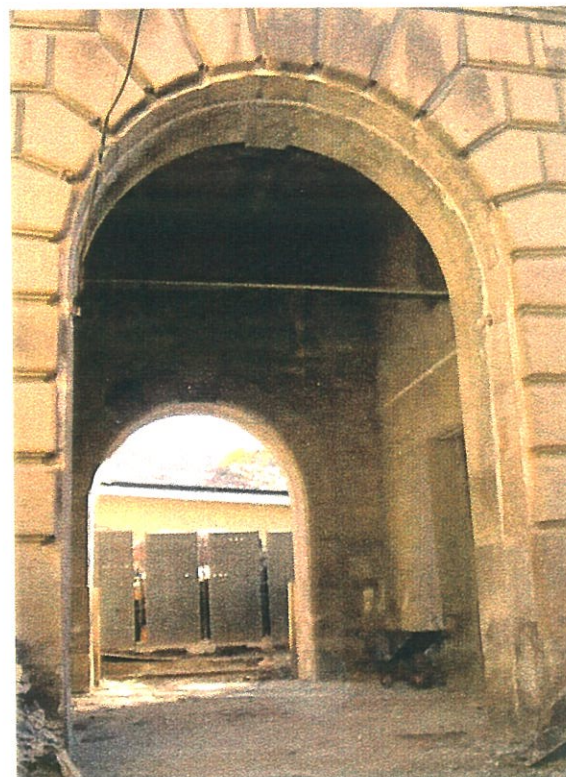
Gateway opened up during restoration.

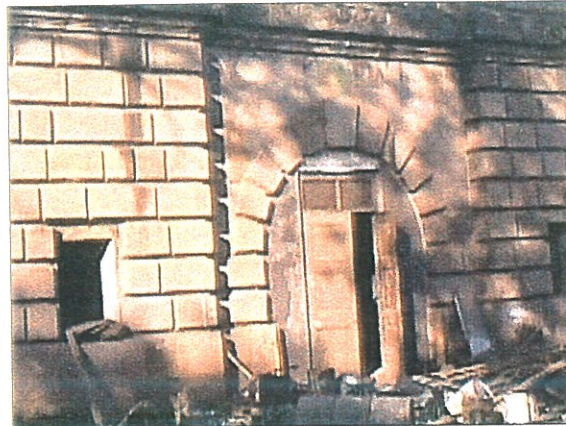
REAR ARCHED OPENING BLOCKED
(BEFORE RESTORATION)

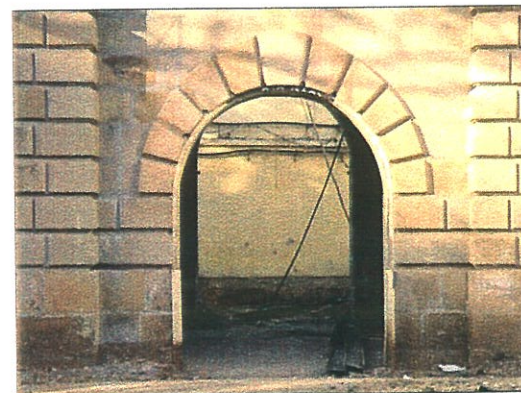
Rear arch opened up during restoration

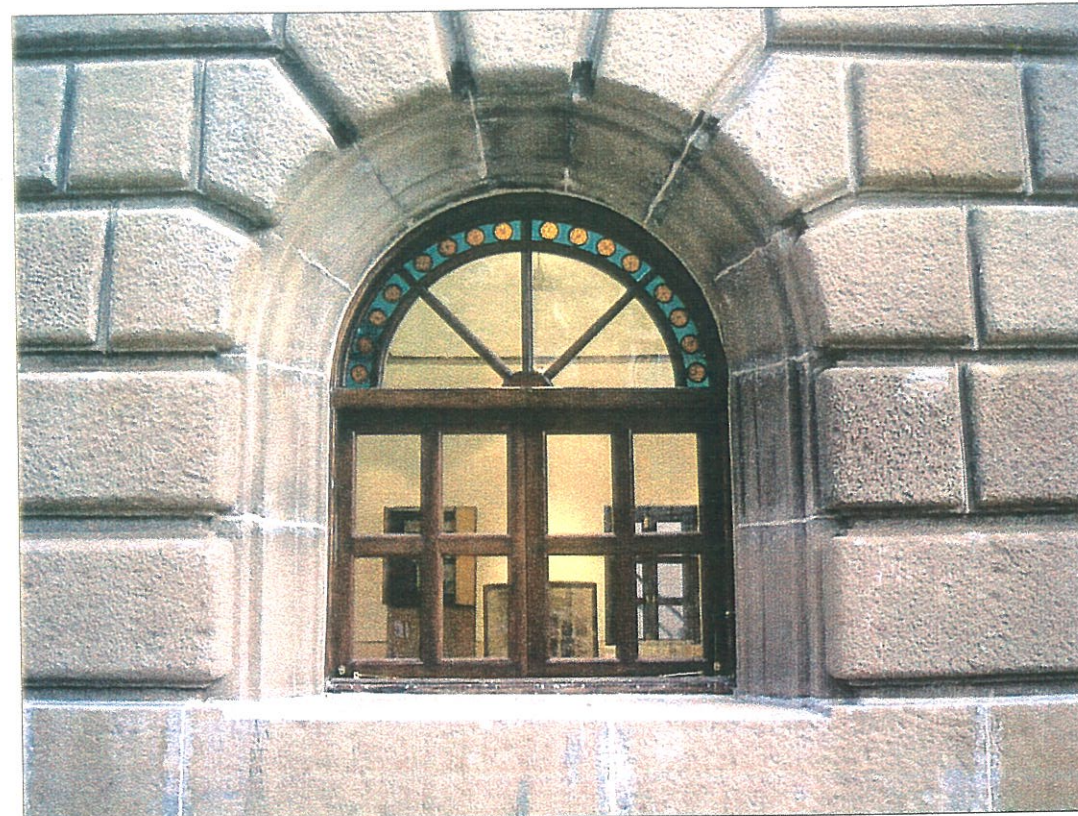
WINDOW OPENING AFTER RESTORATION

- All windows are replaced by timber windows of new design retaining the original direction of shutter opening.
- The semi-circular arched opening relates in design to the arched doors including the use of stained glass.
- Simple mouldings
- 6 mm clear glass for shutters
- Finish in melamine polish
- Removal of cement pointing and repointing of stone joints in the jambs, cracks and window surrounds with Lime mortar.
- Introduction of internal Kotah stone sill.

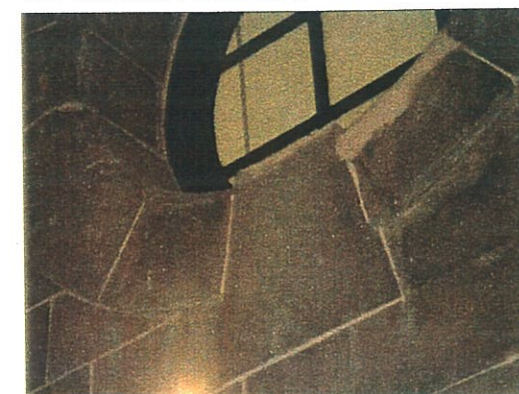
Opening restored after removal of elements causing the damage.

- The steel beam that had affected the slight displacement of the stone arch (voussoir) and caused a vertical crack through the stone wall was removed.

- Plastic repairs for damaged portion of the Bull's eye window.

- Stitching of crack with SS pins, sealing the crack with lime mortar.

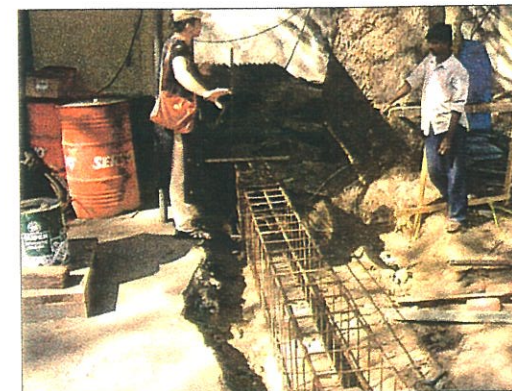
R.C. Beams laid across the massive tree roots to support the masonry above

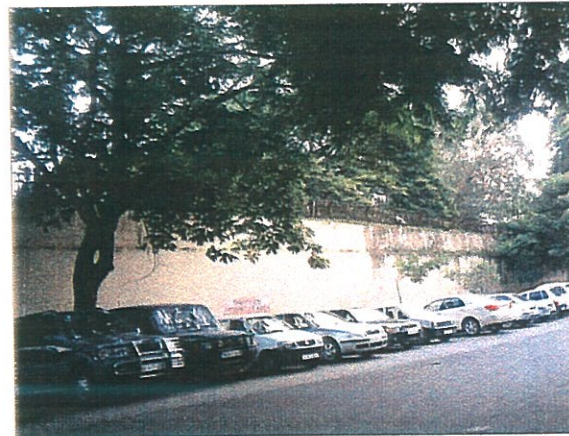
SECURITY WALL DEPRIVED THE VIEW OF THE GATEHOUSE FROM BALLARD ESTATE

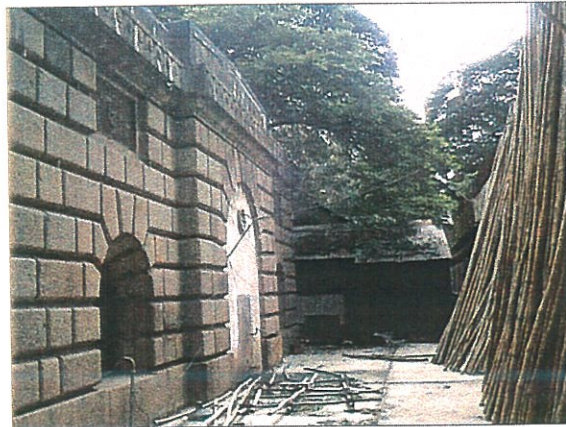
GATEHOUSE SURROUNDED BY HARD PAVING – BEFORE RESTORATION

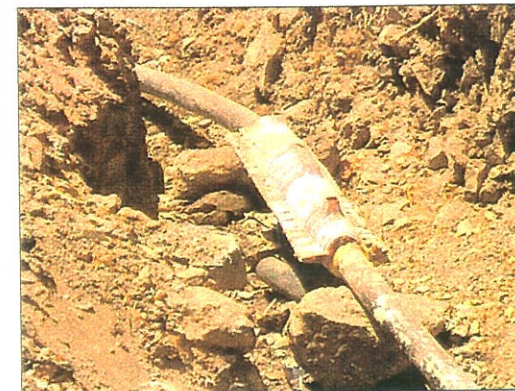
*Junction at LT cable after it was realigned
with an extension.*

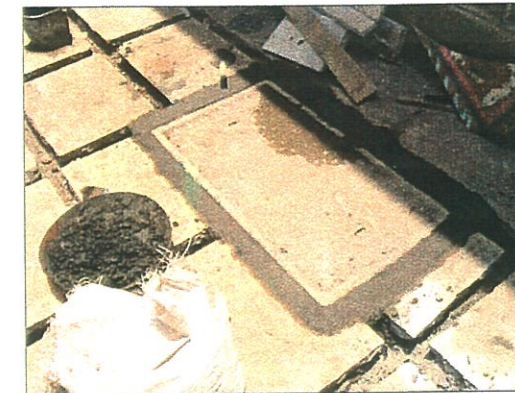
*Inspection chambers and service chambers
integrated with paving pattern.*

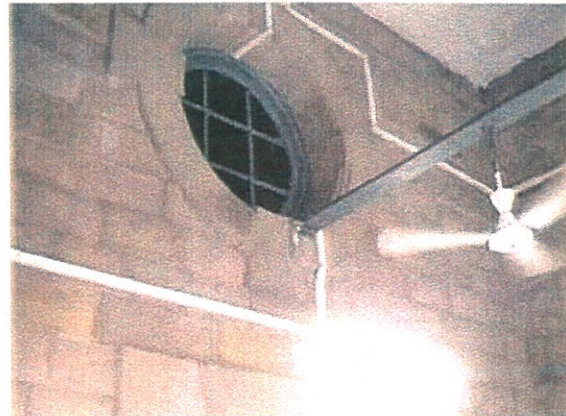
INSENSITIVE DESIGN AND LAYOUT OF ELECTRICAL WIRING AND FITTINGS – BEFORE RESTORATION
