LISTING & GRADING OF HERITAGE BUILDINGS & PRECINCTS IN MUMBAI  
 TASK II: Review of Sr. No. 317 to 632 of the Heritage Regulations

470 SWAMI PREMPURI ASHRAM TRUST BUILDING

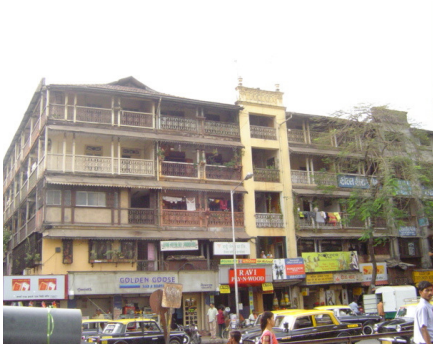
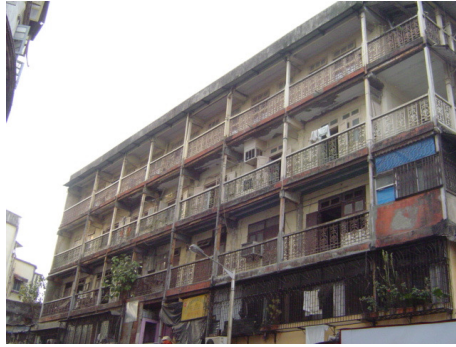
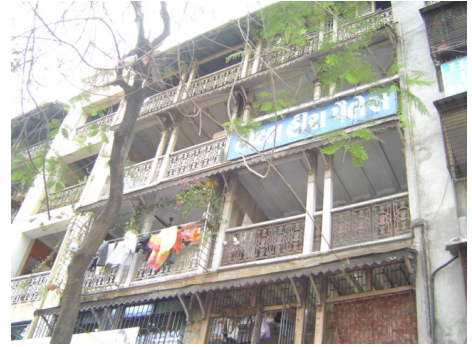
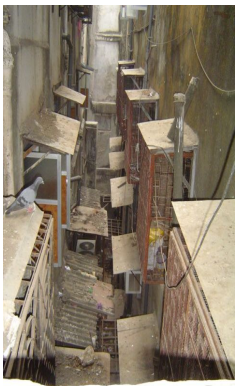
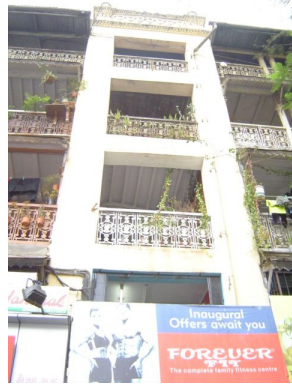
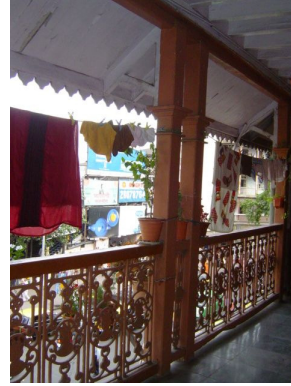
475 UNION BUILDING

9.3	Floor	Wearing away of stone on the ground floor; Some parts of lime concrete floor damaged; So of the shahbad stones broken; Many of the steel sections on the roof of the ground floor are corroded; the wooden beams and rafters of the ground floor broken; the wooden planks and rafters at various parts of the ground floor have dry rot due to water ingress

<b>475</b>	<b>UNION BUILDING</b>	
9.5	Openings	Many of the glass panels of the windows broken; some of the frames broken.
9.6	Roofing	Most of the sunshades on the side facades are broken; No visual damage for the timber planks and rafters in the lobby.

9.7	Articulation & Finishes	Most of the cast iron handrails are corroded; wooden hand rails and top rails of timber stair case broken;
9.8	Services	Rain water pipes on the side facades corroded

9.9	Outbuildings	No out buildings in the plot
9.10	Overall Condition	The building exhibits both structural and architectural deterioration and requires repair and restoration as well as upgradation of the electrical services Maintenance level Poor

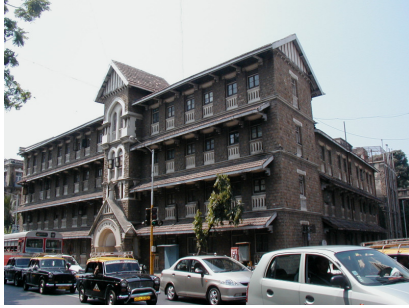
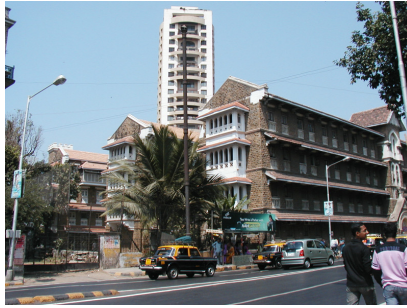
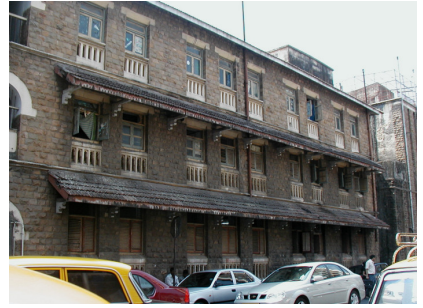
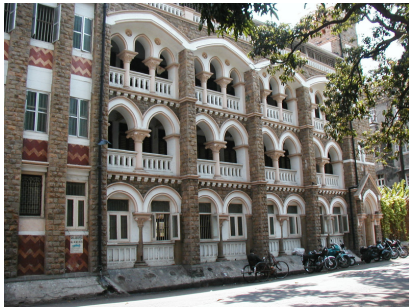
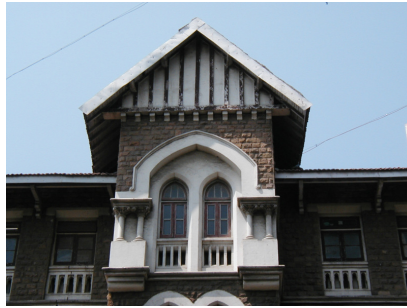
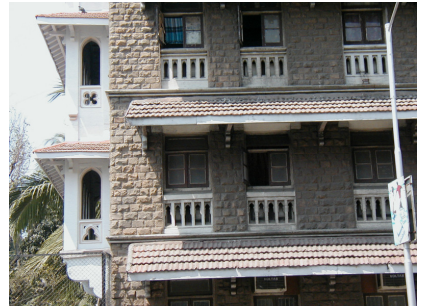
479 MACKICHAN HALL

9.2	Walls	The walls are free from all defects.
9.3	Floor	The floor is in good condition.
9.4	Stairs	The timber staircase is in good condition.
9.5	Openings	All the arched openings are in well maintained and the window frames and shutters are in good condition.

9.6	Roofing	The roof is in good condition.
9.7	Articulation & Finishes	All the details and carvings in limestone on the façade are painted white and are maintained in a good condition. All the finishes including the original flooring and dado materials are in good condition.

9.9	Outbuildings	All the other buildings on the campus are in good structural condition.
9.10	Overall Condition	The overall condition of the building is good. The maintenance level is also good.

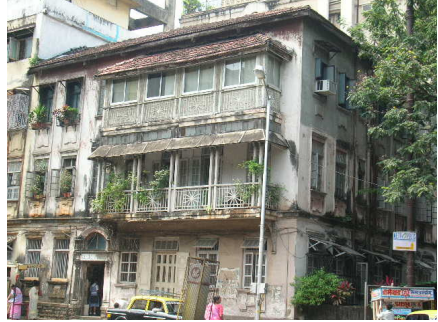
482 DALAL HOUSE

9.0		<b>CONDITION</b>
9.1	Plinth	The plinth does not show any signs of settlement except for moss accumulation seen.
9.2	Walls	The front Neo Classic façade does not show any sign of deterioration. All the other facades also show no sign of deterioration. Except for dampness where the pipes are running and salt effervescence on the walls. Vegetation growth is seen on the walls.

9.5	Openings	Some of the openings are in fair condition; window and glass panes are missing / broken. The balconies on the upper floor are enclosed by the owners. A balcony on the rear façade has additional wooden supports. The upper openings have been altered by the owners and some openings have air conditioners in them. The original chajjas have been altered.

9.6	Roofing	The Mangalore tiled roof seems is in a good condition.
9.7	Articulation & Finishes	The neo classical features on the entrance do not have defects. The wall finish in the staircase block is seen flaking.

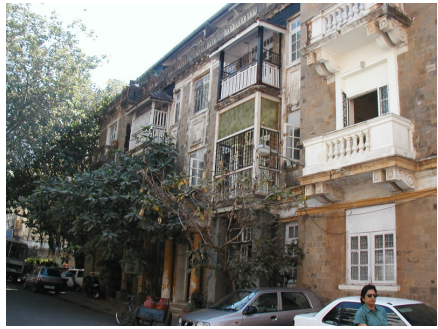
483 SAKSERIA BUILDING

8.6	Fire Precaution	None
8.7	Other (HVAC/BMC/Security Systems)	Manned by private security guard.
9.0		<b>CONDITION</b>
9.1	Plinth	Cracks in the stone masonry and settlement of the plinth are seen.

9.2	Walls	Water leakage has damaged some walls. Discolouration and ficus growth is also seen.
9.3	Floor	The floors are in a structurally stable condition.

9.4	Stairs	Timber treads are a bit worn out. Landing areas have been punctured to allow electric wiring through.
9.5	Openings	A window opening on the ground floor has been boarded up completely. Original stained glass panels have been removed from balconies. Iron grills and jails have been added to window openings and balconies. Timber posts, M.S. members and concrete pillars used to shore up stone balcony slabs.

9.6	Roofing	Water leakage from the roof is observed at some location apart from this the roof does not show any signs of intervention.
9.7	Articulation & Finishes	Discolouration, damage and flaking off due to dampness is seen in many places. Require cleaning and repair work.

9.10	Overall Condition	Fair <span style="float: right;">Maintenance Level: Regular</span>
10.0		<b>TRANSFORMATION</b>
10.1	Form	None
10.2	Structure	Timber posts, M.S. members and concrete pillars used to shore up stone balcony slabs. Though there does not seem to be any visible structural threat, the architectural quality of the building is compromised due to structural transformations.

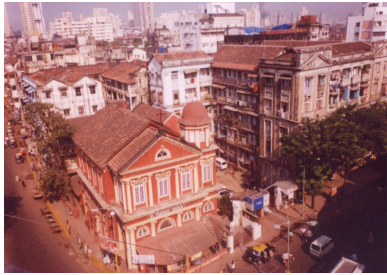
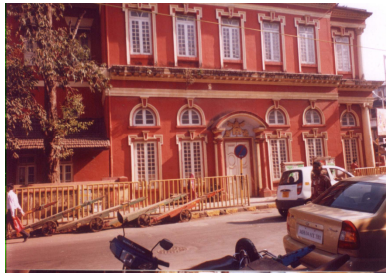
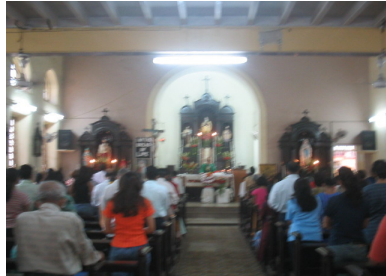
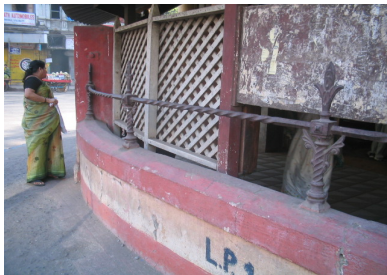
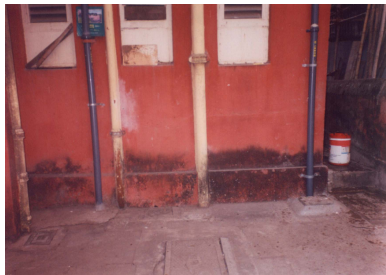
9.0		<b>CONDITION</b>
9.1	Plinth	<p>Rising damp observed along the southern and northern facades as also to a small extent and intermittently on the Western facades. The rising damp thus leads to peeling plaster and paint.The pavement on the east has been raised above the plinth level and damaging the plinth protection.</p>

9.2	Walls	<p>The exterior surface of the walls shows extensive water seepage and dampness. There is constant leakage from down take pipes. This has led to stone staining and efflorescence. There is water accumulation at the cornice bands causing constant dripping of water on the walls below</p>

486 ST TERESA CHURCH		
		and causing damage to the cornice itself. The window sills on the southern wall show gaps causing ingress of water causing dampness on the interior walls. On the inside, the walls have been plastered and painted in crème coloured oil paint. No visual structural problems are recorded on the interior walls and they are regularly maintained.

9.6	Roofing	Fascia boards throughout the roof edge are broken or missing. This has led to deterioration of the end condition of the timber members. Water seepage and warping of timber boarding inside the church. Some of the Mangalore tiles at the junctions of the roofs are broken, and ridge tiles are displaced. Some gutters are also missing.

9.7	Articulation & Finishes	Detailing on the façade is free from major decay. The horizontal cornice bands and architraves around windows show watermarks and are blackened. Articulation and finishes inside the church like original Minton tile flooring and plaster and limestone figurines at the entrance gates are intact. The wall finishes too maintained to lime plaster and lime wash.

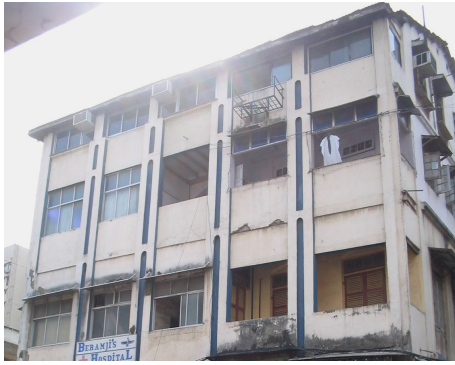
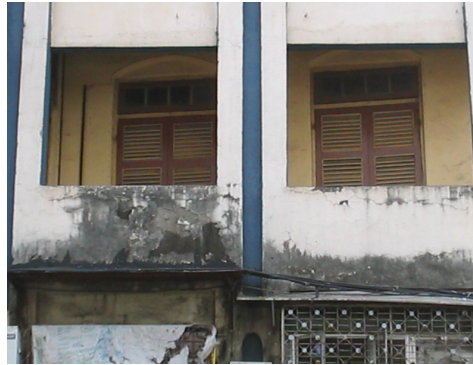
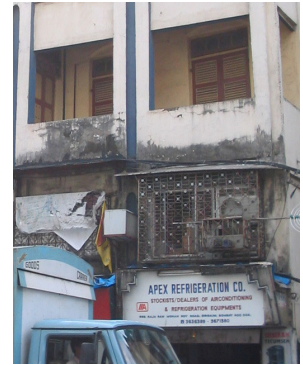
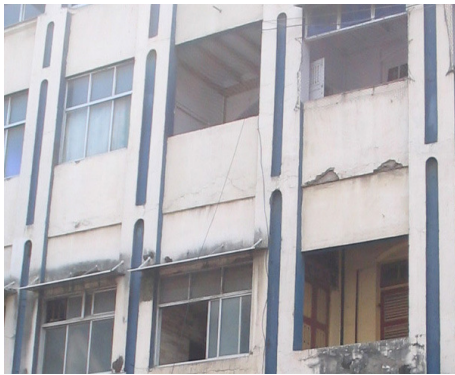
487 PATEL BUILDING

9.0		<b>CONDITION</b>
9.1	Plinth	Rising damp observed on front and side elevations of the building.
9.2	Walls	Seepage from roof on all gable walls and in balconies on the all floors. Some cracks are also seen along the staircase wall between first and second floor. Other cracks observed are from the segmental arches of the windows running towards the roof. These cracks need to be monitored in order to determine the danger.

9.3	Floor	Some of the timber structural floor members are replaced by 'I' sections.
9.4	Stairs	Timber staircases in poor condition and replaced by RCC members in most places. Staircase is oil painted in brown colour

9.5	Openings	Internal doors and windows are original. The balconies and their cast iron elements are missing and replaced by brick walls. The balconies are encroached upon and openings converted into windows with Aluminum frames and glass panes. The openings have new weather shades of tin sheets and corrugated asbestos sheets.

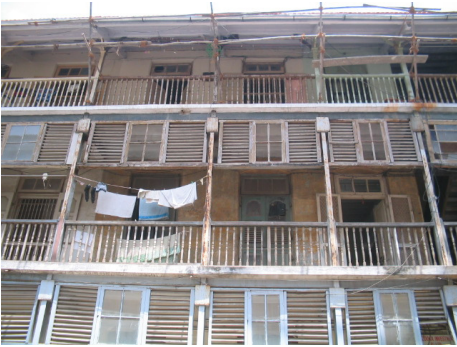
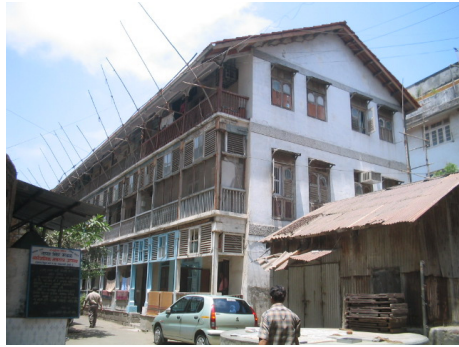
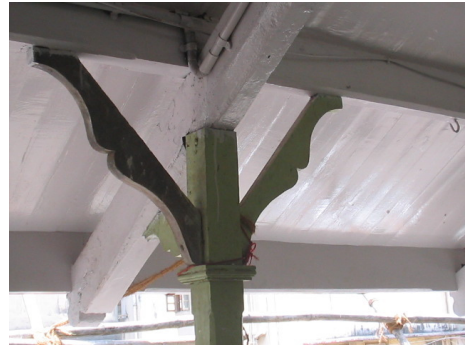
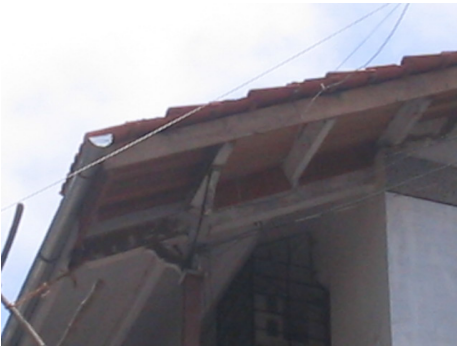
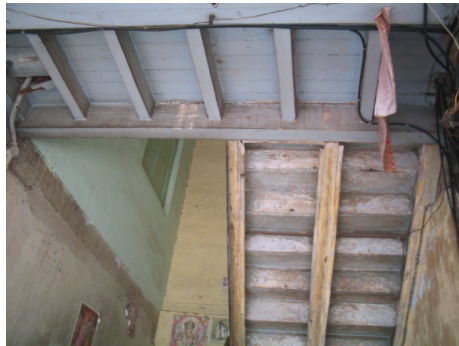
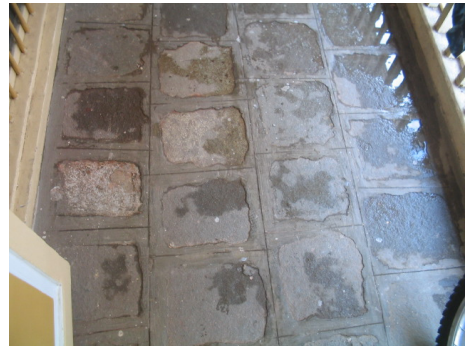
501 SEETA BUILDING

9.1	Plinth	The plinth is in a sound condition and does not show any signs of distress.
9.2	Walls	Most of the walls appear to be free from all defects however some water seepage is visible in the toilet walls.

9.3	Floor	The building was undergoing repairs when the inventory was carried out, on the ground and first floors the timber rafters had been replaced by steel I sections.

9.8	Services	The electrical wiring is haphazard and needs to be upgraded.
9.9	Outbuildings	There are no outbuildings.
9.10	Overall Condition	Fair Maintenance level: Regular

10.0		<b>TRANSFORMATION</b>
10.1	Form	No transformation is recorded in the form.
10.2	Structure	The timber columns for the front verandah on the ground and first floors have been replaced by mild steel columns and the timber rafters for the floors have been replaced by I sections.

10.3	Articulation & Finishes	Some of the decorative timber balusters have been replaced by round mild steel rods. The original Shahbad flooring has been replaced by ceramic and vitrified tiles in some places. The last tenement on either end of the verandah have

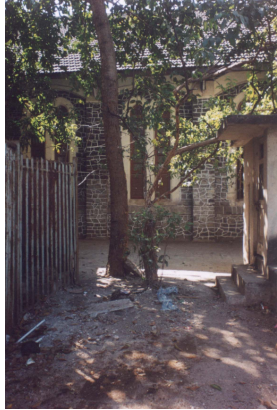
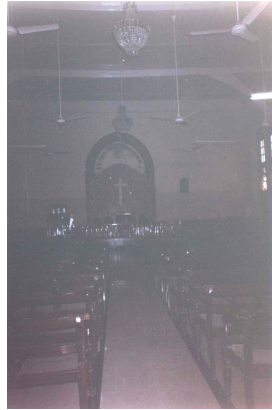
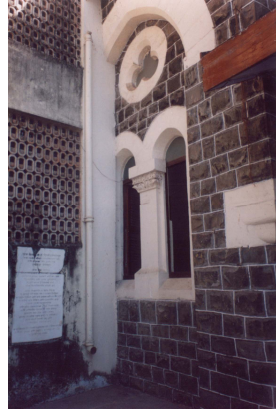
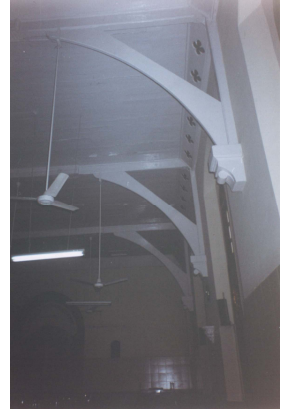
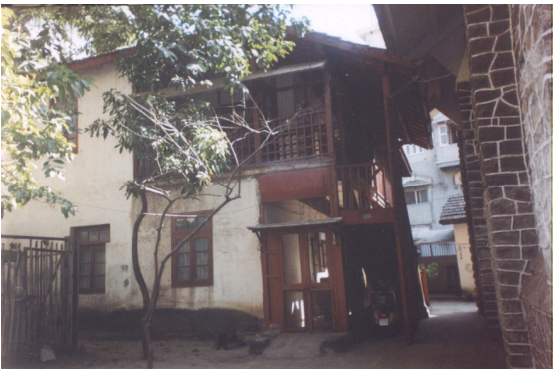
502 | AMBROLI CHURCH

9.6	Roofing	The flat timber roof shows leakage leading to timber boarding sagging. The ends of the roof show water seepage problems causing the timber structural members to deteriorate.

9.7	Articulation & Finishes	Floor finishes are worn out and show stains at various places. The church is devoid of excessive articulation.
9.8	Services	Fire safety in the form of the soda acid type fire extinguisher needs to be monitored regularly – presently it appears to be in a state of disuse. There is no shortage of electricity and water supply.

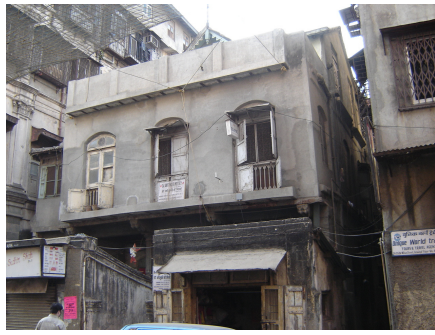
ALTERED ROOF TERRACE

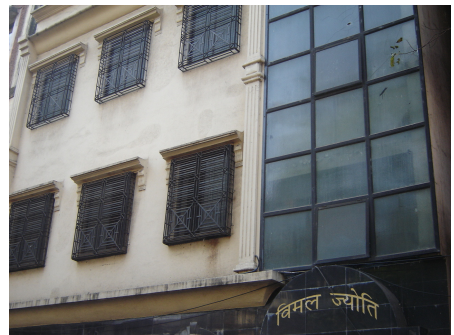
ALTERED OPENINGS

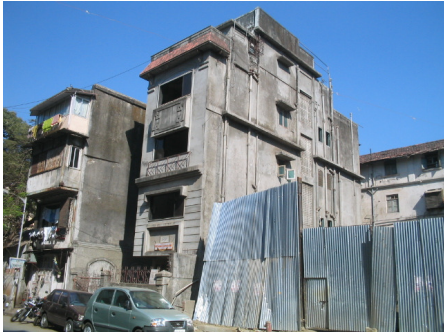
GENERAL VIEW OF RECONSTRUCTED STRUCTURES

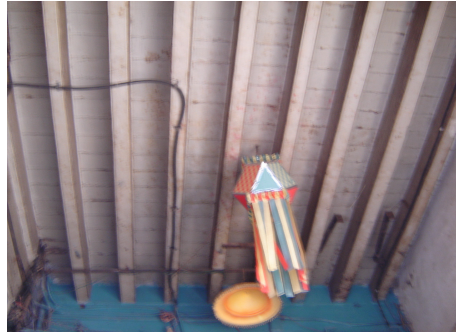
ALTERED FLOORING

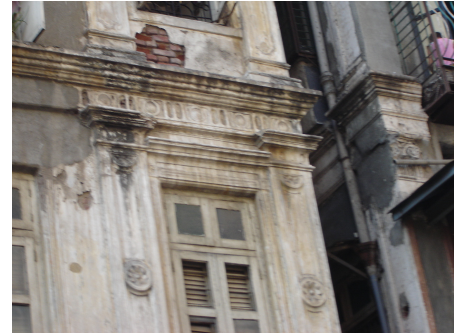
DETERIORATED ARTICULATIONS

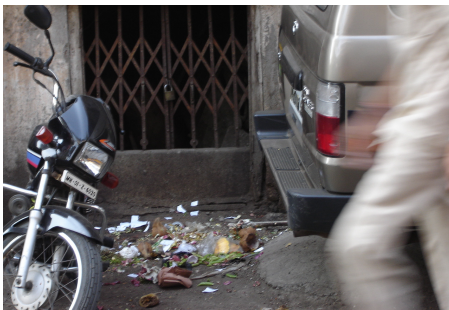
ALTERED PLINTH

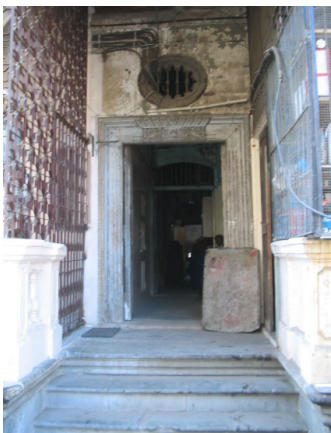
DETERIORATED STRUCTURES

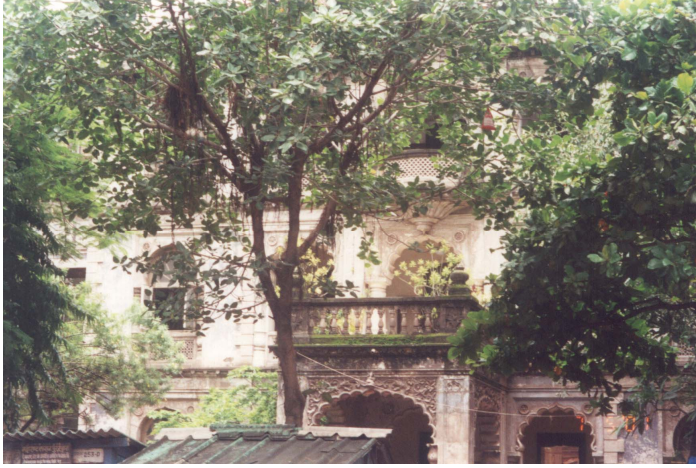
**KILACHAND HOUSE JULY 2001**

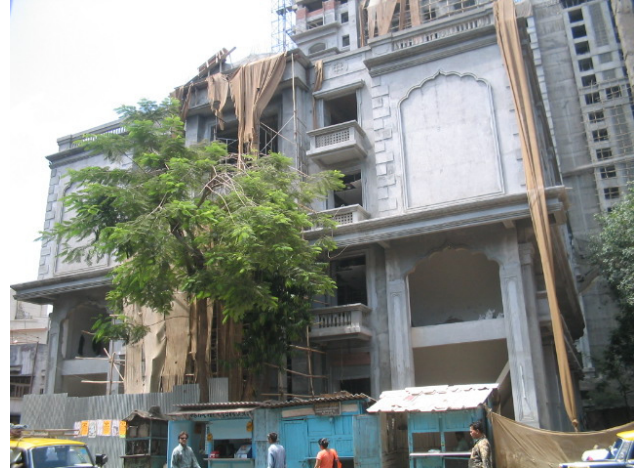
12.0		<b>ADDITIONAL NOTES/REFERENCES/DOCUMENTS AVAILABLE/RECOMMENDATIONS &amp; SUGGESTIONS FOR IMPLEMENTATION</b>
12.1	Historical Background	The original building has been demolished and a new-multi-storeyed construction is underway. This building should be de-listed with immediate effect.

**KILACHAND HOUSE JAN 2005**

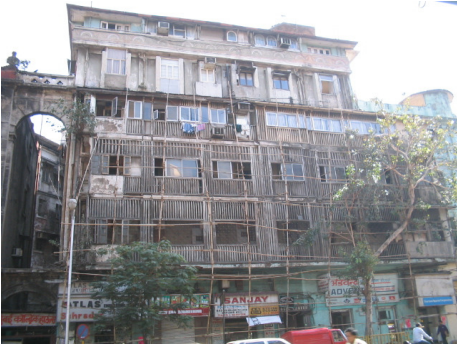
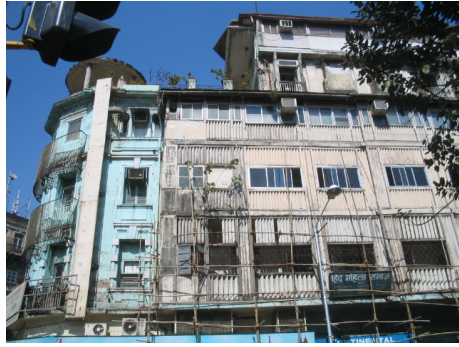
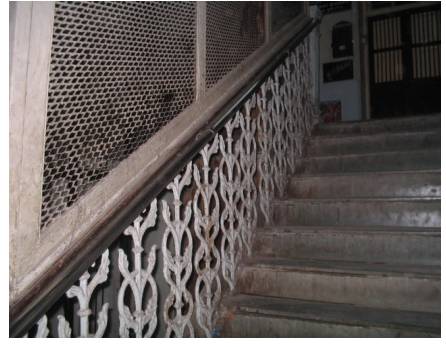
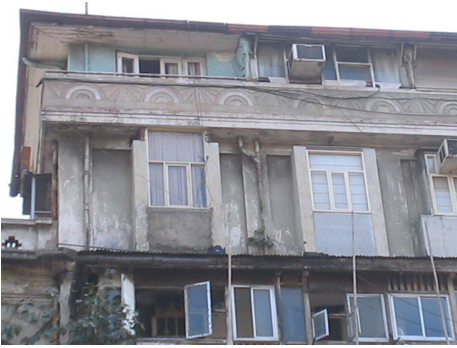
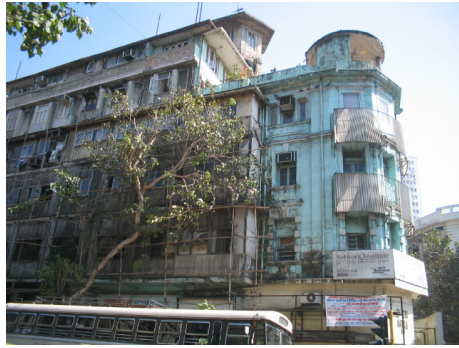
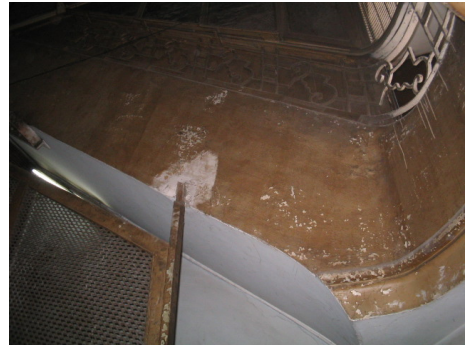
9.0		<b>CONDITION</b>
9.1	Plinth	The entire plinth has been clad with ochre coloured polished stone. At places where the cladding is not present, rising damp is seen. Also the service pipes embedded behind the layers of plaster open up at the plinth level and dispose all the waster water on the plinth.

9.2	Walls	The walls show seepage on all the floors. On the top floor the seepage is more extensive and runs along the entire wall. This leads to peeling plaster and paint. On the external walls especially on the balconies; large amounts of vegetation growth is observed and seems to have been growing over the years. The internal and external walls too are in a state of structural threat and need to be consolidated urgently.

9.3	Floor	The floors show exposed reinforcement at the balconies and the plaster is missing. There is large amount of vegetation growth observed on the floor of the balconies. The floors show large cracks and signs of structural distress. The internal floors are free from any visual structural threat. The floor on the second level also shows leakage, leading to peeling plaster and paint.

509		CUTCH CASTLE
		of disorder. The main entrance gate to the building also has wiring running over it, leading to an external electric station, as the internal electric distribution boards cannot take the added load. The service pipes are embedded behind the various layers of plaster that have been added over the years. The down take and sanitation pipes on the side façade are in a dilapidated state and leaking at various places along the length. Due to the leaking pipes, there are large amounts of vegetation growth on the walls, also causing constant dampness on the walls.

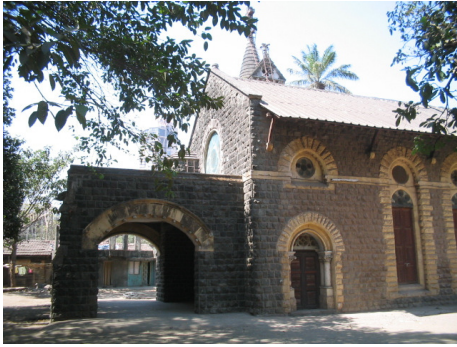
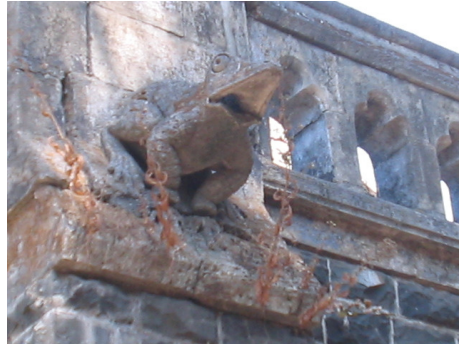
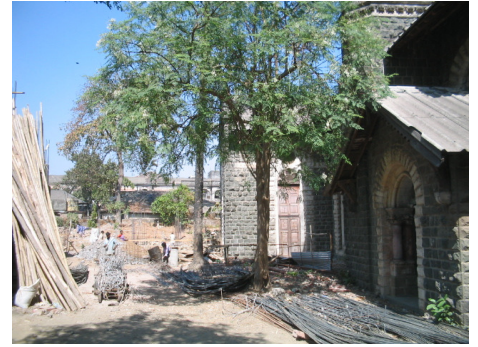
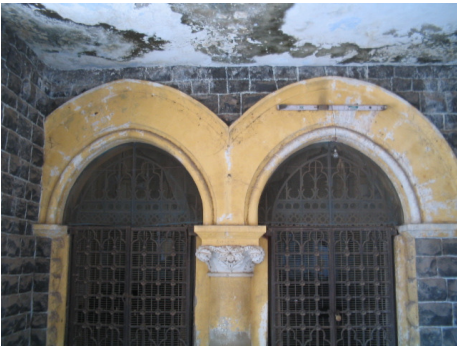
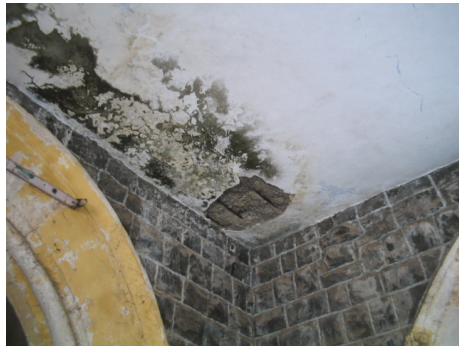
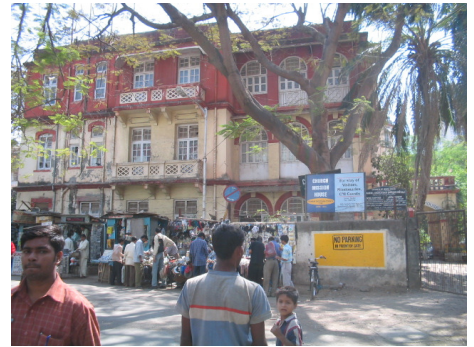
510 | EMANUEL CHURCH

9.6	Roofing	The timber roof inside the church shows signs of dampness and leakage

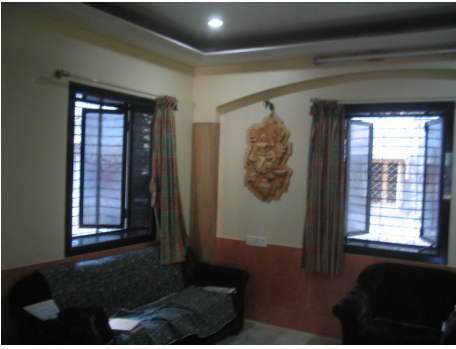
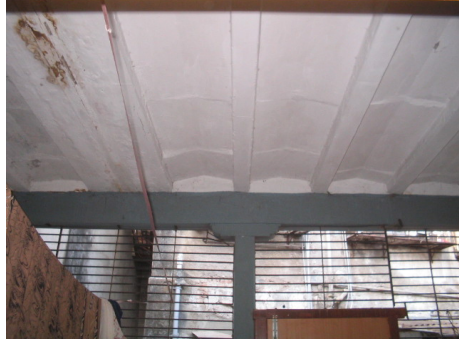
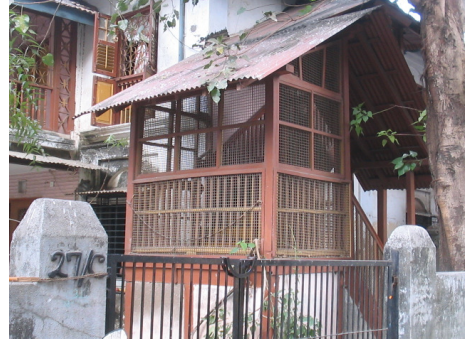
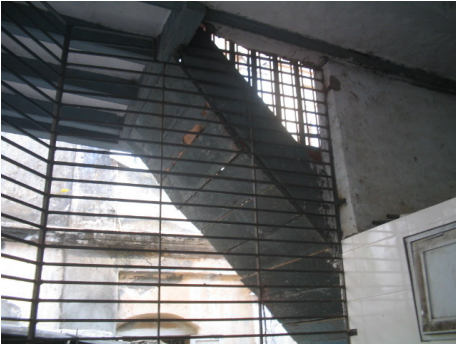
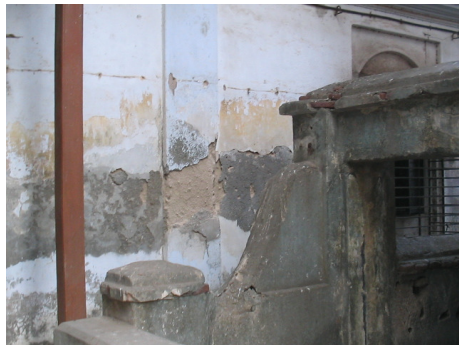
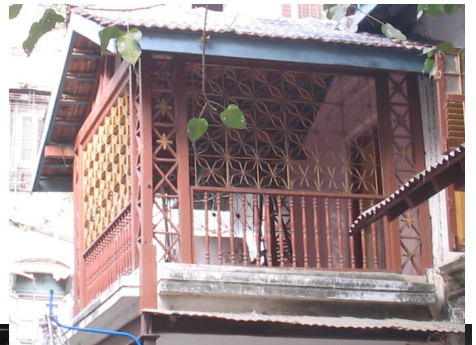
9.0		<b>CONDITION</b>
9.1	Plinth	Rising damp observed in front verandah and at regular intervals all along the periphery of the building.
9.2	Walls	All external walls show condition of peeling plaster. Seepage from roof on all gable walls and in verandahs on the first floor is seen as a recurring problem. Repair works carried out in cement and cement plaster aggravates the problem further. Parts of the wall are painted in oil paint. Internal walls are clad with 3 feet high marble dado, thus structural condition is masked behind.

9.6	Roofing	Water seepage and warping of timber boarding in the verandah, most ends of the timber rafters in the verandahs have rotted. Some of the Mangalore tiles at the junctions are broken, gutters are missing.

9.8	Services	A toilet block is added at the rear of the building in part of the back verandah. Additions of water tanks on terrace, major leakage and seepage problems in the toilet block and rear wall.
