Final Report of the

DOCUMENTATION AND PREPARATION OF CONSERVATION GUIDELINES for

HERITAGE BUILDINGS AND PRECINCTS IN VASAI - VIRAR SUB - REGION

VOLUME II: APPENDICES LIST OF HERITAGE ASSETS IN THE MUNICIPAL COUNCILS

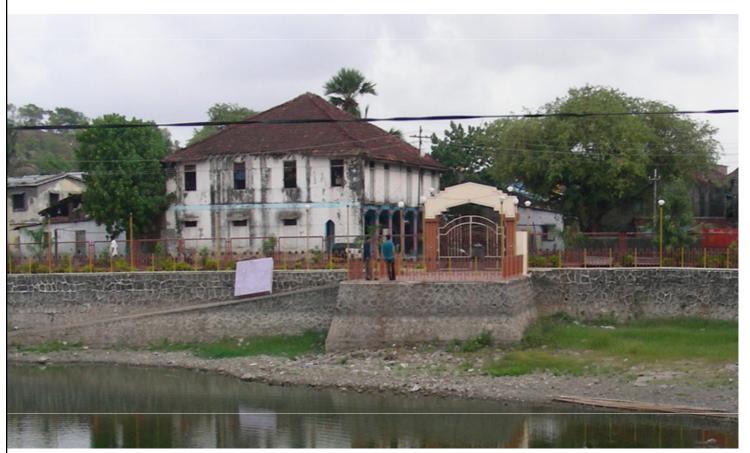
Entrance to the talav with the Naringi gaothan in the background

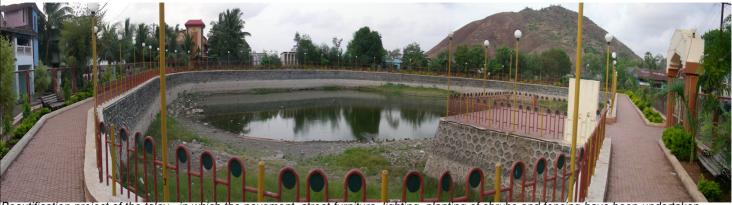
Beautification project of the talav - in which the pavement, street furniture, lighting, planting of shrubs and fencing have been undertaken

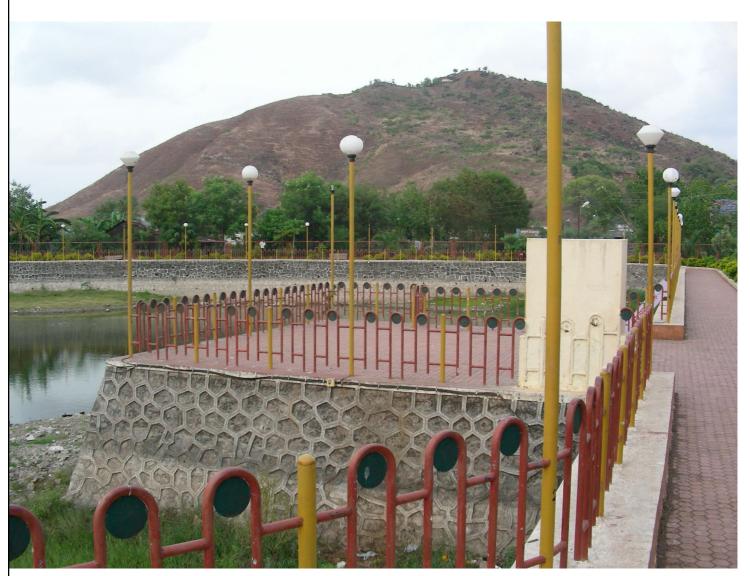
Detail of the platform from which the idols are immersed in the water during the Ganesha festival

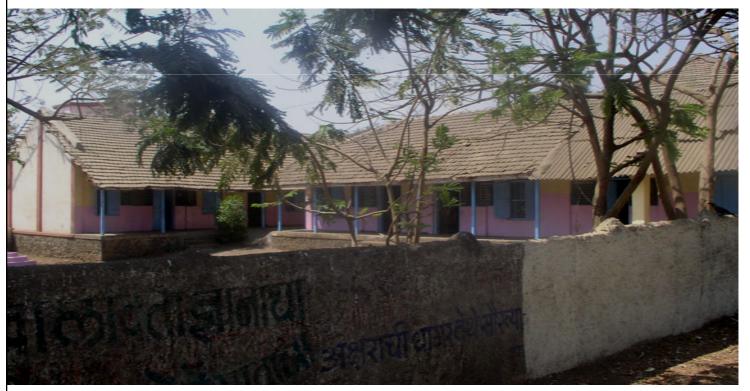
Mangalore tile roof and the verandah with a wooden post form distinct architectural features

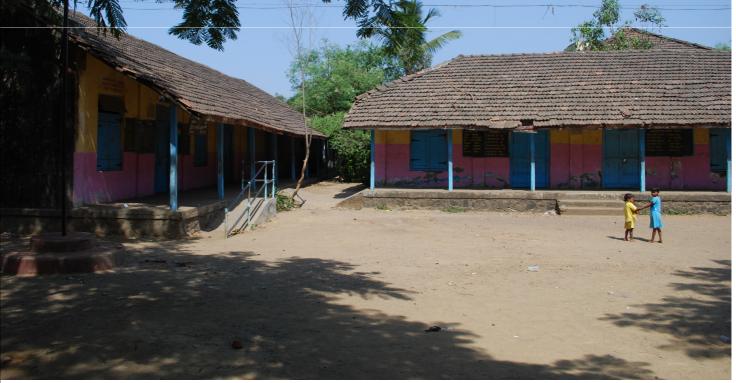
Buildings organised around an open court which acts as a multifunctional space

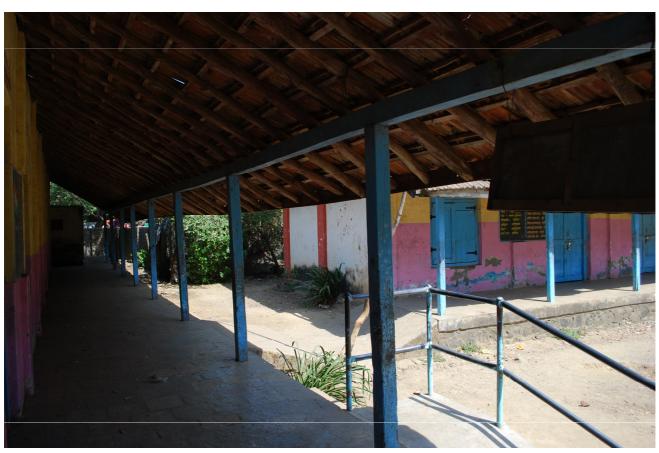
Classrooms strung behind a verandah with wooden columns

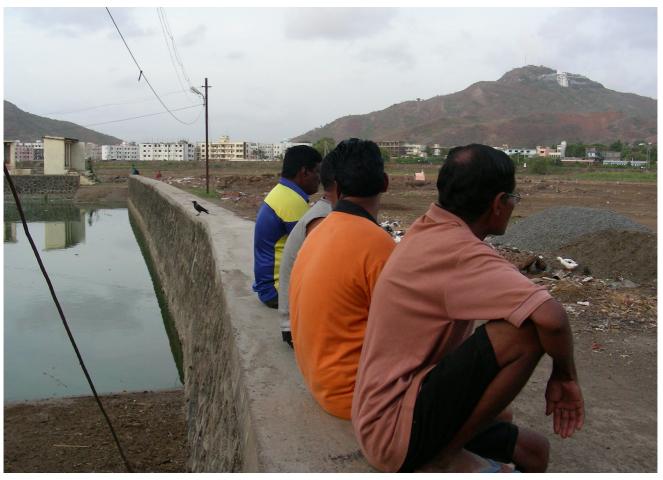
Edge of the talav is used as a public space

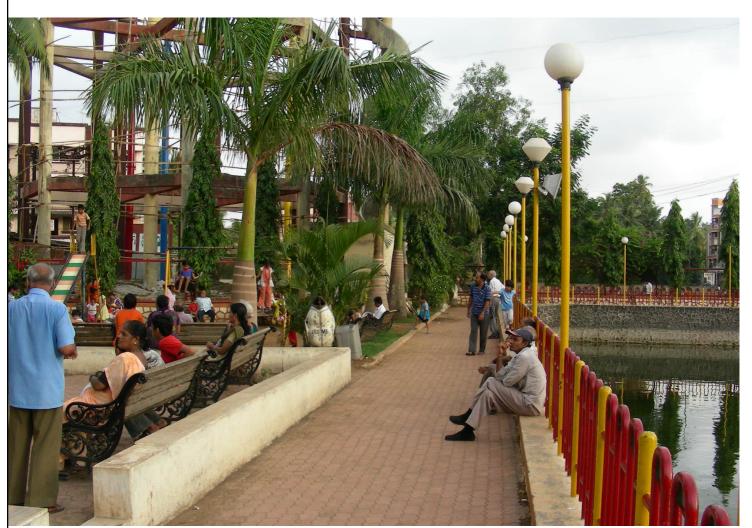
Public space along the edge of the talav

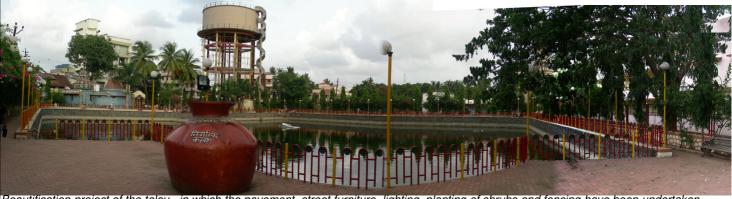
Beautification project of the talay - in which the pavement, street furniture, lighting, planting of shrubs and fencing have been undertaken

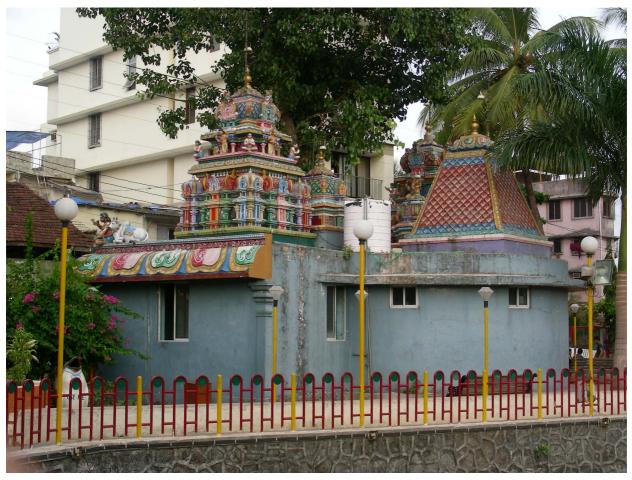
Temple along one of the edges of the talav

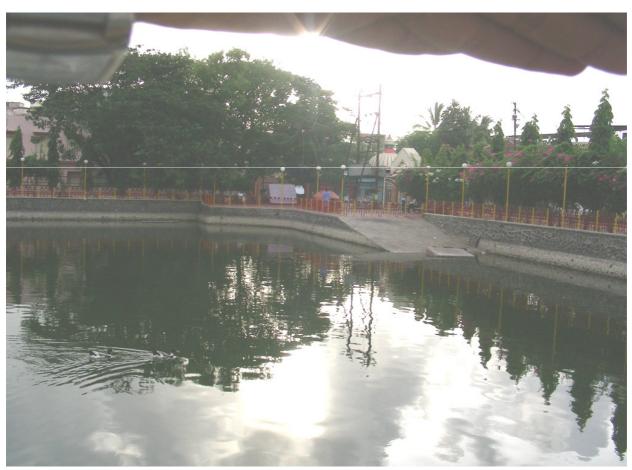
Ramp from which the idols are immersed in the water during the Ganesha festival

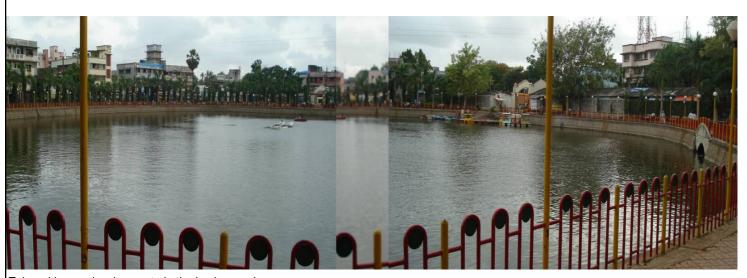
Talav with new developments in the background

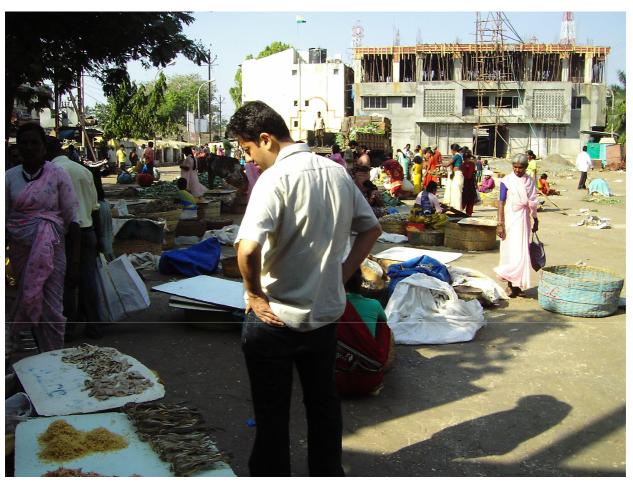
Market along one of the edges of the edges of the talav

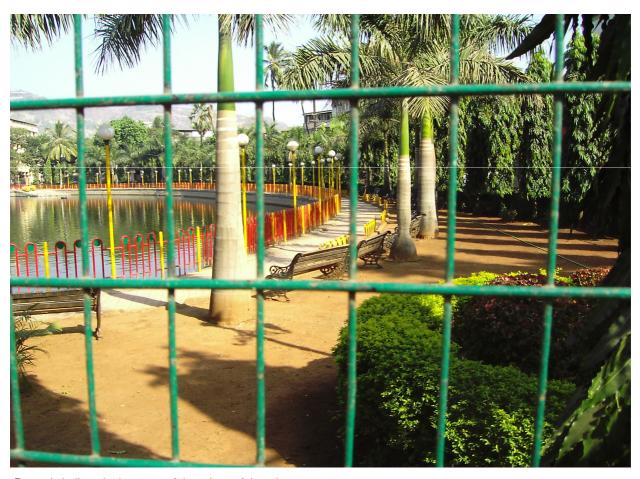
Recently built park along one of the edges of the talav

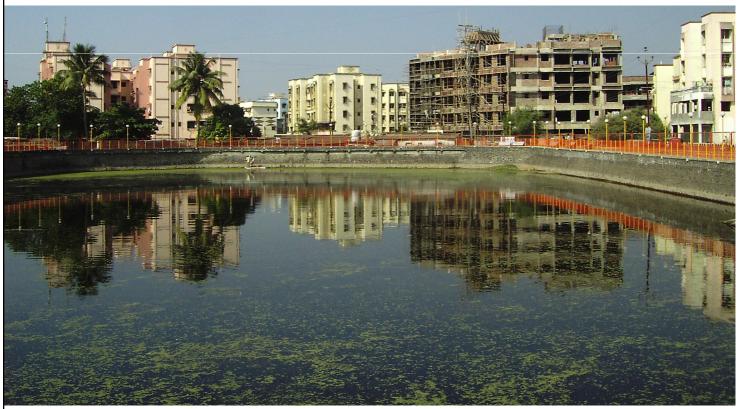
New housing schemes in the vicinity of the talav

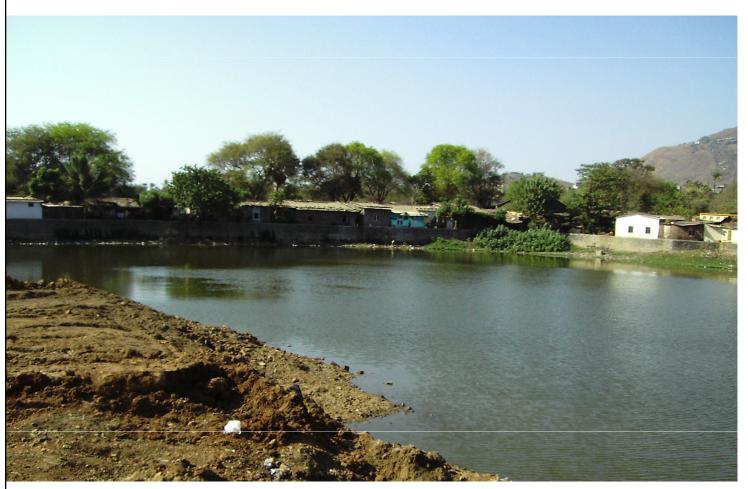
Adivasi settlements around the edge of the talav

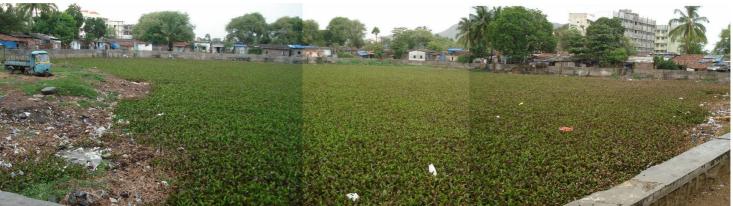
Growth of water hyacinth in the talav

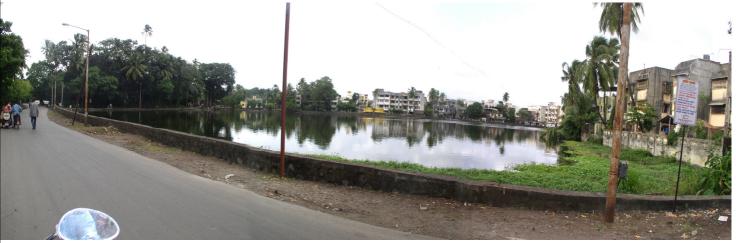
Low level compund wall along the edge of the talav

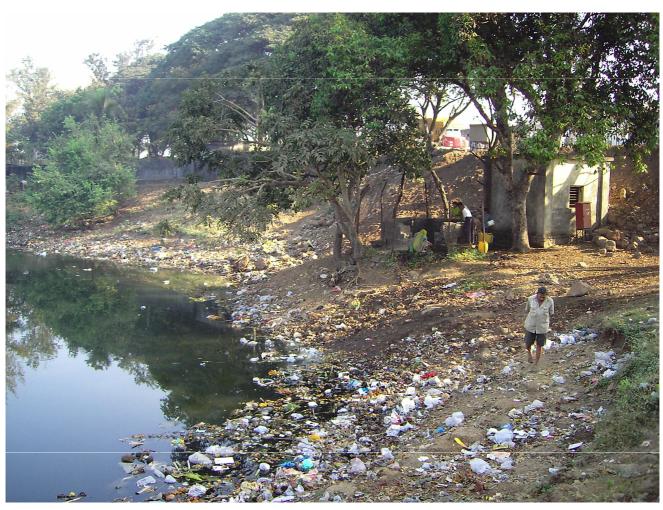
Garbage littered along the edge of the talav

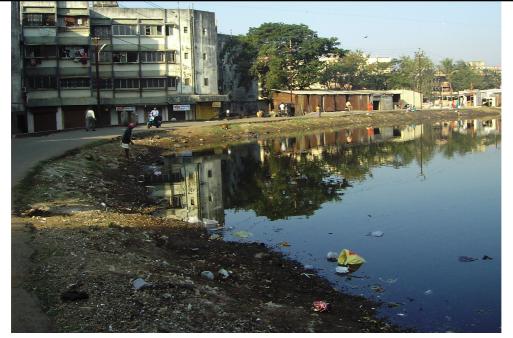
Garbage littered around the road edge

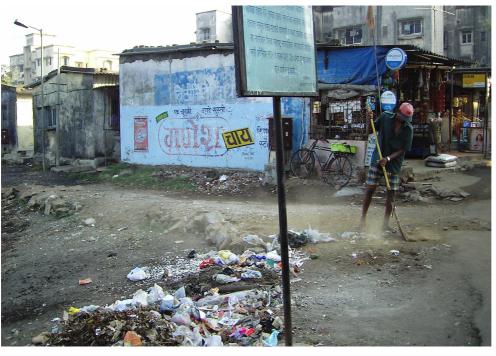
Garbage collection point along the edge of the talav

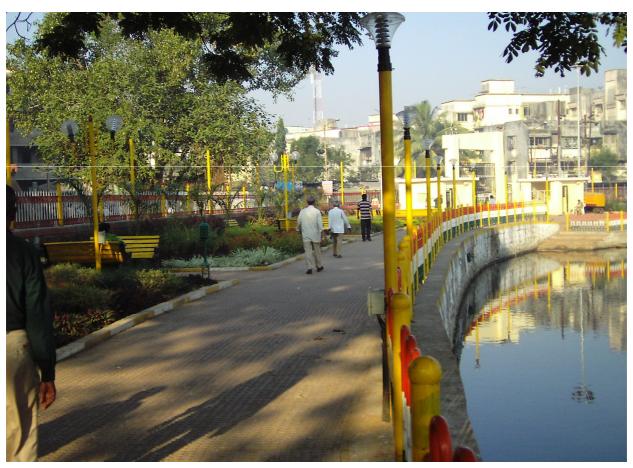
Beautification project of the talav - in which the pavement, street furniture, lighting, planting of shrubs and fencing have been undertaken

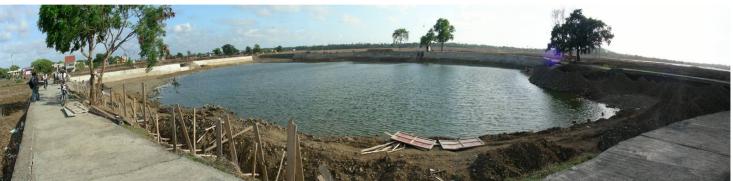
New retaining wall and pathway being constructed around the edge of the talav

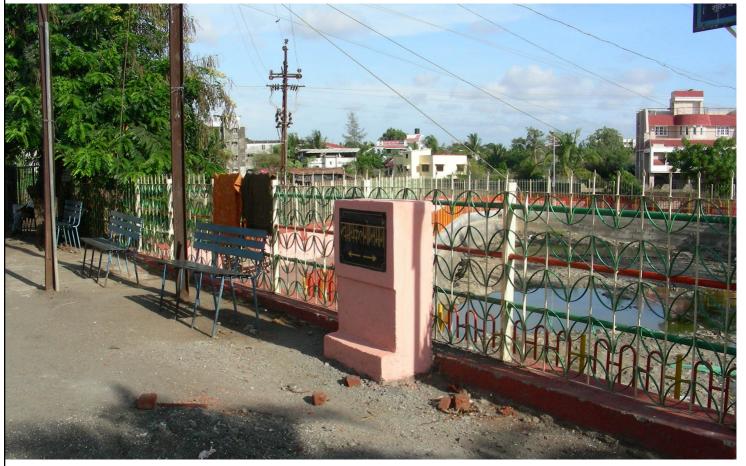
Street furniture along the edge of the talav

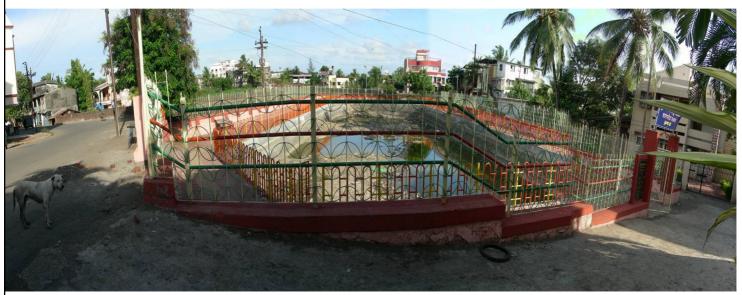
Talav forming an entrance to the gaothan which is seen on the right corner

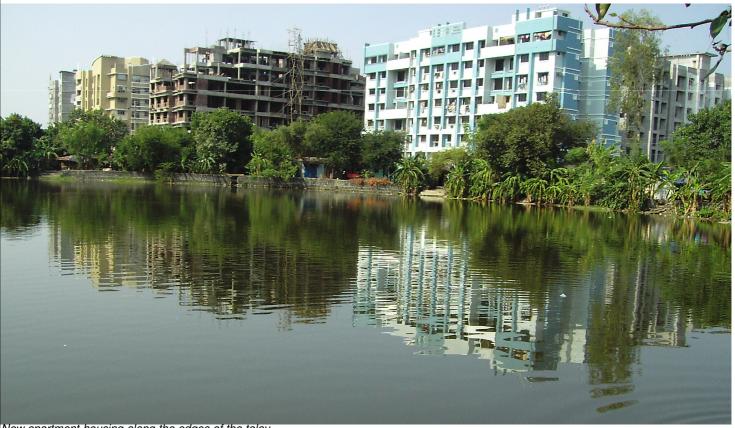
New apartment housing along the edges of the talav

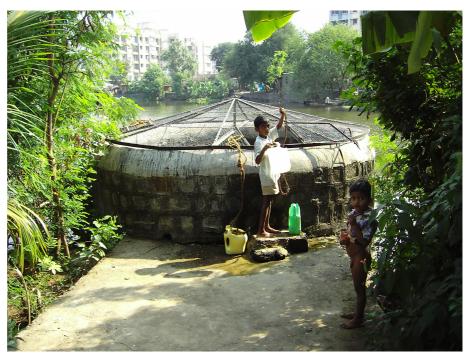
Well along the talav edge and water being drawn by a adivasi boy

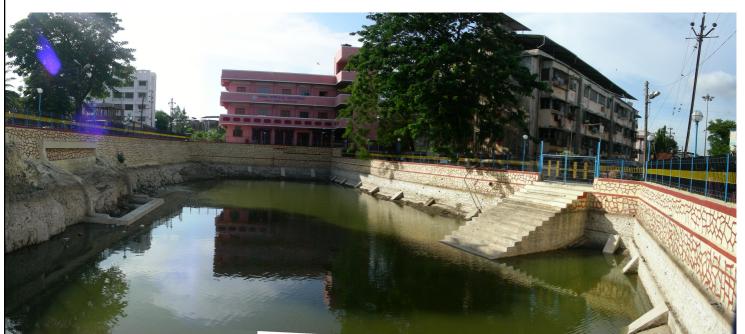
Steps leading to the water in the talav

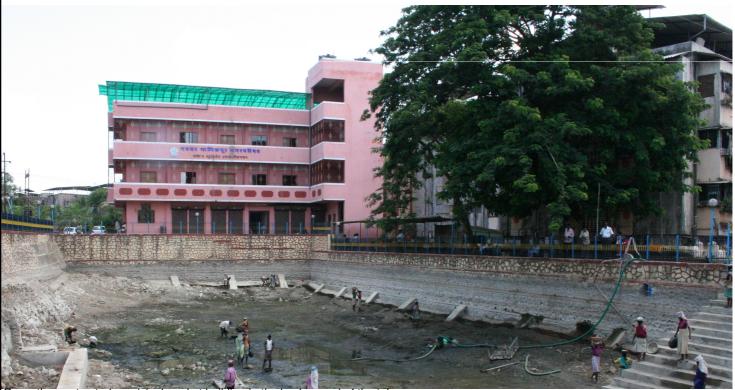
Recently constructed municipal market building in the background of the talav

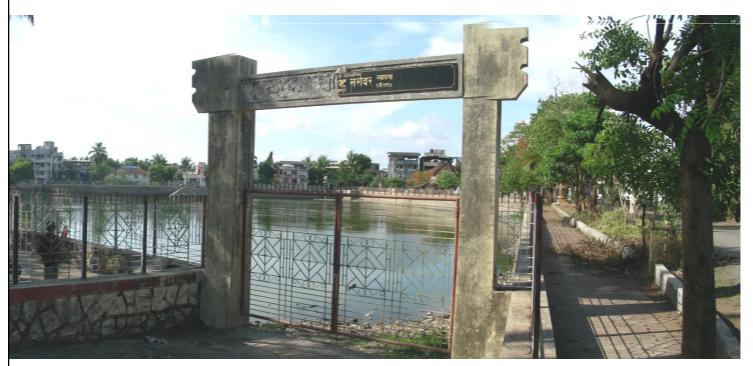
Father Benedict Talav – fencing and pavement along the edge

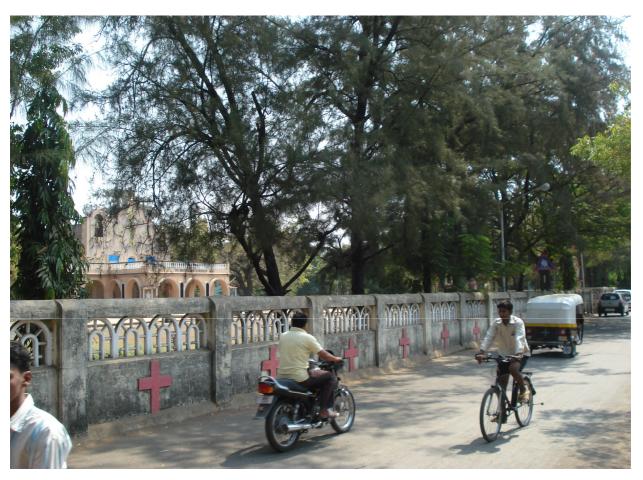
Edge condition of the road adjacent to St. Micheal's Church

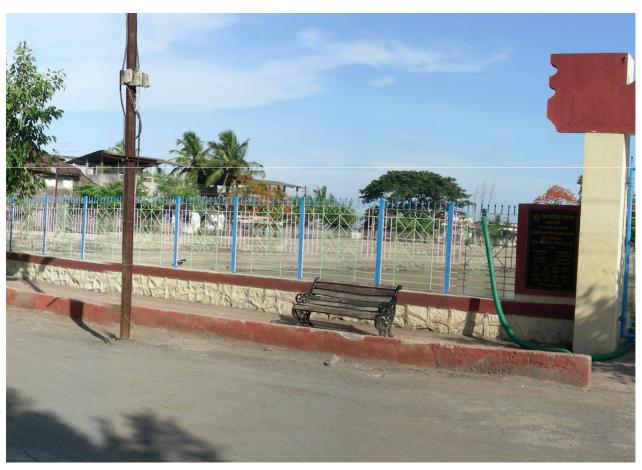
Edge condition of the road adjacent to the talav

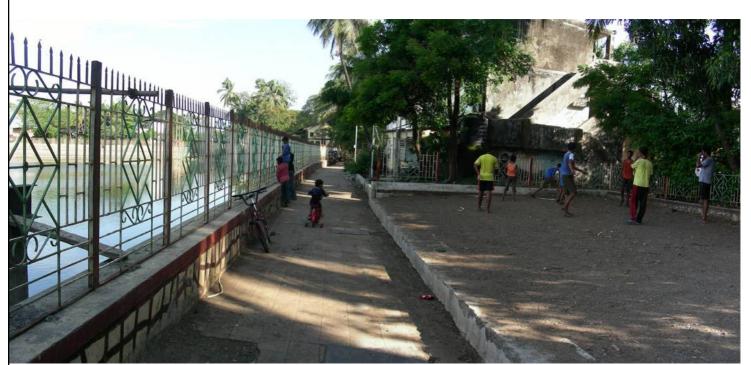
Play area along one of the edges of the talav

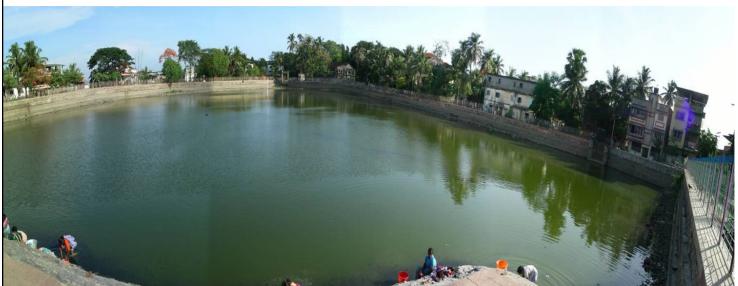
Women washing clothes in the foreground; gaothan in the background

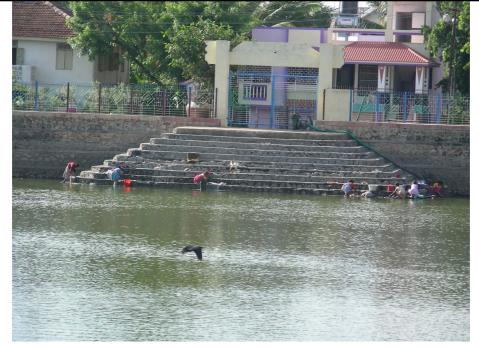
Steps leading to the water being used as washing ghats

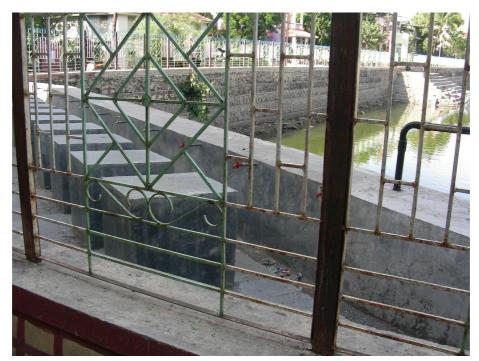
New type of provisions made for washing clothes along the edge

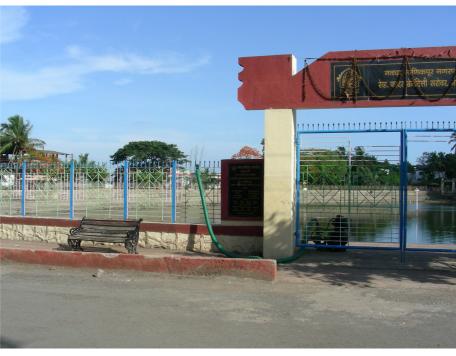
Pavement and street furniture along the edge of the talav

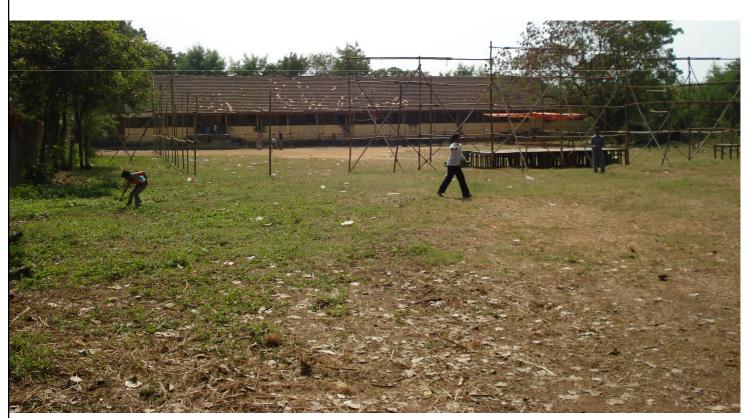
The school building forms a backdrop to the large playground

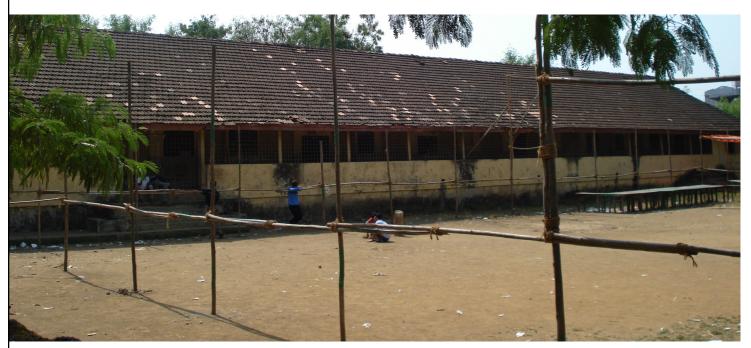
The pitched roof of the long barn like structure forms the most important architectural element in the landscape

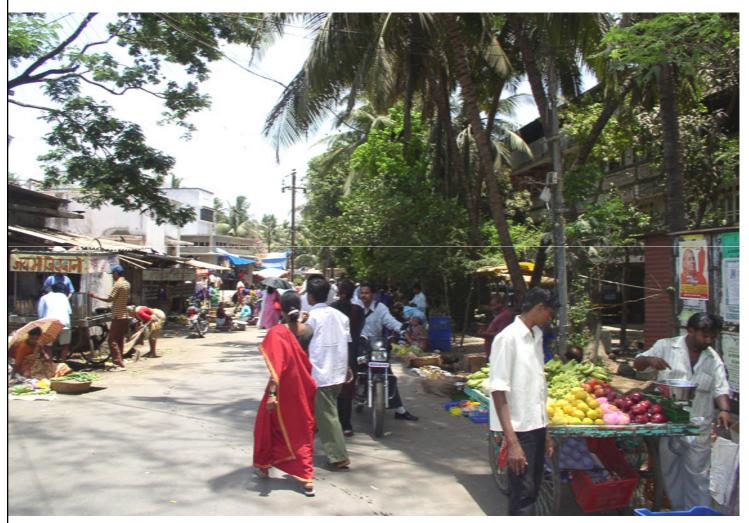
Vegetable and fruit vendors along the edge of the road in Holy bazaar

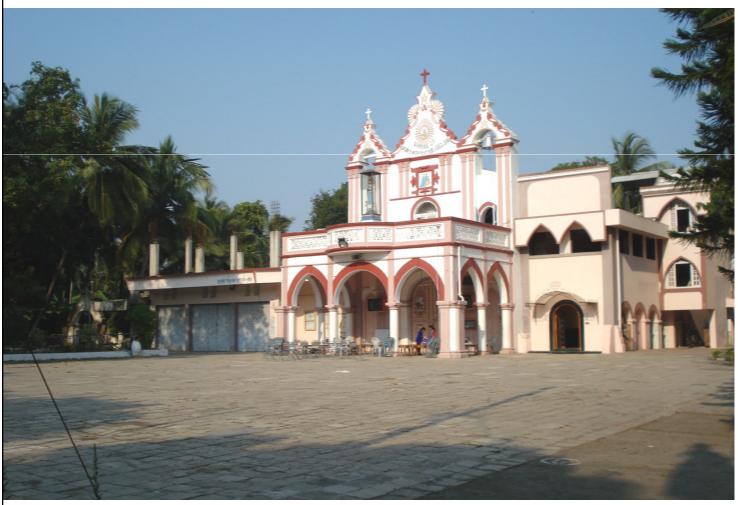
False front façade of the church with extensions of the front portico and sides

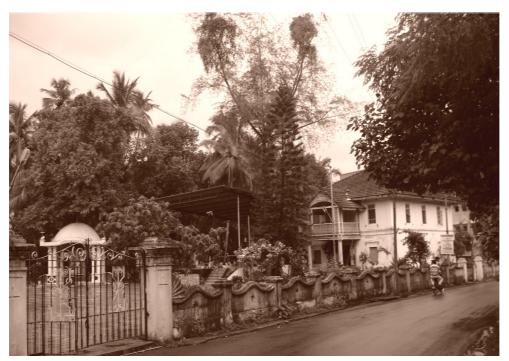
Low level compound wall along the edge

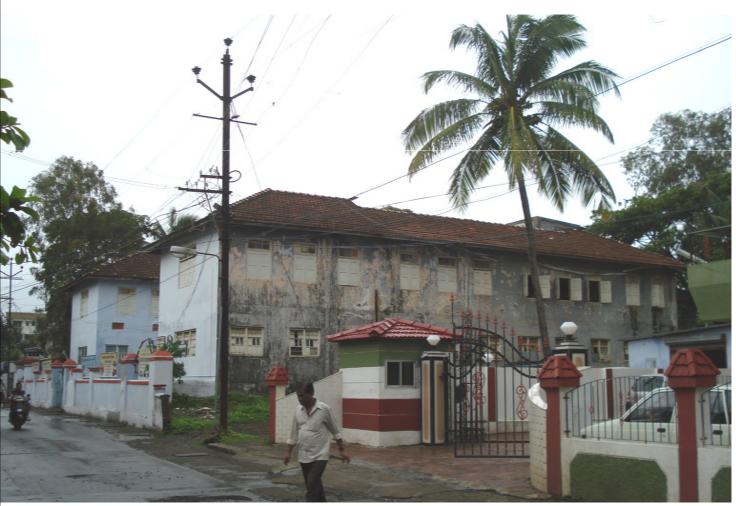
Pitched Mangalore tile roof forms a distinctive architectural element

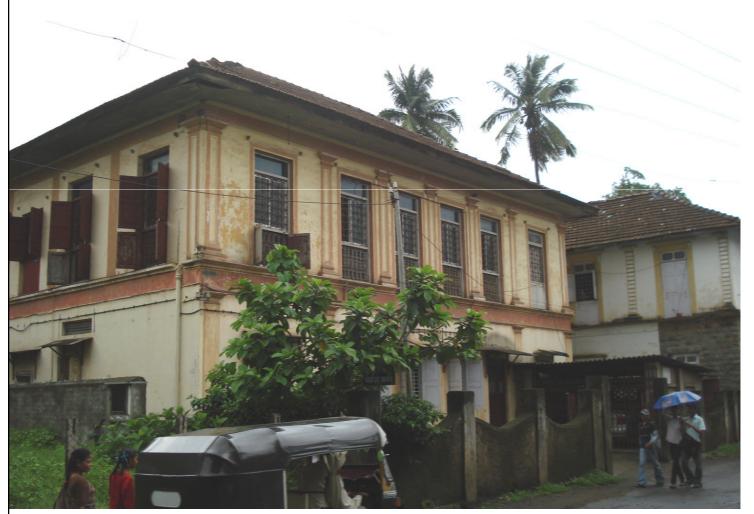
Decorative pilasters and full length windows – a typical feature of the wada type

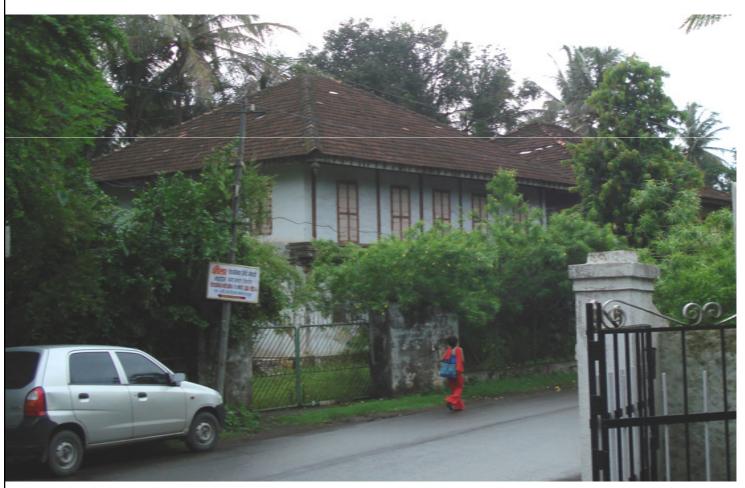
Wooden posts with infill walls forming the structure to support the Mangalore tile roof

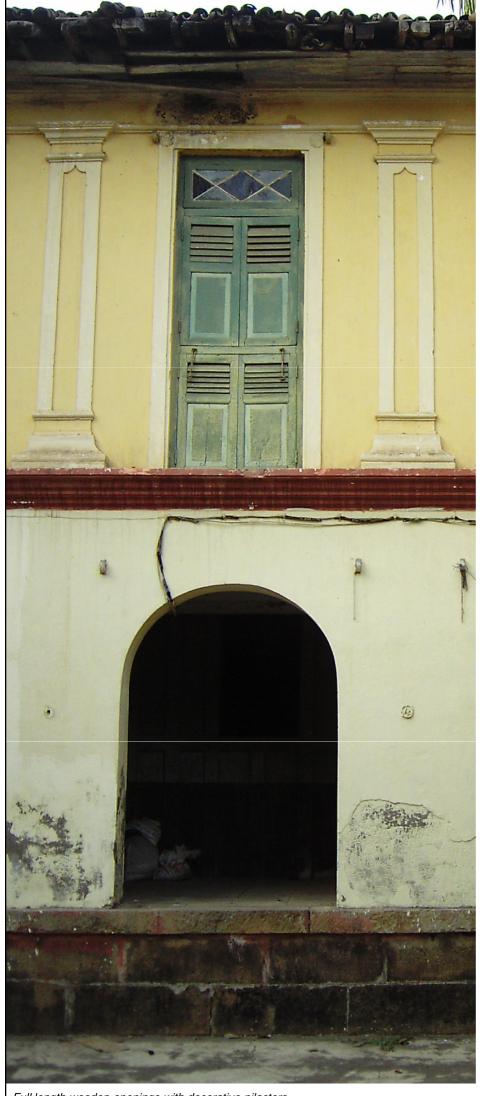
Full length wooden openings with decorative pilasters

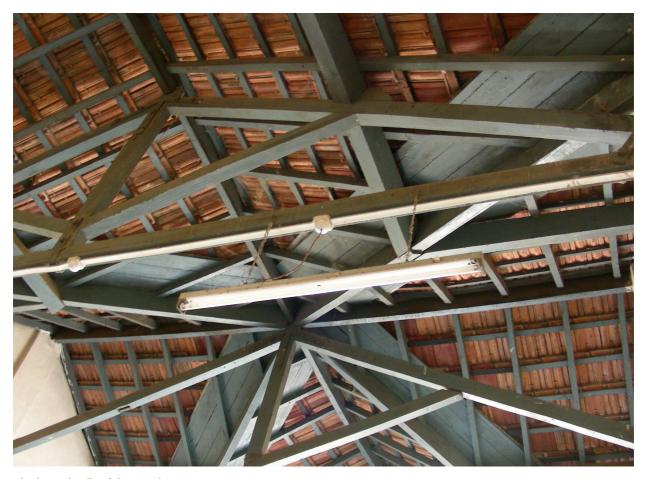
Intricate details of the wooden truss

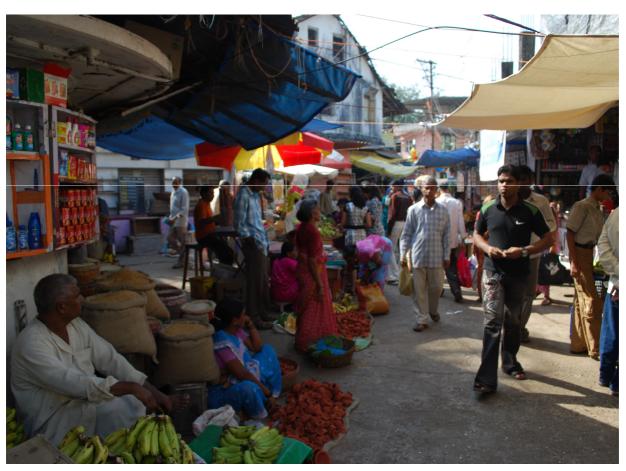
Vendors squatting in the market street with temporary tarapulin roofs

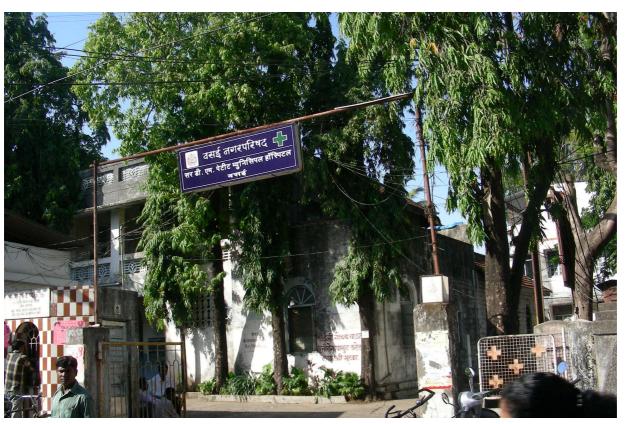
Façade opening on the main street which is covered behind a thick growth of trees

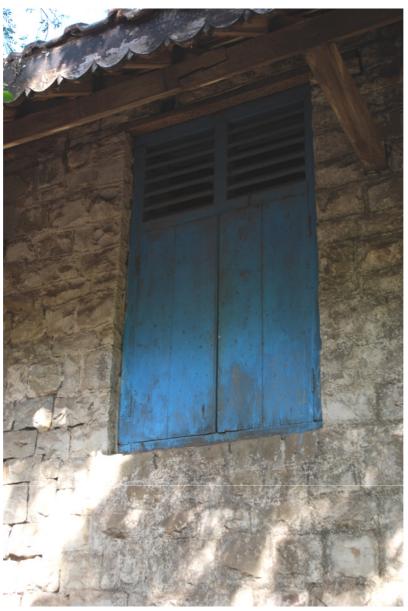
High level windows which touch the roof

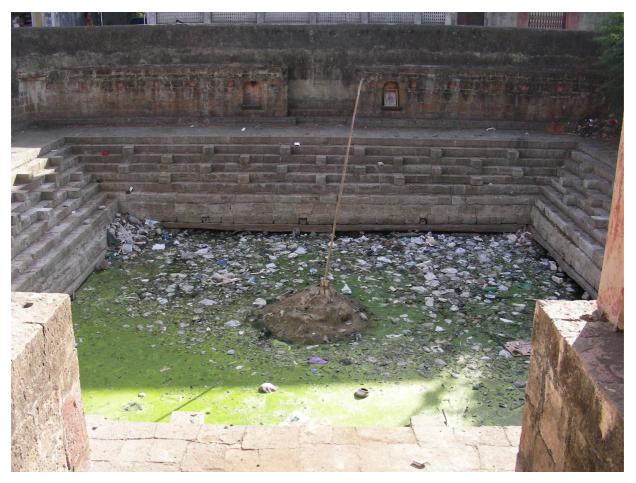
Solid waste disposal into the Devi Talav (kund) which exists in the temple complex

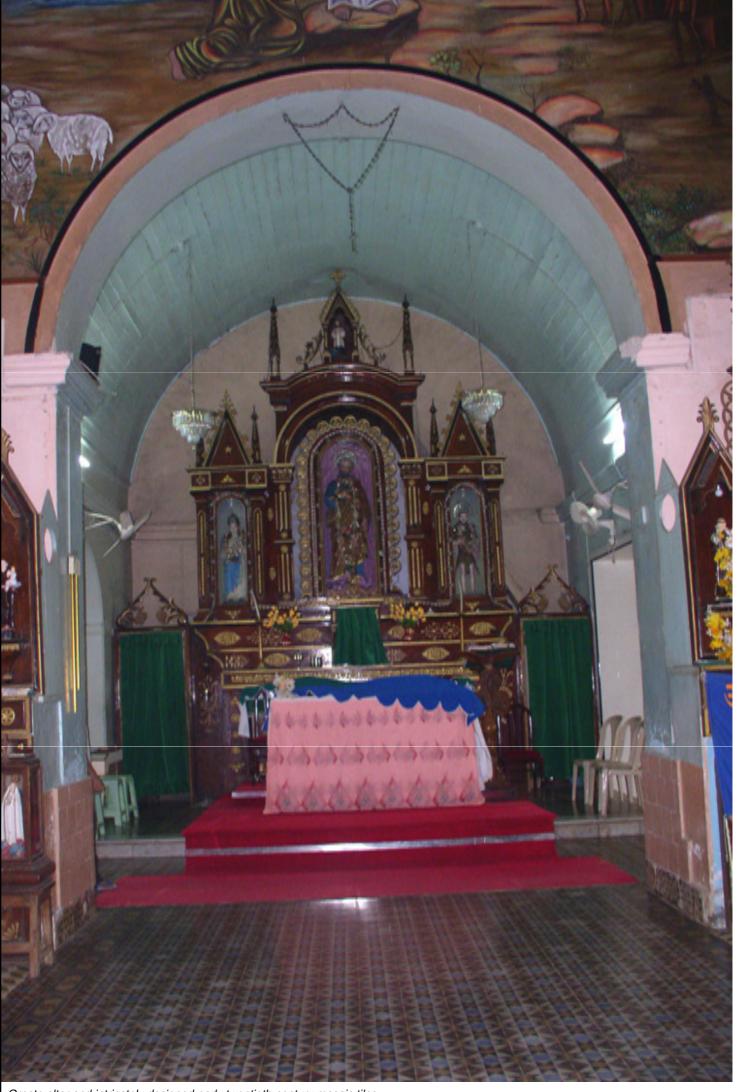
Ornate altar and intricately designed early twentieth century mosaic tiles

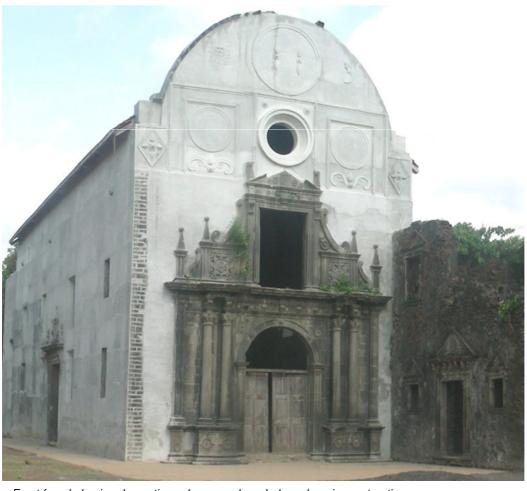
5.3	Maintenance and Repairs	Assessment
	Measures: The Archaeological Survey Of India has undertaken restoration work of this heritage asset. However, the insensitive restoration work to the structure is a cause of concern.	
	Agency and Capacity: Archaeological Survey of India The Archaeological Survey of India has shown a fair amount of commitment towards restoring and maintaining this structure which has a national significance.	Fair

0: RUIN / NON EXISTENT 1: POOR 2: FAIR 3: GOOD FUTURE RELEVANCE DP Remarks: Reserved as a Place of Historical Importance. Perceived Threats: The ASI is currently carrying out structural repairs an However the restorations are not sensitive to the historic structure which	d finishes to the structure could permanently cause

Front façade having decorative columns and symbols undergoing restoration

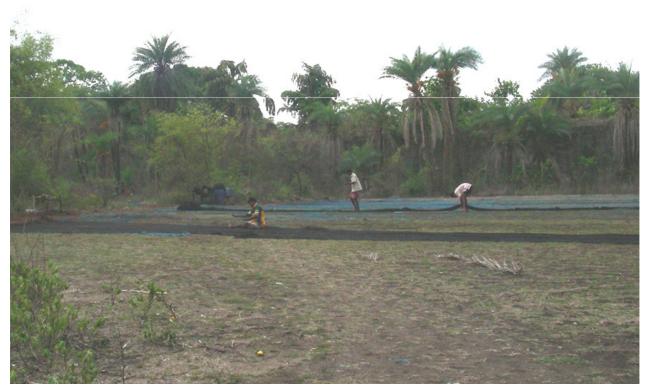
Spaces within the citadel used by the fishermen for net mending

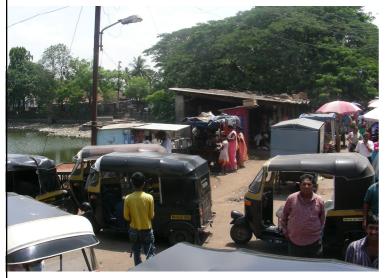
Rickshaw stand along the edge of the talav

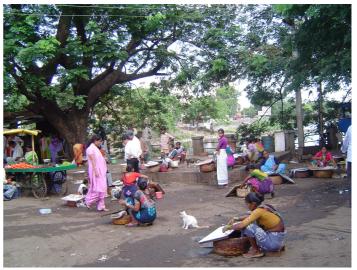
Informal market along the edge of the talav

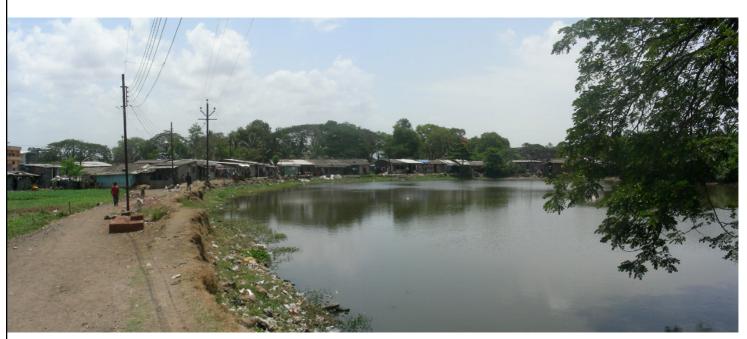
Adivasi settlement adjacent to the talav

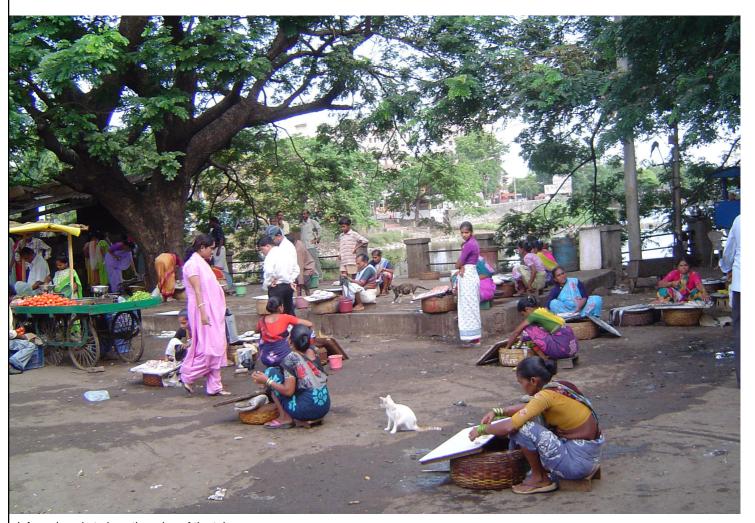
Informal market along the edge of the talav

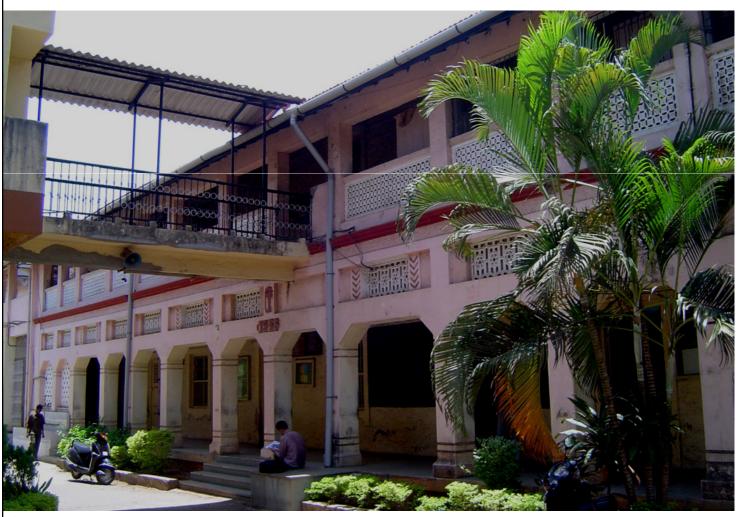
5.4	Overall Condition Assessment (based on 5.1, 5.2 and 5.3):	FAIR
	The building is in a structurally good condition. The infrastructure necessary for the school is in a good condition. The trust has shown a fair capacity for maintenance and repairs.	Maintenance 1 2 3 Structure Infrastructure

School building with a colonnade at the ground level

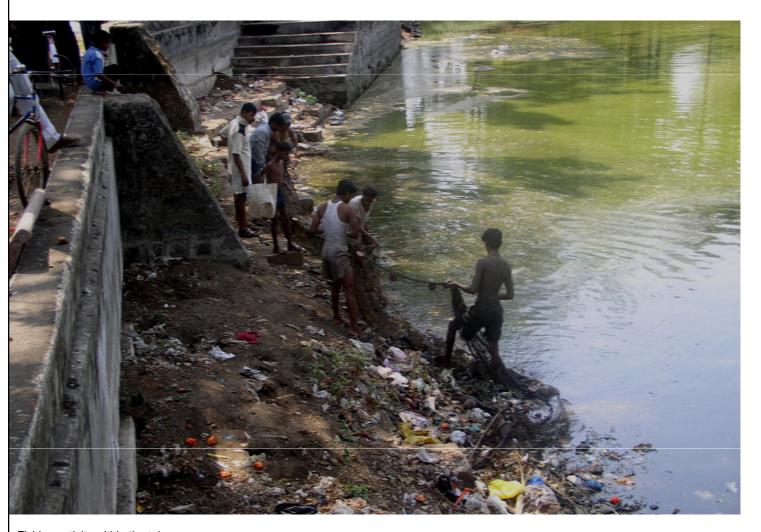
5.4	Overall Condition Assessment (based on 5.1, 5.2 and 5.3): The structure of the talav and the infrastructure around it is in a poor condition. The urban local body has maintained the talav in a fair condition.				POOR Maintenance

Fishing activity within the talav

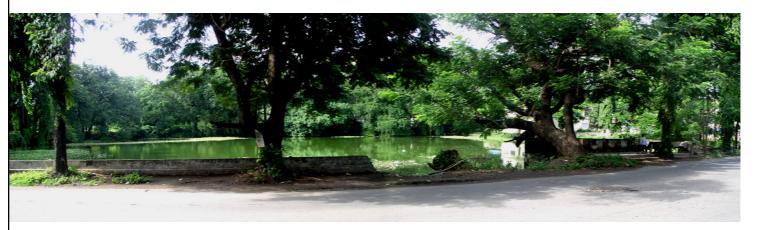
The edge of the talav has a soft landscape of trees
