Heritage Sites in Pen	
Ref. No.	Name of property
P - 01	Ahilya Mandal
P - 02	Ambika Mandir
P - 03	Asha Niwas
P - 04	Beth Haelohim Synagogue
P - 05	Bhagwat Wada
P - 06	Bridge
P - 07	Datar Ganpati Mandir
P - 08	Datar Wada
P - 09	Deodhar Wada
P - 10	Despande Wada (Ziral Ali)
P - 11	Dharkar Wada
P - 12	Ganpati Mandir - Chavadinaka
P - 13	Ghangrekar Wada
P - 14	Gosavi Datta Mandir
P - 15	Goteswar Mandir
P - 16	Hanuman Mandir
P - 17	Hazare Wada
P - 18	Patil House
P - 19	Jari Mari Aai Mandir
P - 20	Patwardhan House
P - 21	Karmarkar Wada
P - 22	Kasar Tale
P - 23	Kelkar Wada
P - 24	Kolhatkar Wada
P - 25	Kumbhar Tale
P - 26	Kaundal Tale
P - 27	Limaye Wada
P - 28	Londhe Wada
P - 29	Mandlik Wada
P - 30	Manohar Chawl
P - 31	More Wada
P - 32	Motiram Talav
P - 33	Parmar Wada
P - 34	Tilak Wada 1
P - 35	Tilak Wada 2
P - 36	Tilak Wada 3
P - 37	Vishweshwar Mandir
P - 38	Ziral Ali Ganpati Mandir
P - 39	Tipecha Maruti Mandir
P - 40	Rameshwar Mandir
P - 41	Mahakali Mandir

MUMBAI METROPOLITAN REGION HERITAGE CONSERVATION SOCIETY

Record Details for Ahilya Mandal

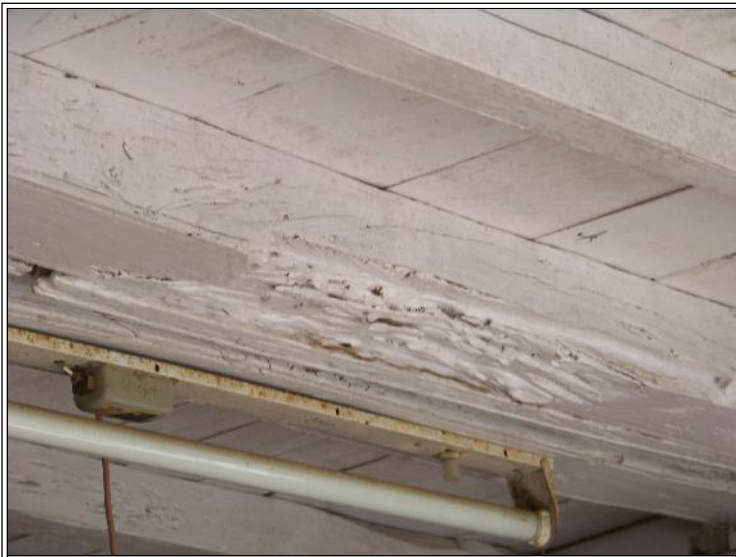
Image Title: Ahilya Mandal
Image Type: Top-View
Reference: A Floor beam showing damage due to dampness

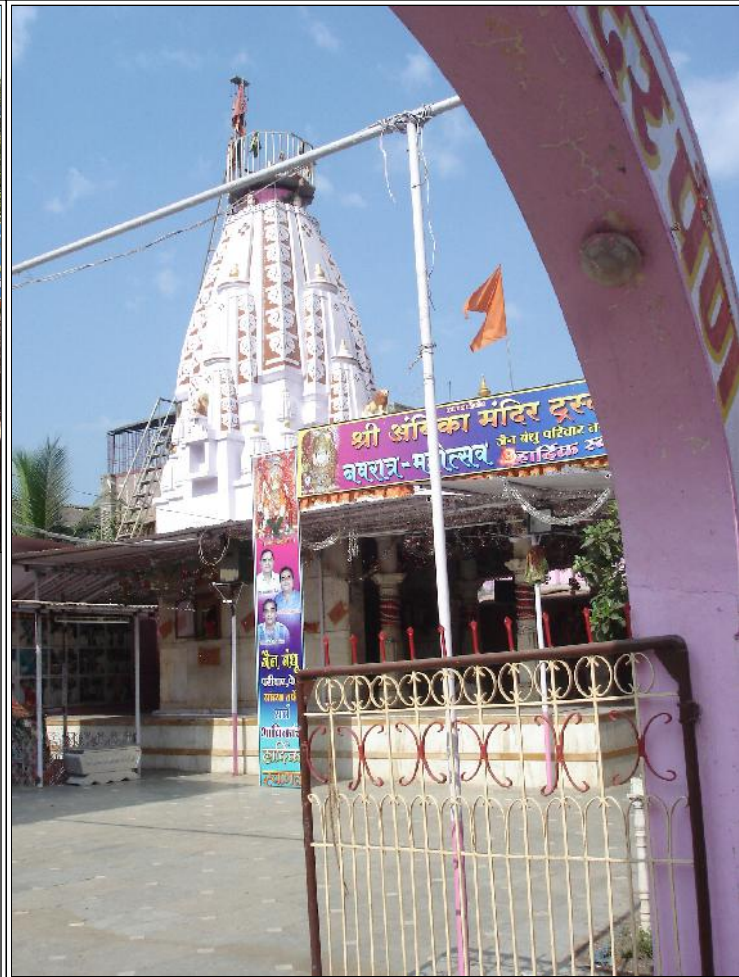
3.21	Incongruent Transformation	The entire original basalt structure of the Mandir is clad in white marble. The Shikhara is entirely new. Temporary structure with GI sheet roofing added around Mandir. The new finishes are not complementary to the original character of the old Mandir. The campus is full of colourful hoardings and notice boards in different sizes which particularly damage the religious and spiritual atmosphere of the place as well as the character of its architecture.
3.22	Overall Maintenance Status	The premises and the building are clean and well kept.
3.23	Overall Condition	Good

Image Title: Ambika Mandir
Image Type: Front-View
Reference: The cluster and incongruency of a variety of materials of elements that obscure the original temple

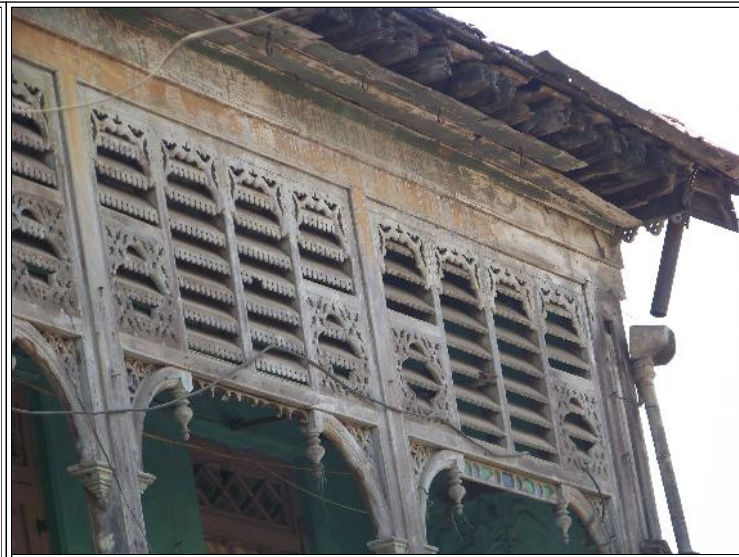
3.10	Articulation	Circular wooden columns on stone bases and simplified capitals receiving the beams of the first floor verandah, Facing boards of the balcony floor, beam ends, brackets, pendants, higher level louvered panels of the first floor verandah, cast iron grills of the verandah, window treatment on the gable end, eaves board of the roof.	Rusting of MS members, rotting of timber eaves and brackets, discoloration	Major Repair

Image Title: Asha Niwas
Image Type: Front-View
Reference: Wooden louvered panels of the first floor balcony form a prominent character giving feature of the building. These how are not in a good shape and require urgent repairs

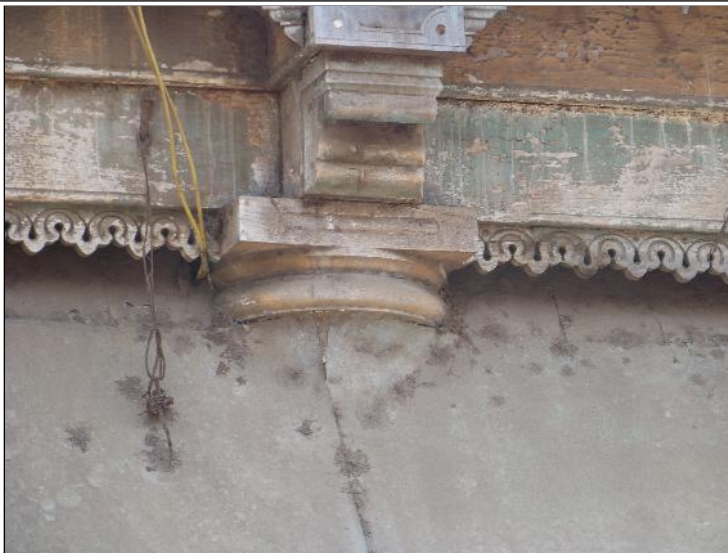
Image Title: Asha Niwas
Image Type: Front-View
Reference: Detail of the column capital now obscured by the awning

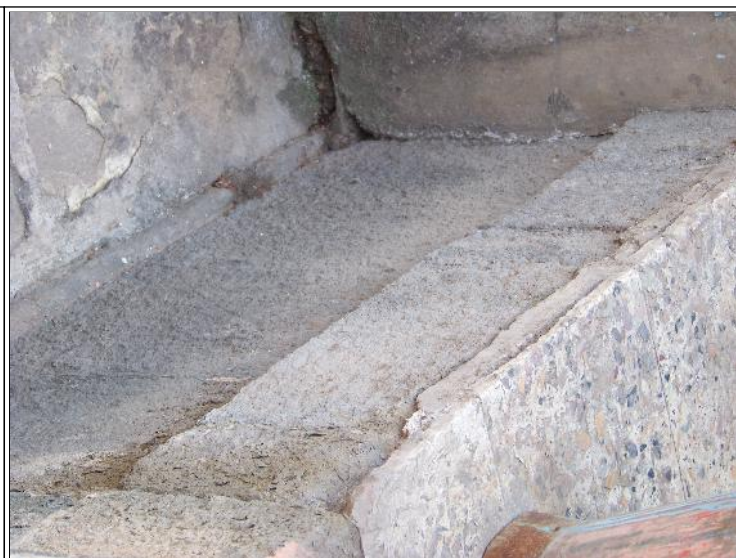
Image Title: Beth Haelohim Synagogue
Image Type: Front-View
Reference: Deterioration of the store on the exterior of the building

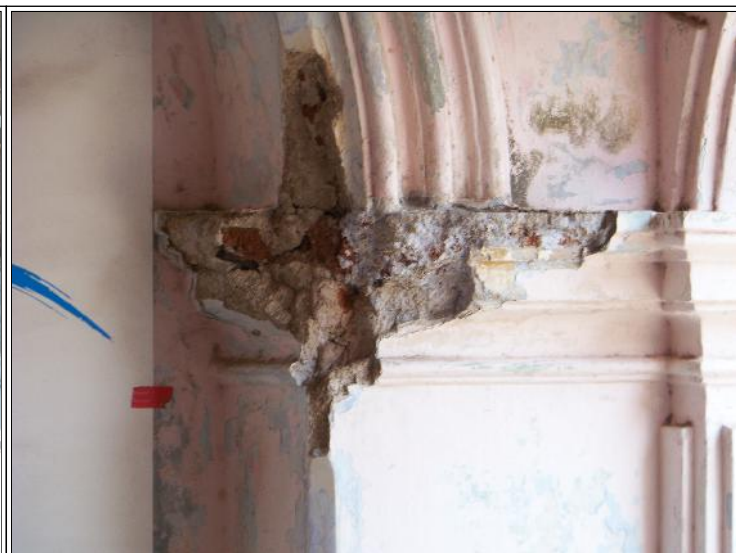
3.10	Articulation	The front facade is articulated with arches at ground level, quoins, cornice at first floor level and fluted round pilaster columns in pairs on the first floor facade. The internal walls have deep cornice under the ceiling.	Shows weathering and staining around all ledges and mouldings	Minor Repair

Image Title: Beth Haelohim Synagogue
Image Type: Top-View
Reference: Damaged Stucco work

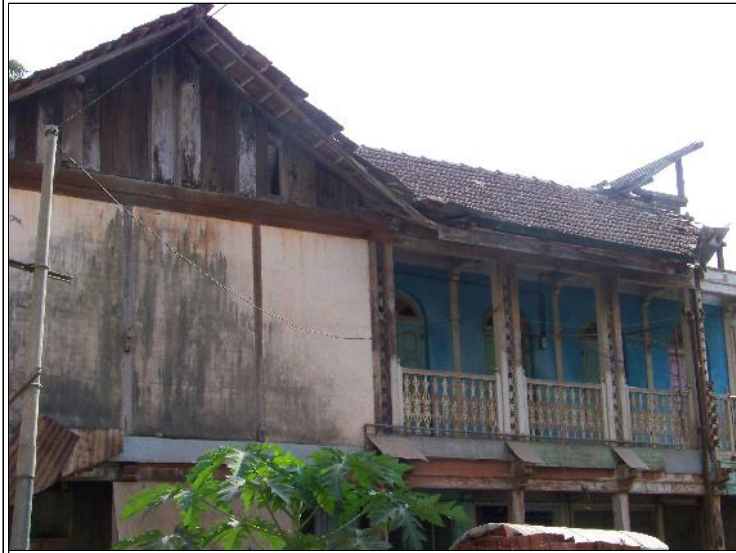
Image Title: Bhagwat Wada
Image Type: Front-View
Reference: General view from the street

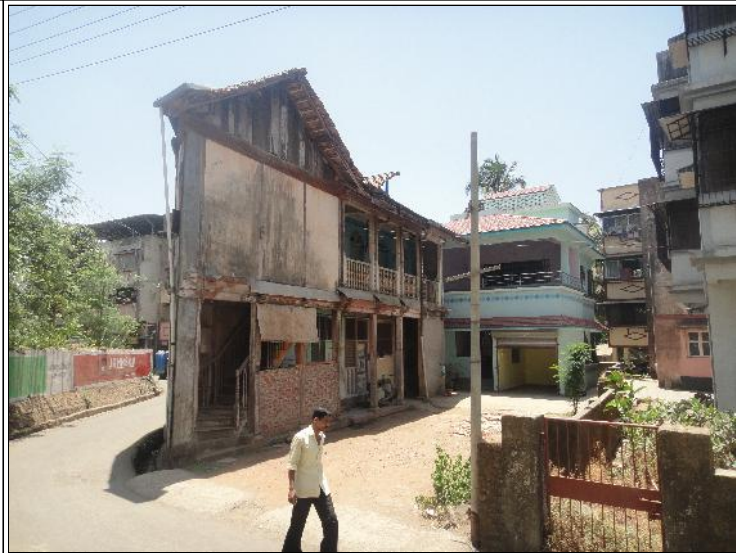
Image Title: Bhagwat Wada
Image Type: Front-View
Reference: Bhagwat wada at the junction of 2 streets

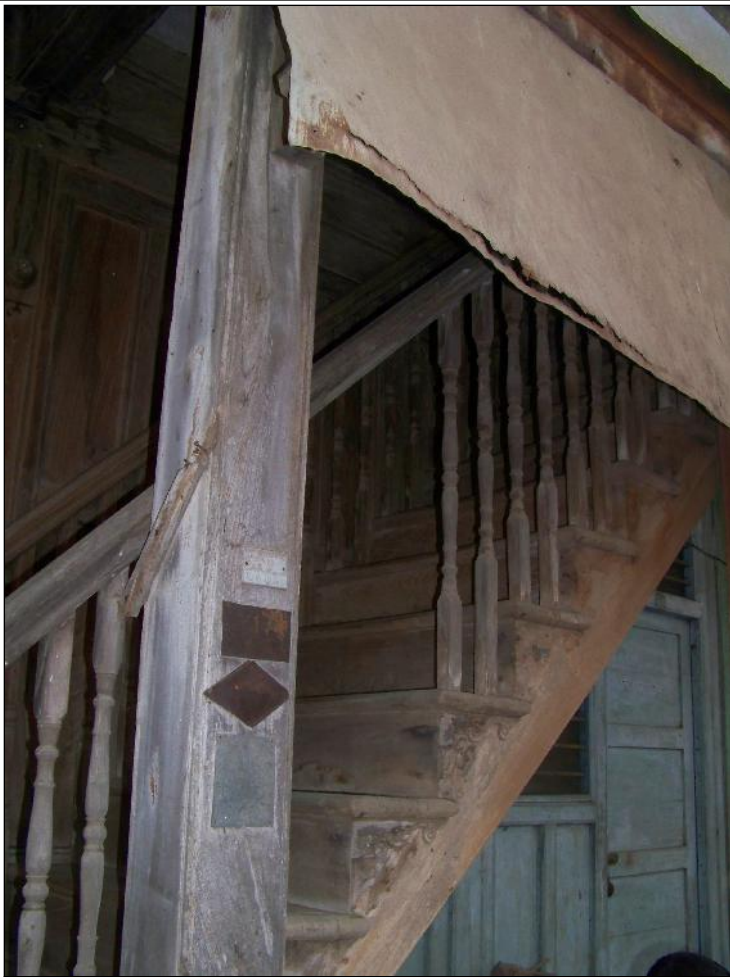
Image Title: Bhagwat Wada
 Image Type: Front-View
 Reference: Deteriorating woodwork missing balusters of the stairs

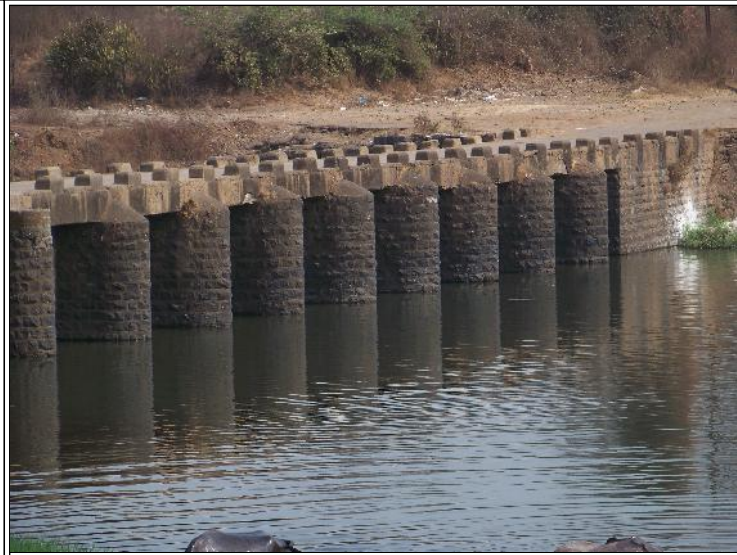
Image Title: Bridge
Image Type: Side-View1
Reference: Masonary Piers on one side of the bridges. Arches are not seen from this side either

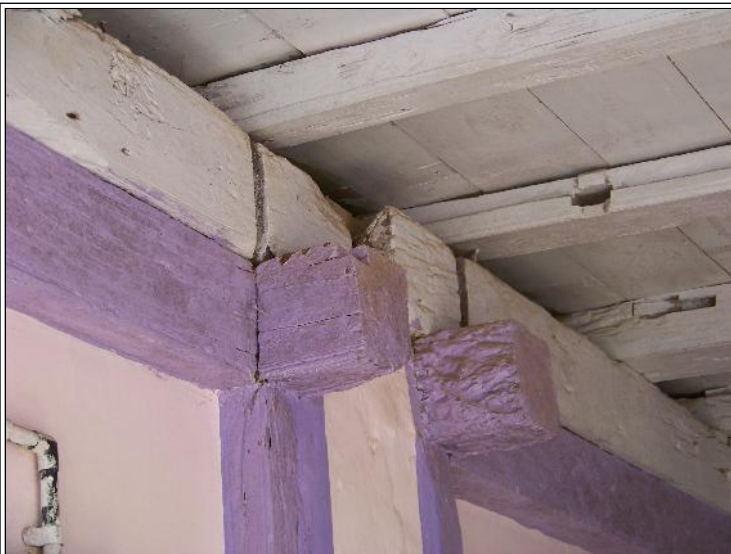
Image Title: Datar Ganpati Mandir
Image Type: Top-View
Reference: Deterioration to structural woodwork

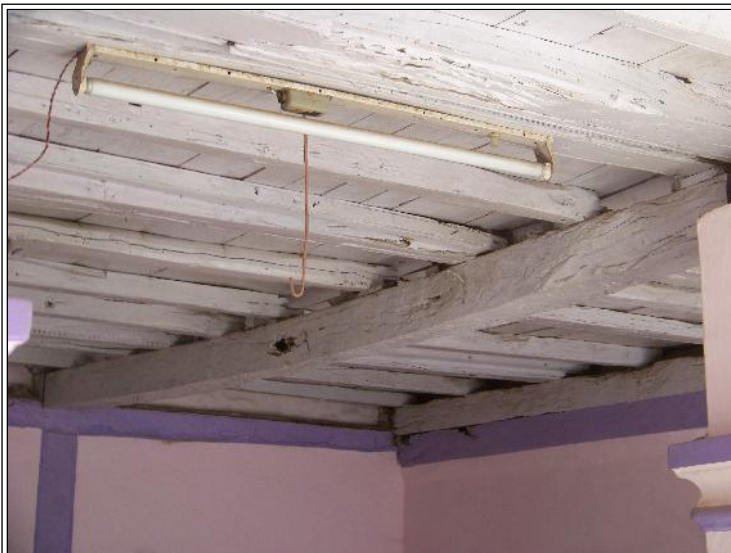
Image Title: Datar Ganpati Mandir
Image Type: Top-View
Reference: Deteriorating wooden ceiling of the temple

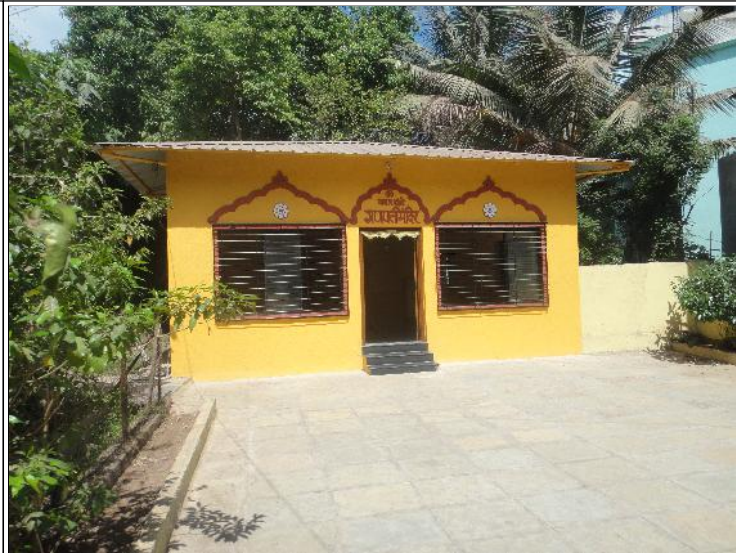
Image Title: Datar Ganpati Mandir
Image Type: Front-View
Reference: The newly built temple in place of old one

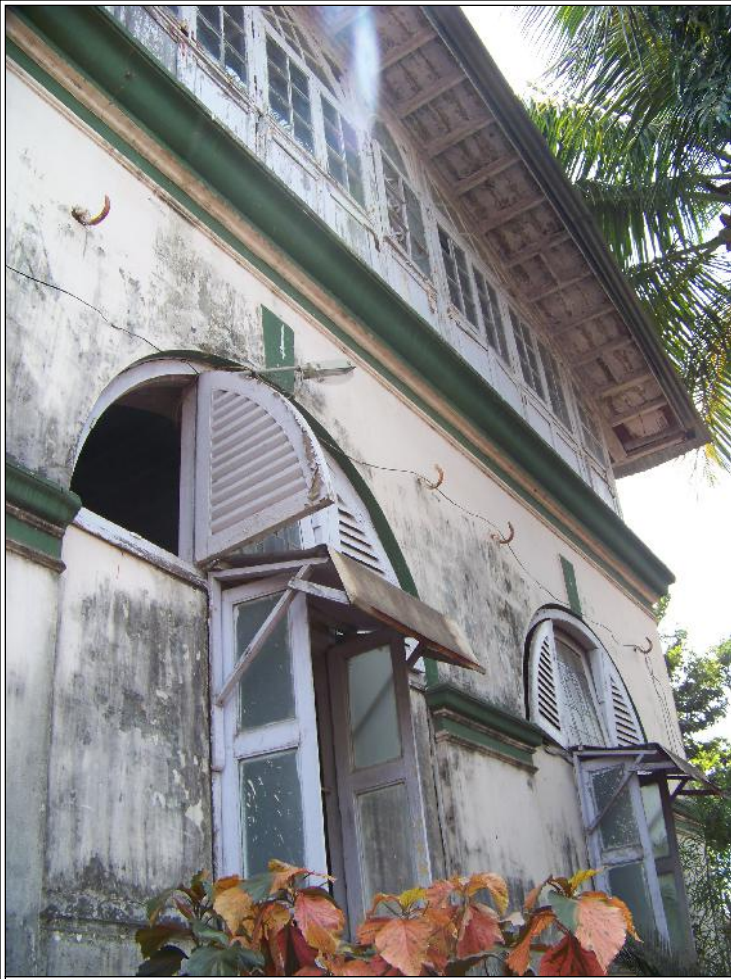
Image Title: Dharkar Wada
Image Type: Side-View1
Reference: Street facing arched openings of the verandah later filled in with windows

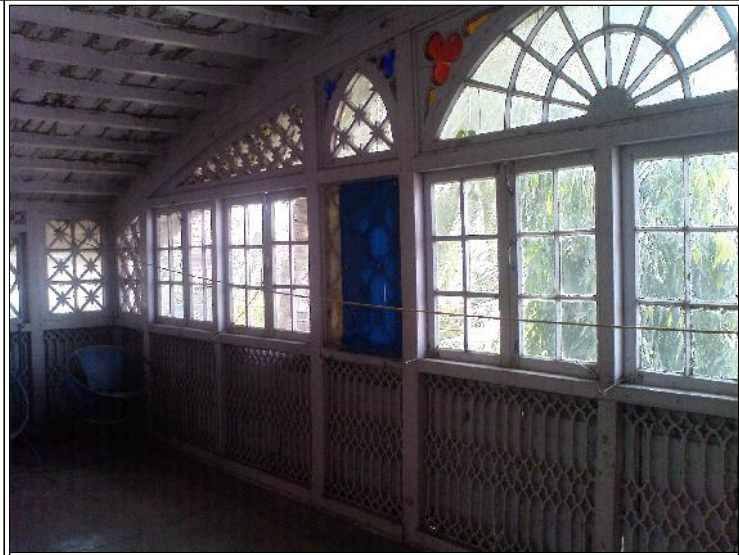
Image Title: Dharkar Wada
Image Type: Rear-View
Reference: Disfiguration due to dampness

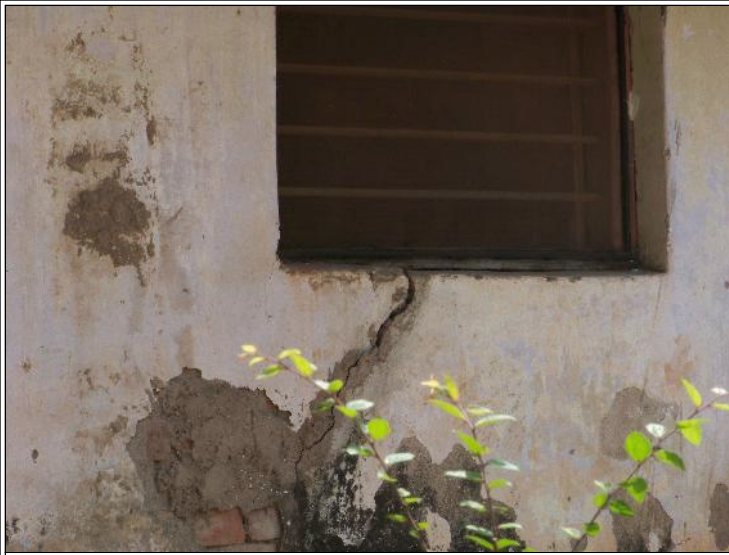
3.01	Height	@27 feet till ridge		
3.02	No. of Floors	Ground + 1 Upper + 1/2		
		Description	Problem/Threat	Condition
3.03	Structural System	Timber structure on stone plinth with brick load bearing walls	Timber members show loss in alignment at a few places. Walls show a few deep cracks	Major Repair

3.04	Plinth	Basalt stone dressed	Uneven settlement in a few places	Major Repair
3.05	Walls	Partly load bearing brick walls with plaster and paint	Needs maintenance shows cracking. Gable end wall on east looks like it was modified	Minor Repair

Image Title: Ghangrekar Wada
Image Type: Front-View
Reference: Detail of cracking of the wall on the front side

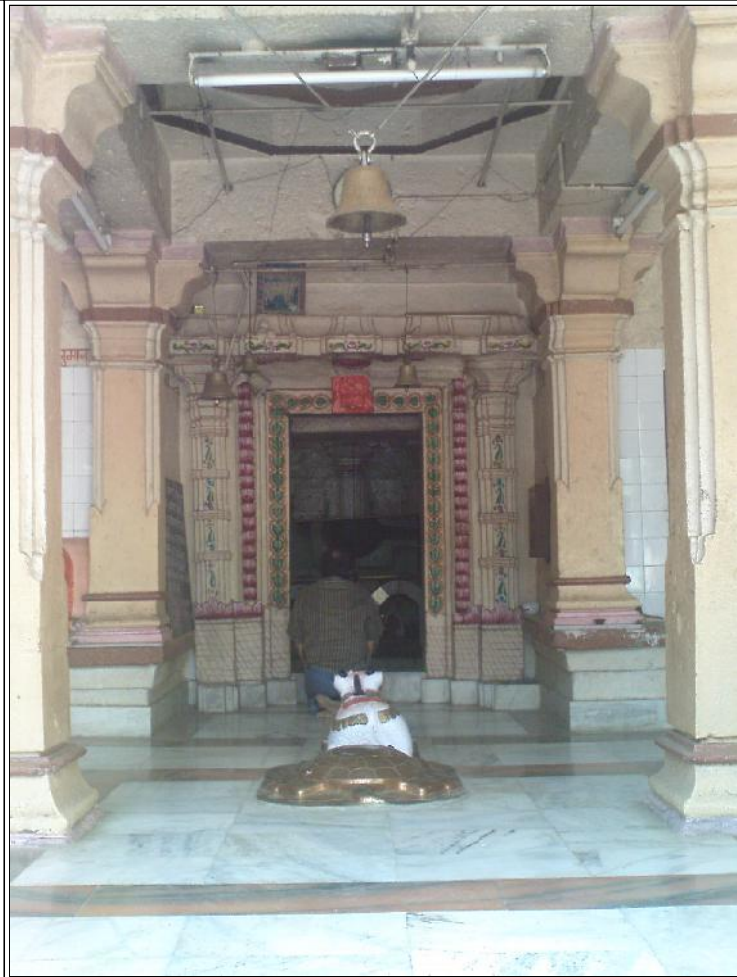
Reference: Nandi in the verandah of the temple, newly done marble flooring is visible

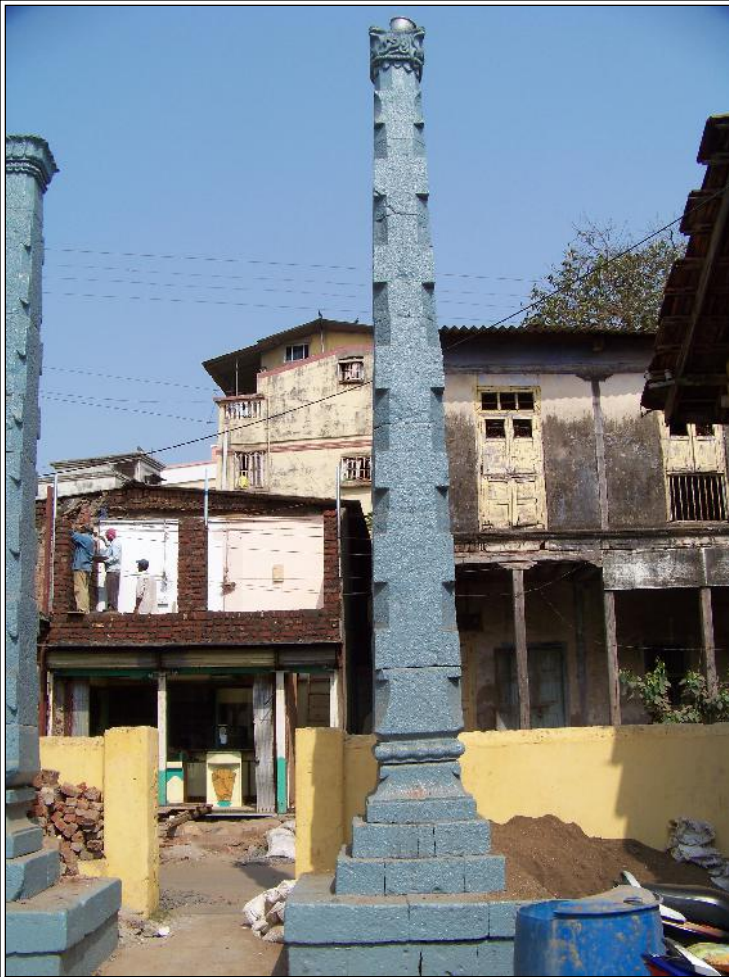
Image Title: Goteswar Temple
Image Type: Top-View
Reference: Intensive additions done to the old stone construction of the temple

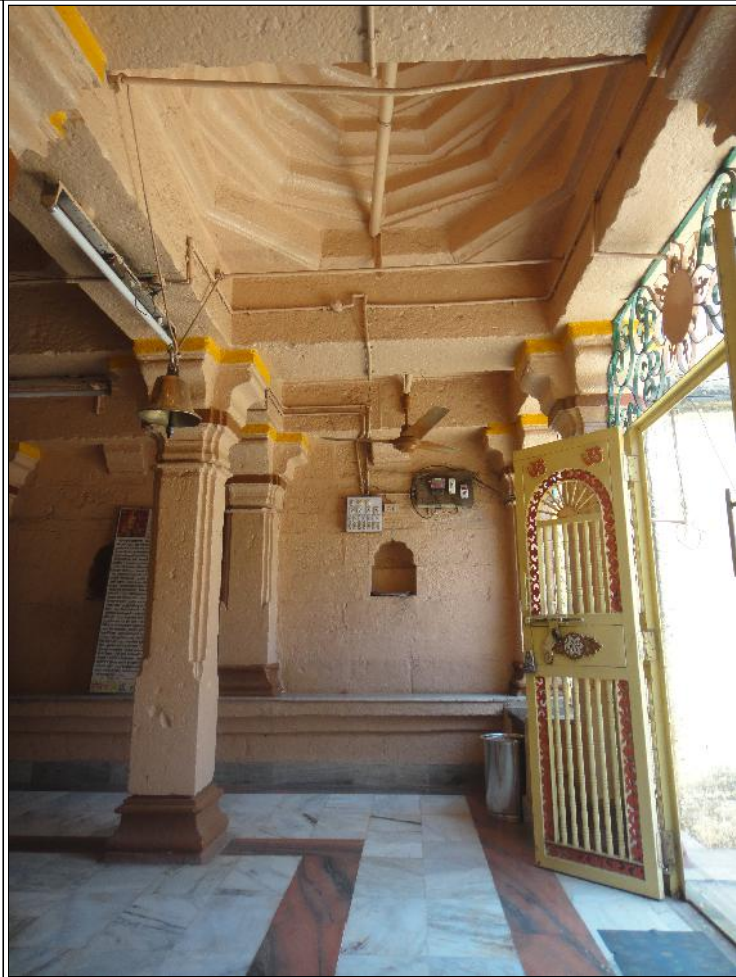
Image Title: Goteswar Mandir
 Image Type: Front-View
 Reference: Newly fit MS grills enclosing the mandap

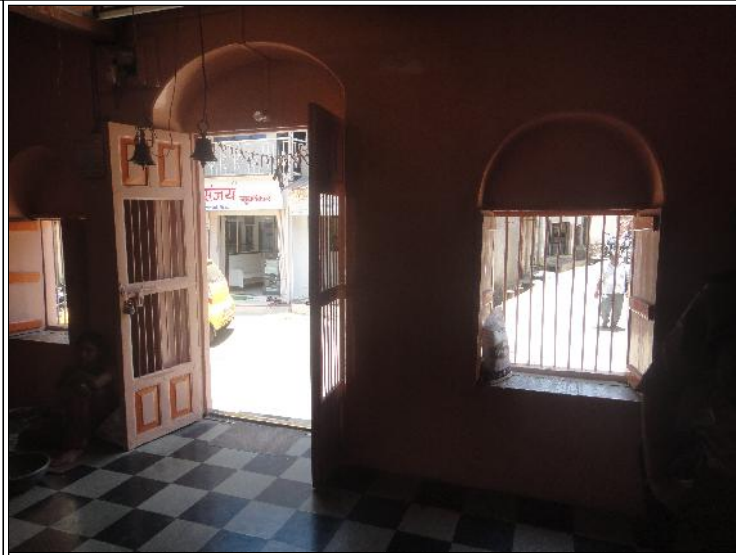
Image Title: Hanuman Mandir
Image Type: Front-View
Reference: Original Shrine inside and later the outer building

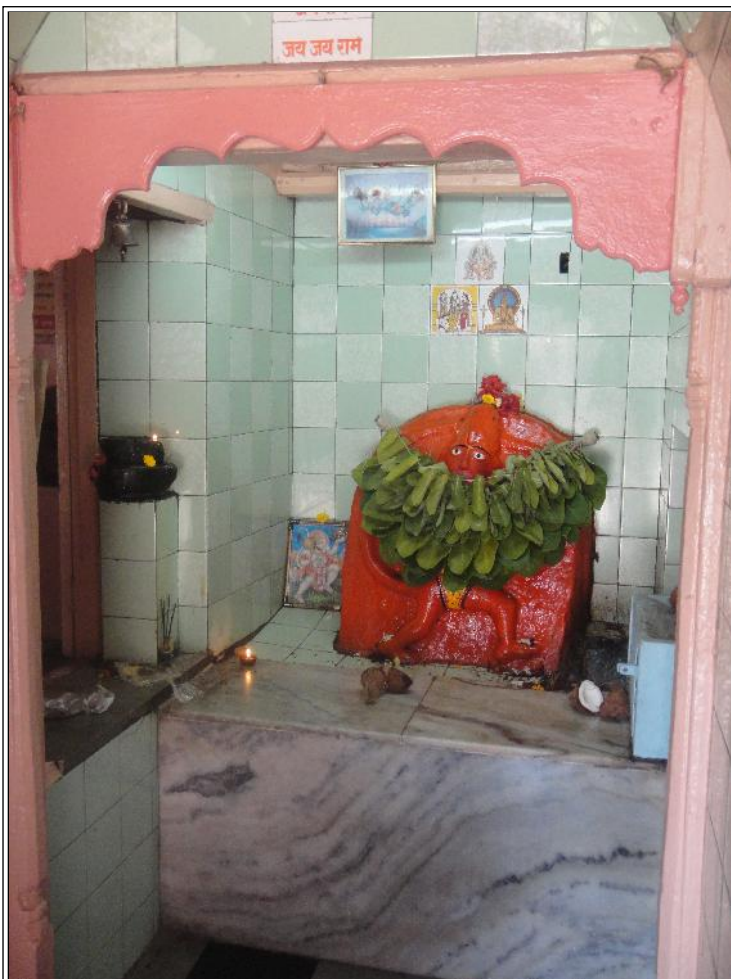
3.06	Floors	Timber, flooring at ground floor replaced by Kota and Granite Tiles. Chequered flooring of Kota and granite tiles. Mezzanine floor on timber joints in front portion of the building	Flaking of Timber members, decay	Good

3.09	Roof	Mangalore tiles on Timber Truss. Tin roof on GI Pipes.	Rainwater leakages	Minor Repair
3.10	Articulation	Articulated stone column bases brick arches for Garbhagriha	Structural decay	Ruin

Image Title: Hanuman Mandir
Image Type: Side-View1
Reference: Rotting timber of the temple structure

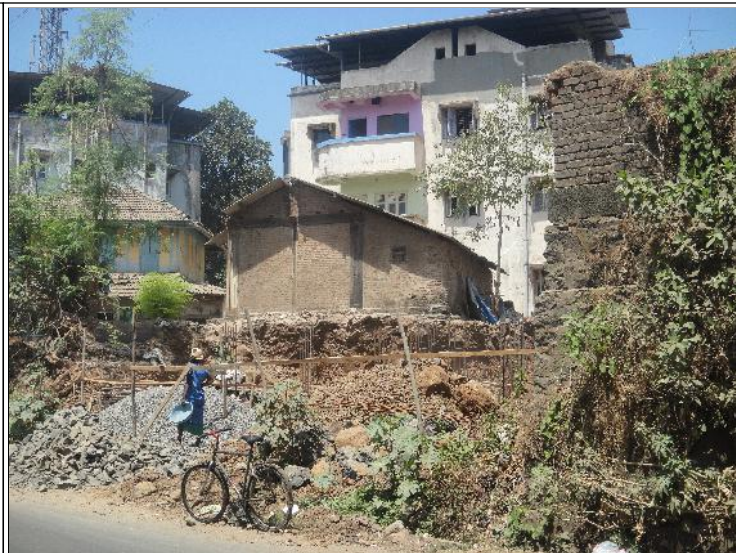
Image Title: Jari Mari Aai Mandir
Image Type: Front-View
Reference: Demolished temple of Jari Mari Aai

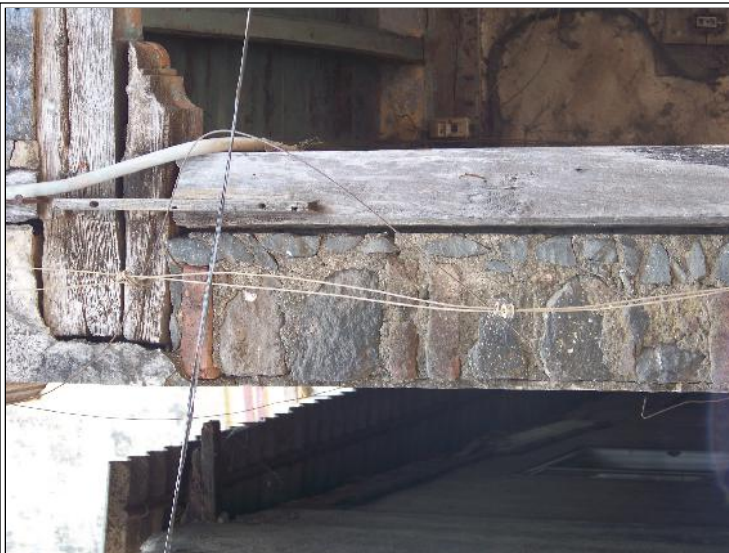
Image Title: Karmarkar Wada
Image Type: Front-View
Reference: Weathered timber frame cracked joints

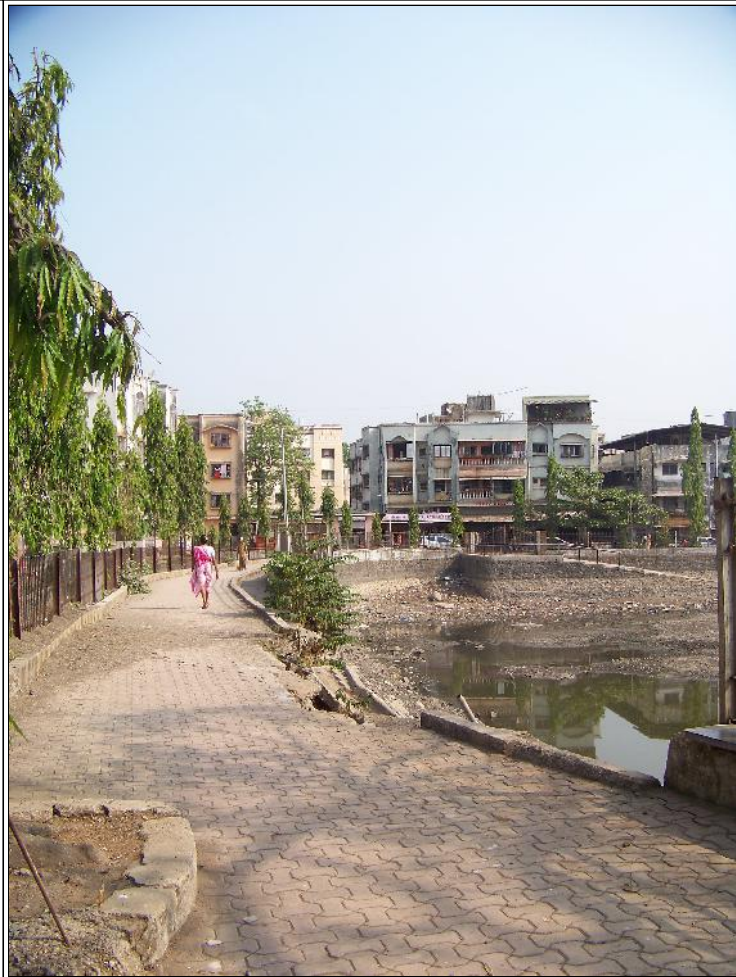
Image Title: Kasar Tale
Image Type: Front-View
Reference: Desrepair of the new sidewalk

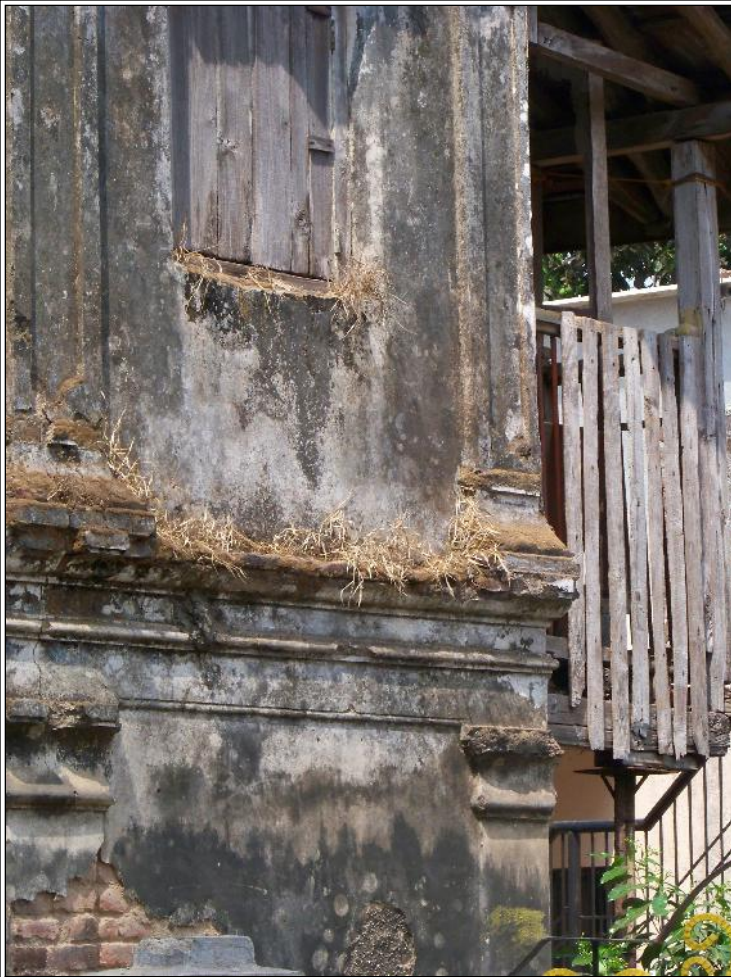
Image Title: Kelkar Wada
Image Type: Side-View2
Reference: Overgrowth, Dampness, destruction of details are some of the problems of the building

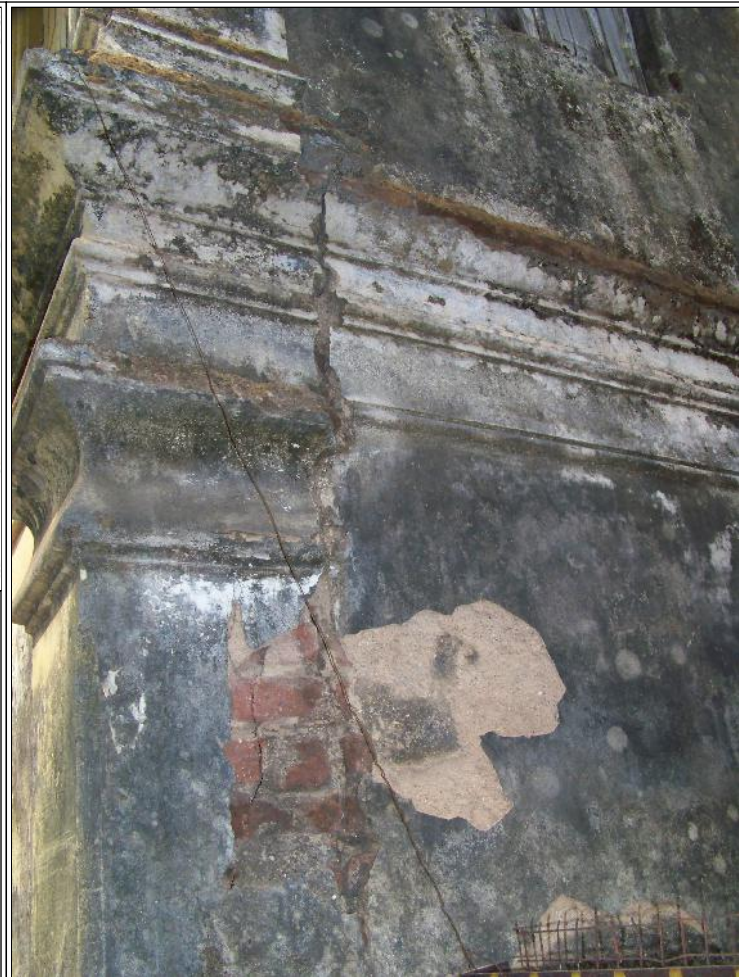
Image Title: Kelkar Wada
Image Type: Side-View1
Reference: Moss growth on plaster cracking and peeling off of the plaster is apparant or the external surface

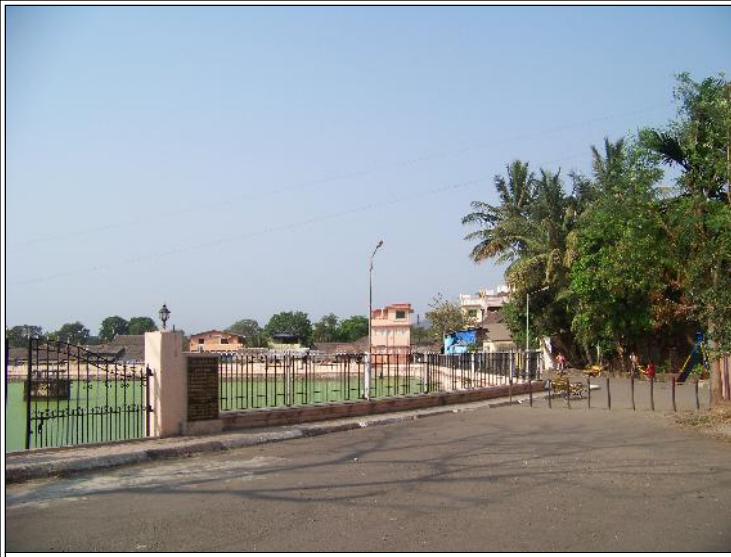
3.20	Other(Fire protection, HVAC, Security etc)	NA	NA	-
3.21	Incongruent Transformation	Though safety and security may be a concern, the way in which the compound wall is built is not recommended. Apart from being a visually discordant, it cuts off the surface water drain that once reached the lake.		
3.22	Overall Maintenance Status	Below Average		
3.23	Overall Condition	Minor Repair

Image Title: Kumbhar Tale
Image Type: Front-View
Reference: The lake now protected by a compound

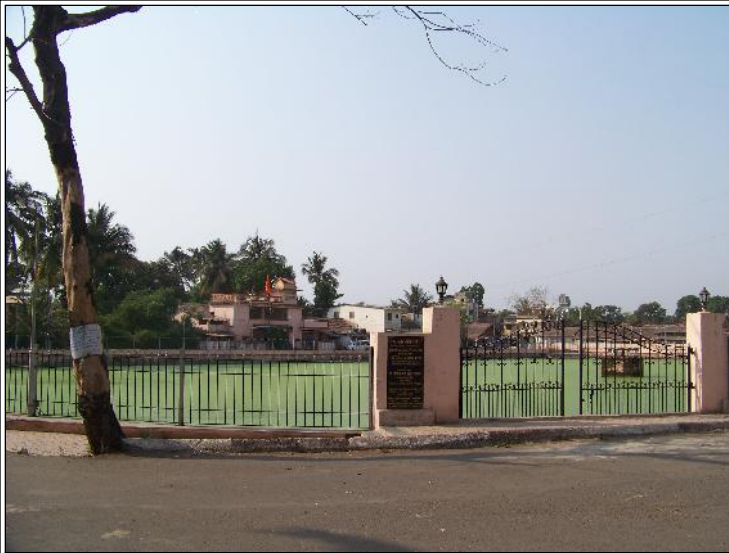
Image Title: Kumbhar Tale
Image Type: Front-View
Reference: The newly built compound to the lake

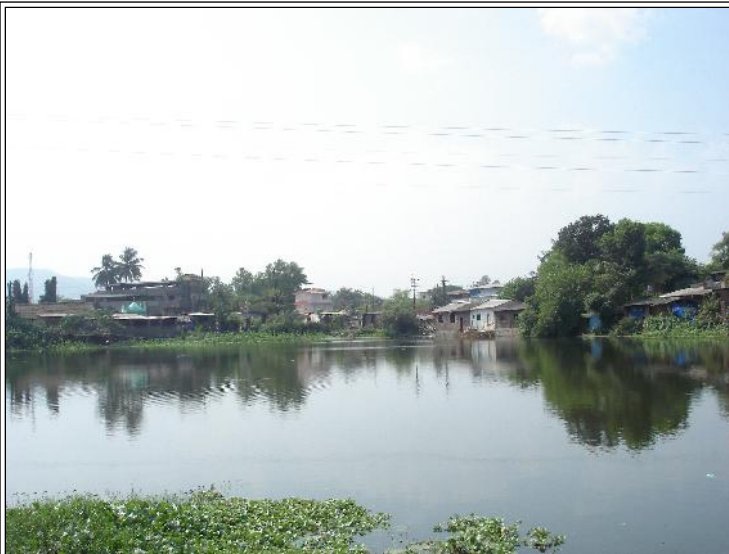
3.14	Curtilage / unbuilt / space /out buildings / landscape	The banks of the lake are not sharply demarcated. The edges are mostly covered by hyacinth and other plants and weeds growing on or beside the water. Surrounding development is of various types, mostly residential. There is a small portion where the road touches the lake.	haphazard surrounding development. needs to be checked for encroachment	Major Repair

Image Title: Kaundal Tale
Image Type: Front-View
Reference: Hyacinth growth in the lake

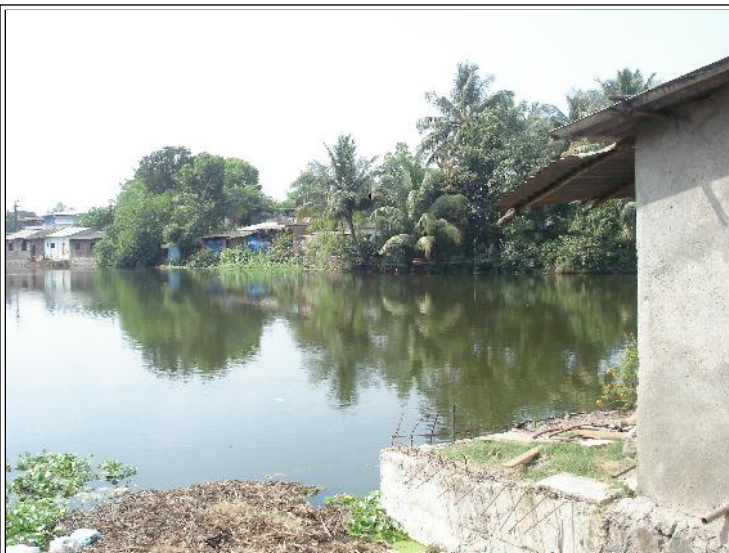
3.12	Furniture	NA	NA	-
3.13	Compound/Fence/Gate	Natural lake. Edges not constructed. Plinths and walls of other structures abut the water, but lake is not built	haphazard construction. needs to be checked for encroachment	Major Repair

Image Title: Kaundal Tale
Image Type: Front-View
Reference: Construction really into the lake water

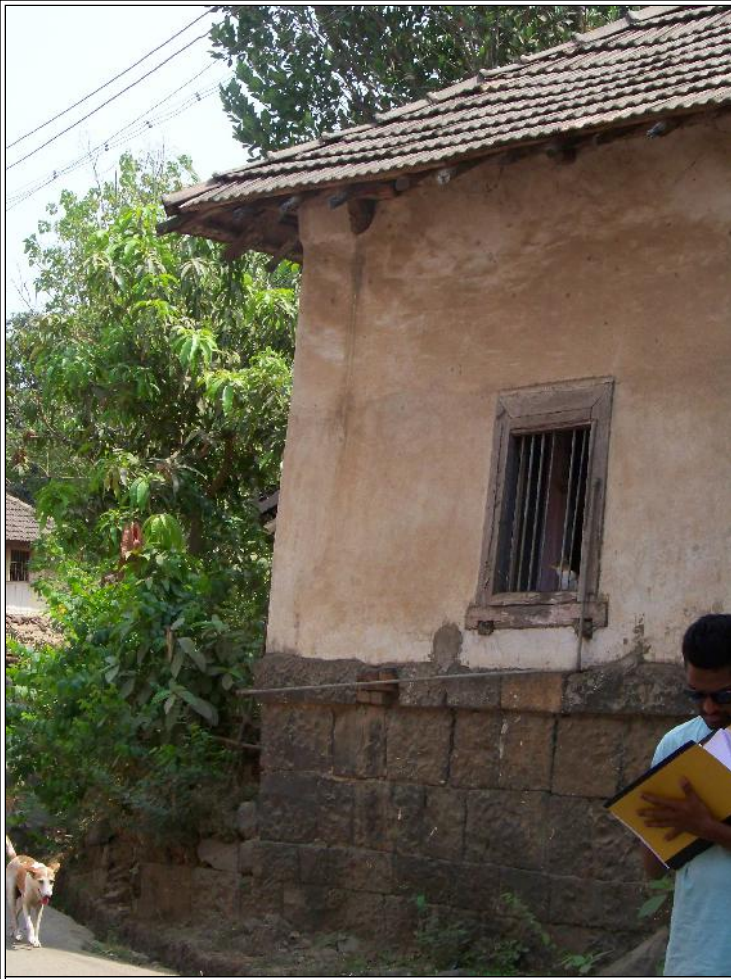
3.03	Structural System	timber structure on stone plinth with load bearing walls	though most of the structure appears sound, there are a few places where there are wide and long cracks in the walls, especially at corners. Timber has deteriorated due to rotting and decay.	Major Repair

Image Title: Limaye Wada
Image Type: Front-View
Reference: Corner of the wada

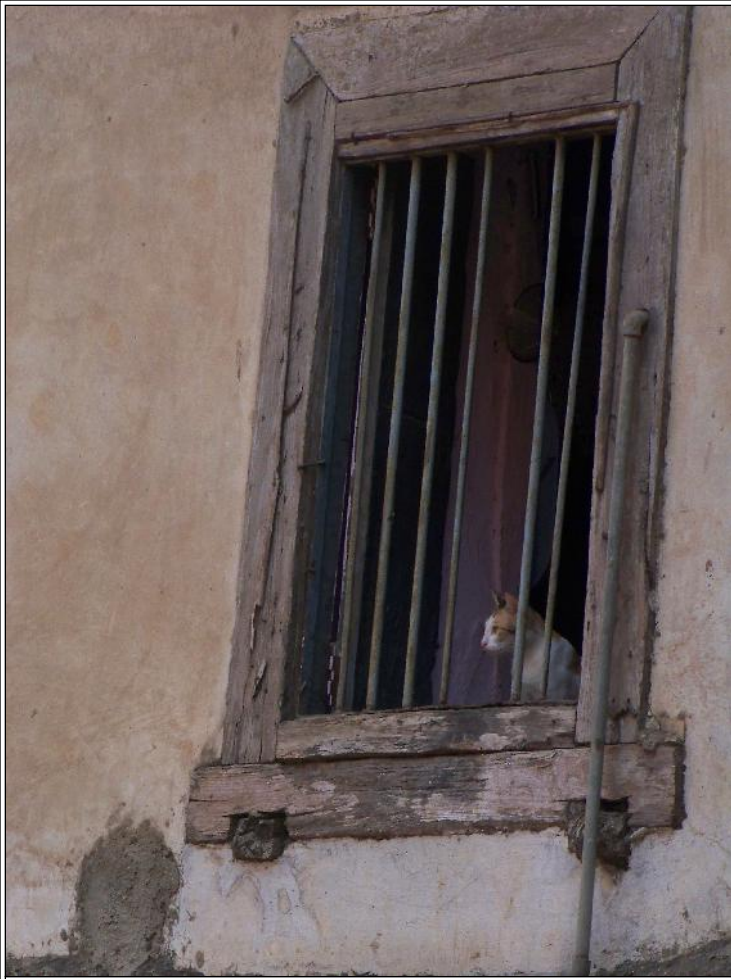
3.07	Stairs	Timber stairs with timber balustrades, stone steps in courtyard.	Signs of sagging and ageing of timber member	Minor Repair
3.08	Openings	Plank timber shutter for doors and windows. Original grills are made of wood. Later grills are verticle iron bars.	Few are successively introduced. Later additions lack detail and finesse. Grills and Mosquito Nets added on First Floor	Minor Repair

Image Title: Limaye Wada
 Image Type: Front-View
 Reference: Window detail showing the deterioration and ageing of the timber

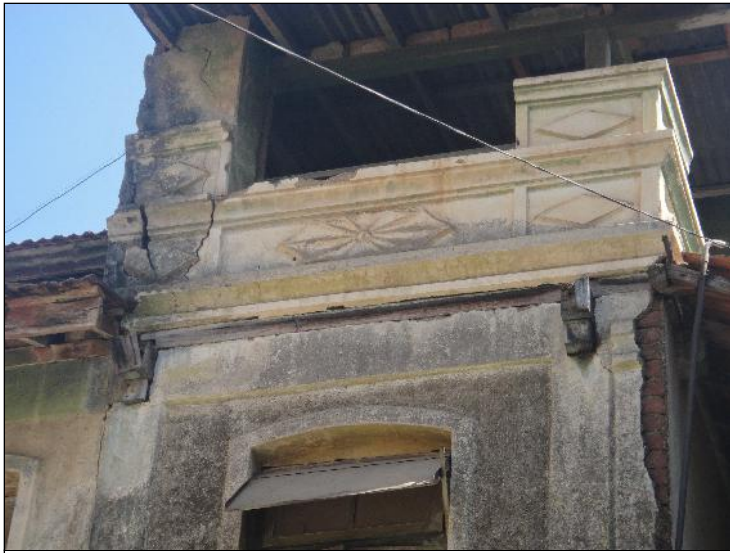
Image Title: Londhe Wada
Image Type: Front-View
Reference: Deterioration of the stucco work

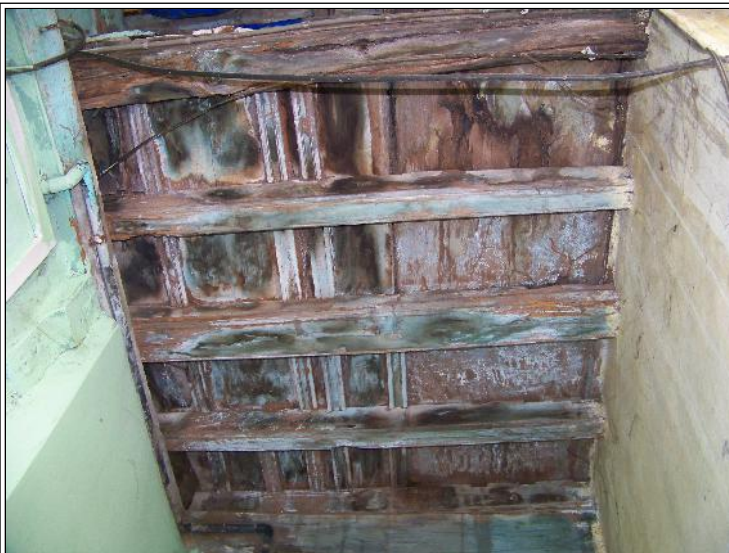
Image Title: Mandlik Wada
Image Type: Top-View
Reference: Water leakage in the wooden ceiling

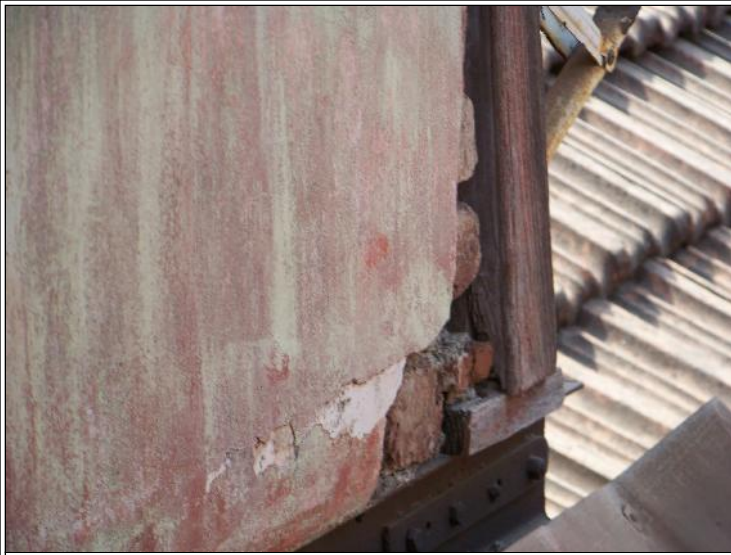
Image Title: Manohar Chawl
Image Type: Front-View
Reference: Deteriorating walls of timber work

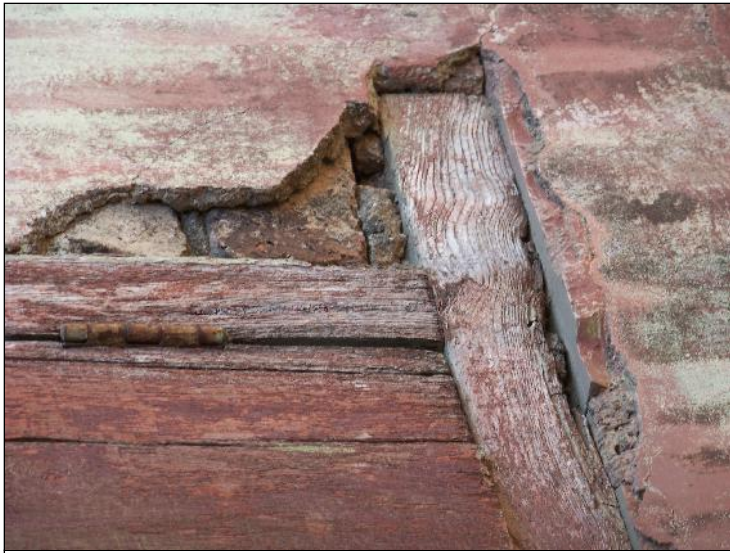
Image Title: Manohar Chawl
Image Type: Top-View
Reference: Deteriorating timber work

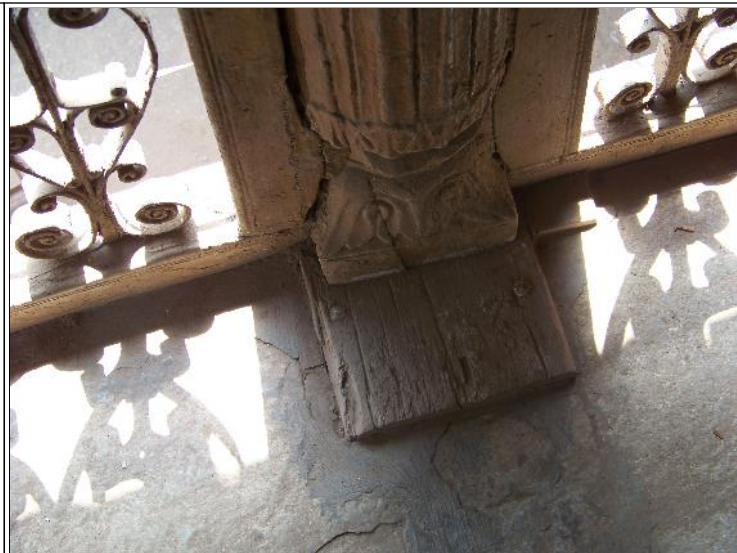
Image Title: More Wada
Image Type: Front-View
Reference: Deteriorating timber work on First Floor

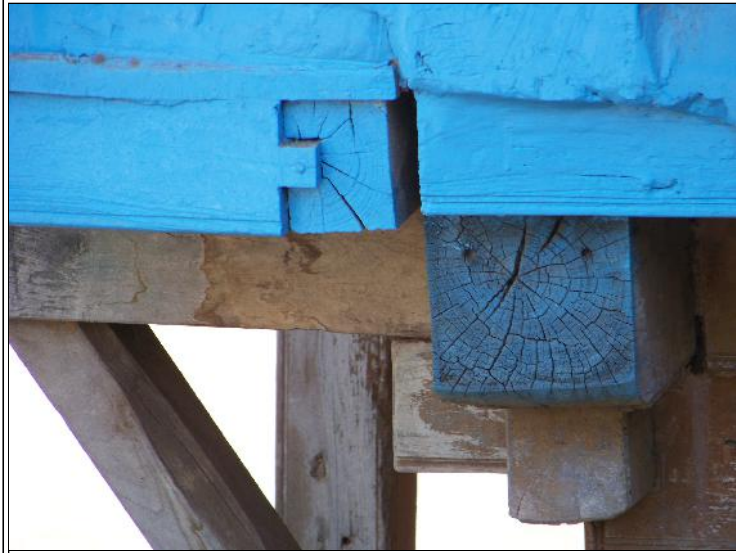
Image Title: More Wada
Image Type: Top-View
Reference: Stressed wooden joinery

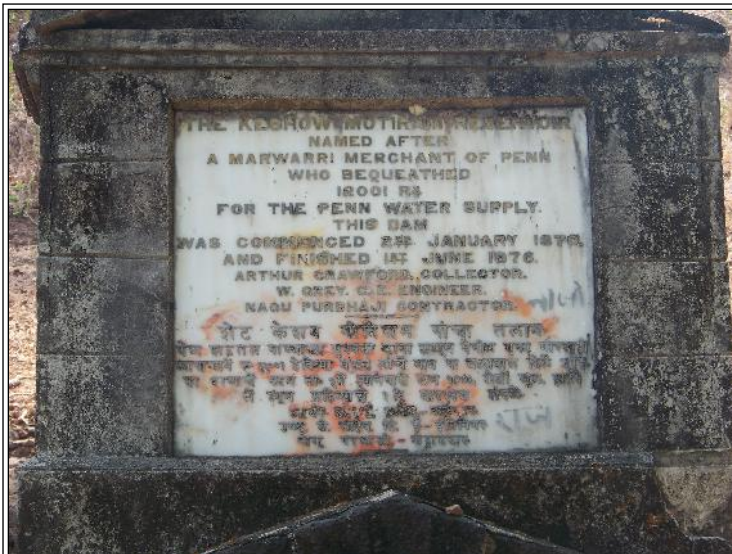
3.04	Plinth	NA	NA	-
3.05	Walls	NA	NA	-
3.06	Floors	NA	NA	-
3.07	Stairs	NA	NA	-
3.08	Openings	NA	NA	-
3.09	Roof	NA	NA	-
3.10	Articulation	Commemorative marble plaque set in stone border.	Needs cleaning	Minor Repair

Reference: Plaque showing the dedication of the water works

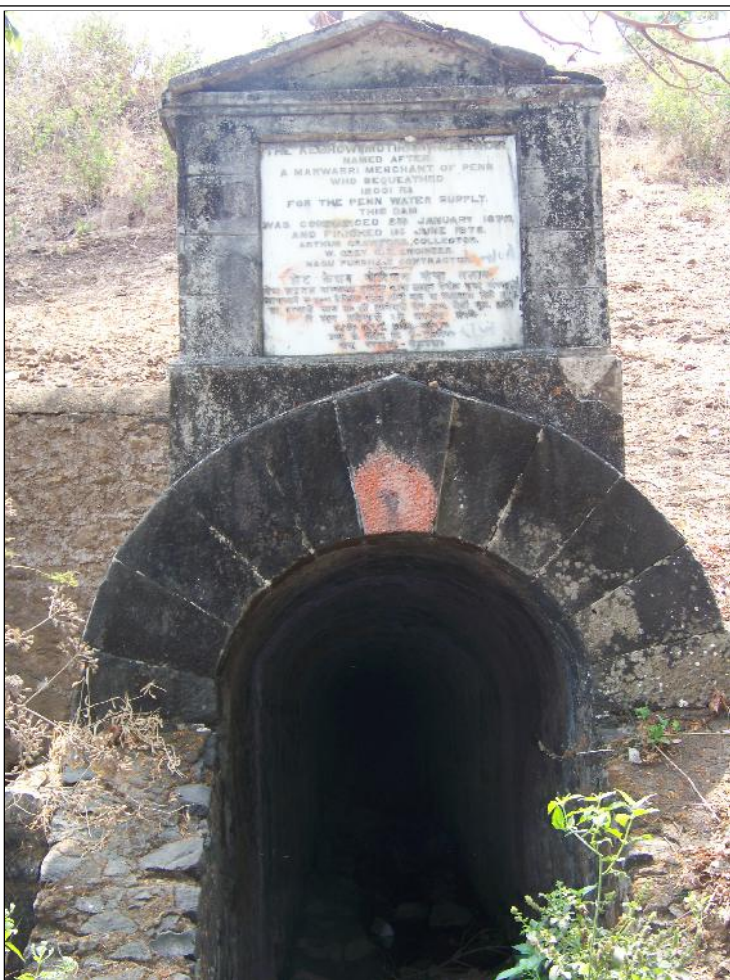
3.01	Height	NA		
3.02	No. of Floors	NA		
		Description	Problem/Threat	Condition
3.03	Structural System	Loadbearing, stone faced earth retaining wall. Barrel vaulted supply duct with pointed keystone	The visible part of the supply duct shows growth of vegetation which needs to be checked to prevent structural damage. There is leakage from the talav.	Minor Repair

Image Title: Motiram Talav
Image Type: Front-View
Reference: Close up view of the water outlet
