Heritage Sites in Pen	
Ref. No.	Name of property
P - 01	Ahilya Mandal
P - 02	Ambika Mandir
P - 03	Asha Niwas
P - 04	Beth Haelohim Synagogue
P - 05	Bhagwat Wada
P - 06	Bridge
P - 07	Datar Ganpati Mandir
P - 08	Datar Wada
P - 09	Deodhar Wada
P - 10	Despande Wada (Ziral Ali)
P - 11	Dharkar Wada
P - 12	Ganpati Mandir - Chavadinaka
P - 13	Ghangrekar Wada
P - 14	Gosavi Datta Mandir
P - 15	Goteswar Mandir
P - 16	Hanuman Mandir
P - 17	Hazare Wada
P - 18	Patil House
P - 19	Jari Mari Aai Mandir
P - 20	Patwardhan House
P - 21	Karmarkar Wada
P - 22	Kasar Tale
P - 23	Kelkar Wada
P - 24	Kolhatkar Wada
P - 25	Kumbhar Tale
P - 26	Kaundal Tale
P - 27	Limaye Wada
P - 28	Londhe Wada
P - 29	Mandlik Wada
P - 30	Manohar Chawl
P - 31	More Wada
P - 32	Motiram Talav
P - 33	Parmar Wada
P - 34	Tilak Wada 1
P - 35	Tilak Wada 2
P - 36	Tilak Wada 3
P - 37	Vishweshwar Mandir
P - 38	Ziral Ali Ganpati Mandir
P - 39	Tipecha Maruti Mandir
P - 40	Rameshwar Mandir
P - 41	Mahakali Mandir

MUMBAI METROPOLITAN REGION HERITAGE CONSERVATION SOCIETY

Record Details for Ahilya Mandal

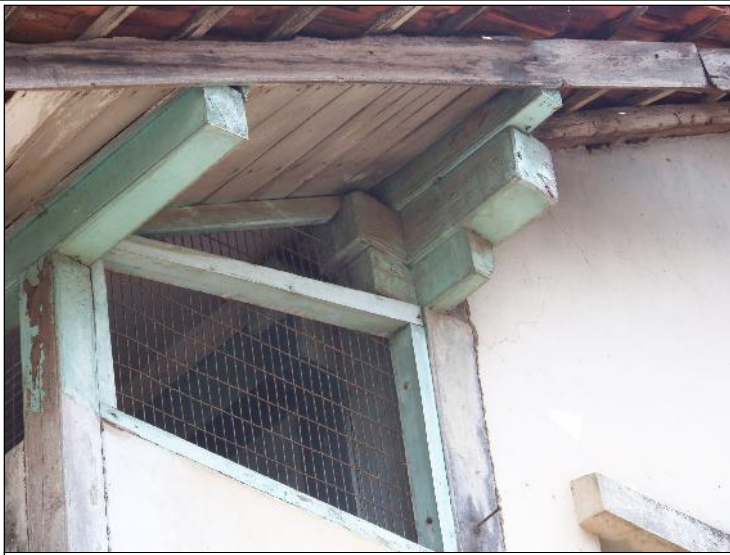
Image Title: Parmar Wada
Image Type: Top-View
Reference: Small addition like this safety mesh done at a later date

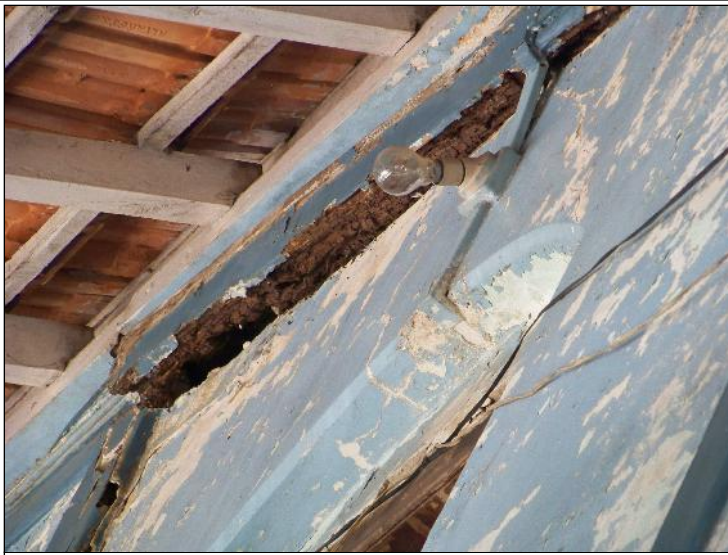
Image Title: Parmar Wada
Image Type: Top-View
Reference: Rain water damage to the verandah roof

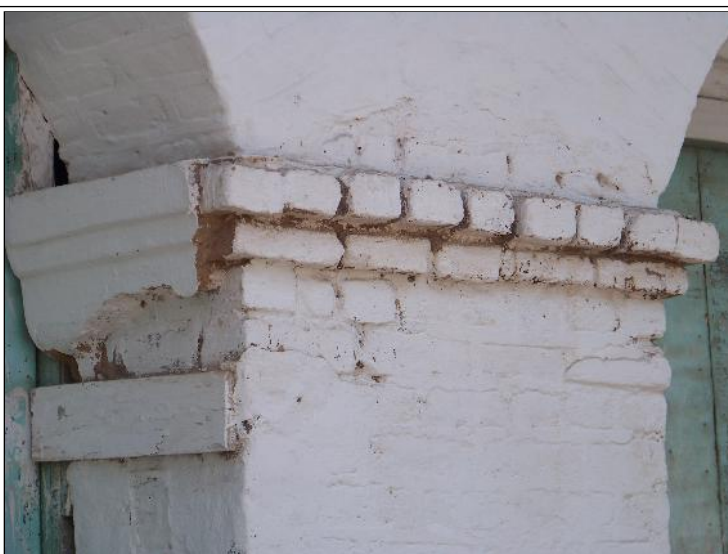
Image Title: Parmar Wada
Image Type: Top-View
Reference: Deteriorating Plaster

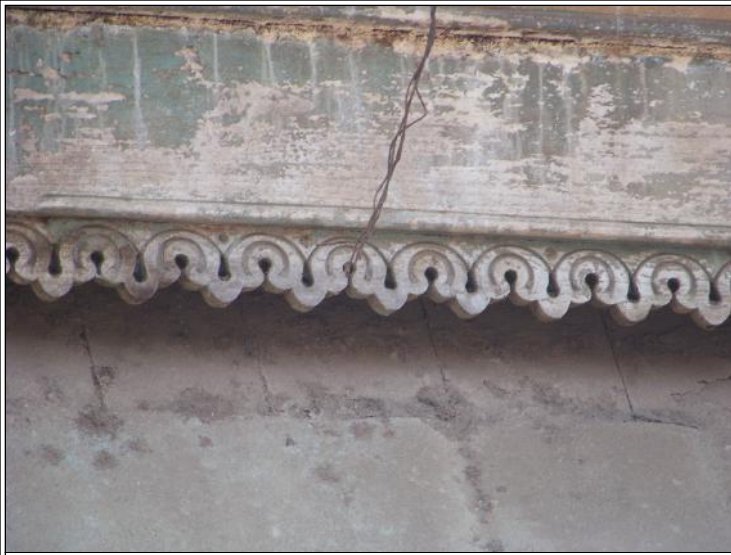
3.09	Roof	Manglore tile roofing on corrugated GI sheet over timber rafters	Rainwater leakages, Soffit and eaves damaged	Good
3.10	Articulation	Woodwork is simple and plain with only a slight ornamental shape to the brackets and beam heads. First floor doors have semicircular fan lights. Balcony has a decorative cast iron railing.	Railing pieces are missing, glass panes of fan lights are broken, ground floor has new windows and RCC grills altering and marring the original character of the building.	Minor Repair

Image Title: Tilak Wada
Image Type: Top-View
Reference: Detail of eaves board

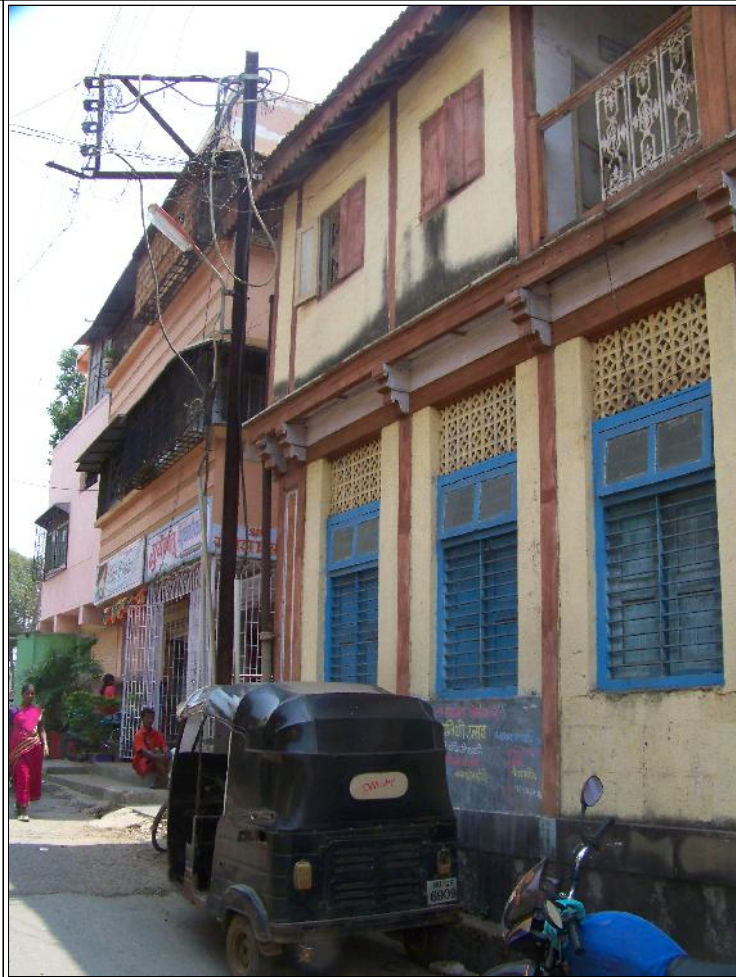
Image Title: Tilak Wada
Image Type: Front-View
Reference: Windows on Ground Floor added later

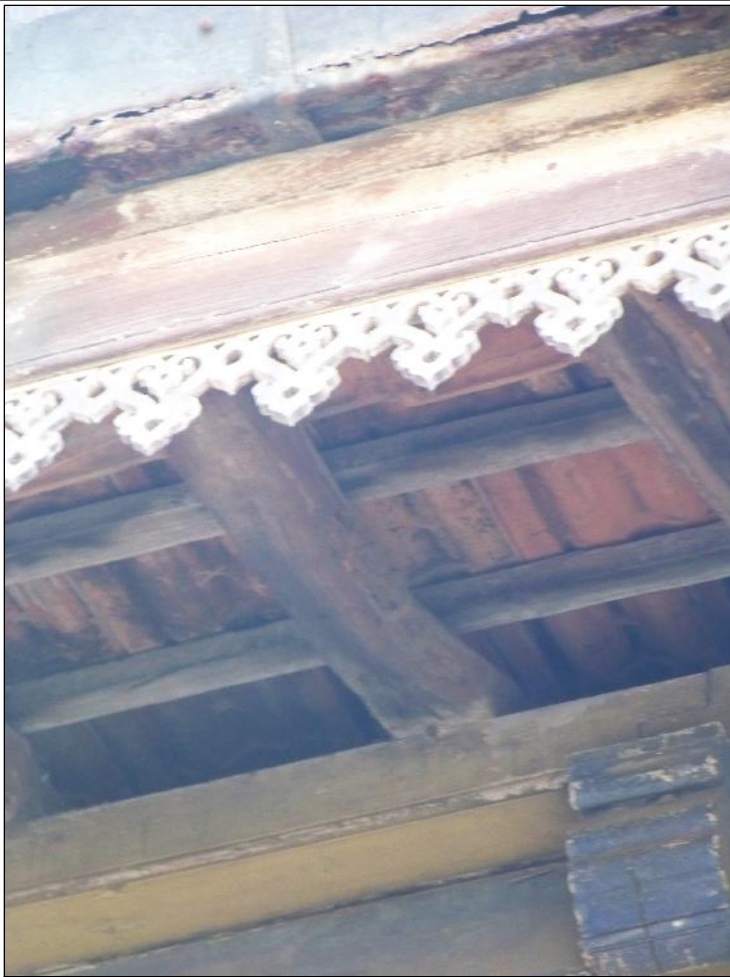
3.09	Roof	Hipped roof with Mangalore tiles on timber rafters	sagging of some timber members, repairs to eaves board and gutter	Minor Repair
3.10	Articulation	Timber columns on GF front verandah fashioned like European Classical stone columns with rounded base, flutings and rounded capital that receives a very Indian timber carved bracket and medallion. Ornamental relief stucco work on FF walls, Elaborate main door, Painted wall panels. Delicately carved eaves board.	additions mar the appearance of original features, need maintenance, wall paint is deteriorating due to lack of care	Minor Repair

Image Title: Tilak Wada
Image Type: Top-View
Reference: Detail of Eaves Board

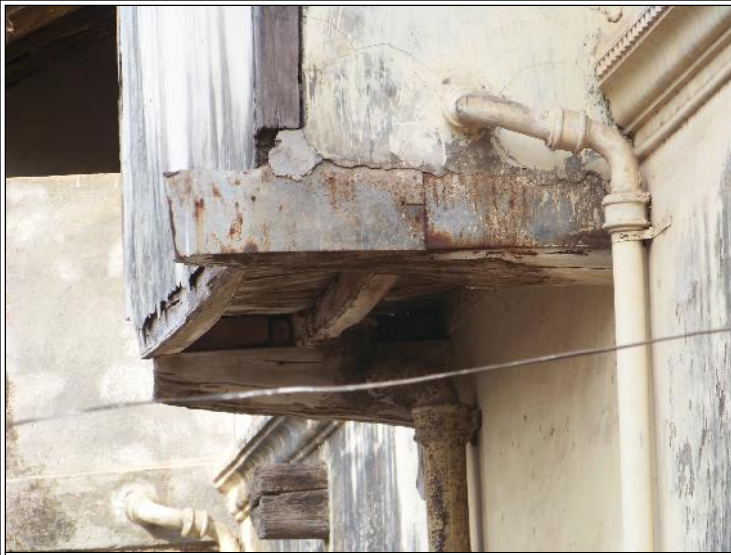
Image Title: Tilak Wada
Image Type: Front-View
Reference: Deterioration due to water seepage

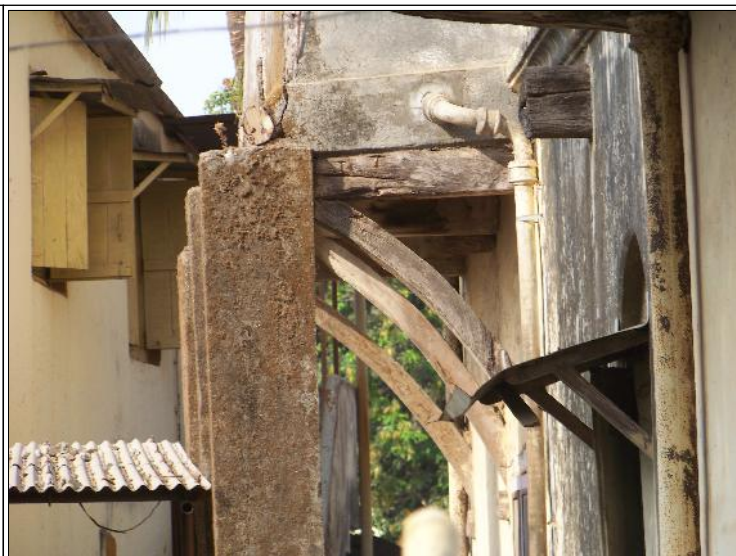
Image Title: Tilak Wada
Image Type: Side-View1
Reference: temporary support to the upper floor

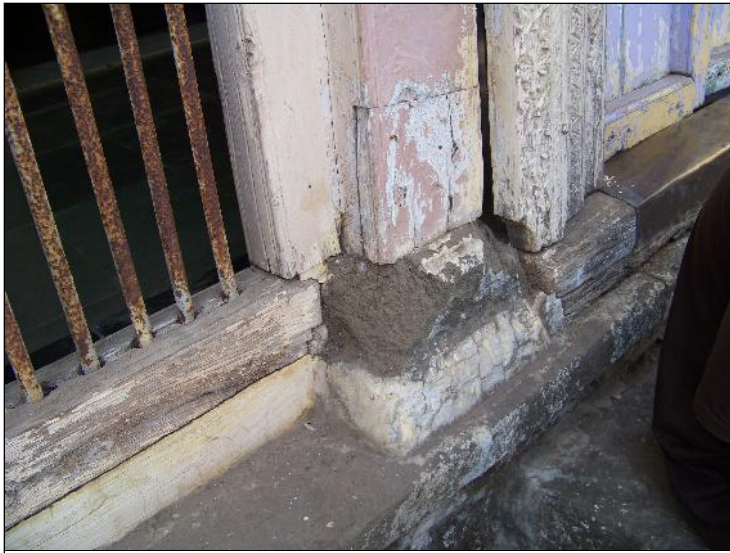
Image Title: Mahakali Mandir
Image Type: Front-View
Reference: Deteriorating Wood work

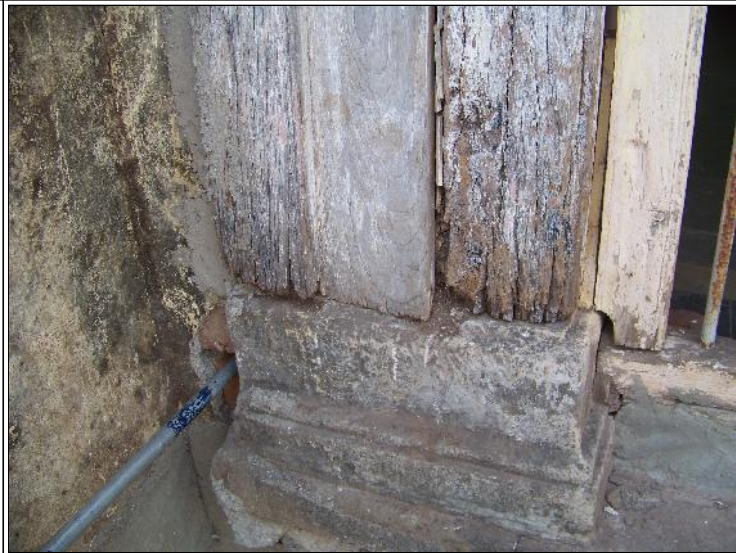
Image Title: Mahakali Mandir
Image Type: Front-View
Reference: Deteriorating Wood work
