Heritage Sites in Karjat	
Ref. No.	Name of property
KA – 01	Bafna House
KA – 02	Datta Mandir
KA – 03	Kale House
KA – 04	Railway Station
KA – 05	Shiva Mandir
KA – 06	Vaidya House

MUMBAI METROPOLITAN REGION HERITAGE CONSERVATION SOCIETY

Record Details for Medhi House

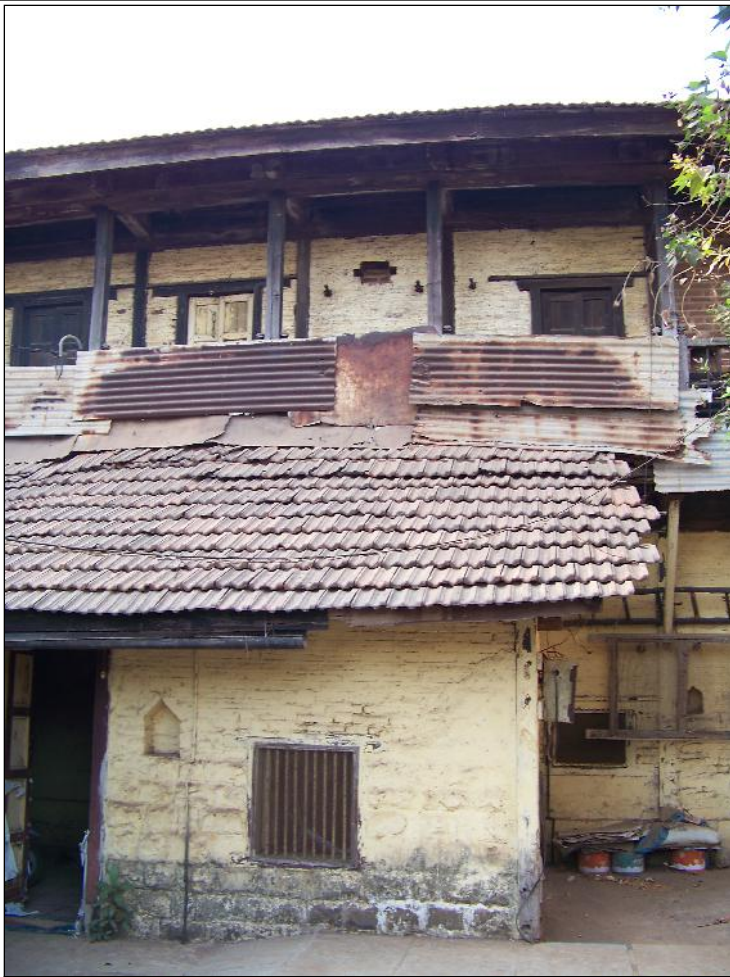
Image Title: Medhi House
Image Type: Side-View1
Reference: Side elevation of the house

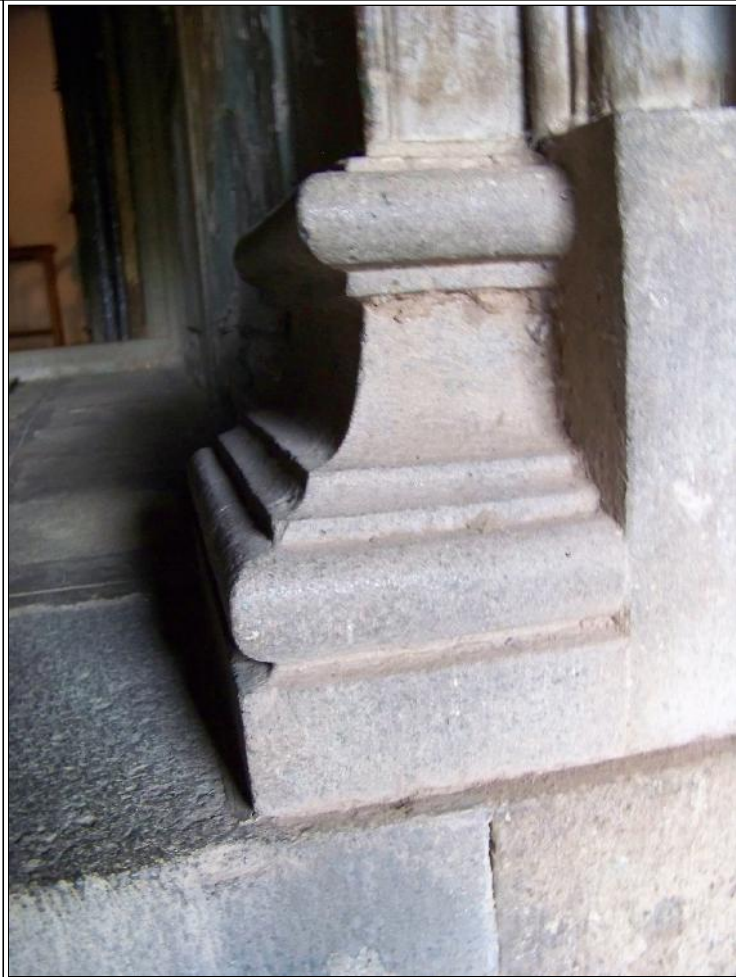
Image Title: Medhi House
Image Type: Front-View
Reference: Stone base to timber column

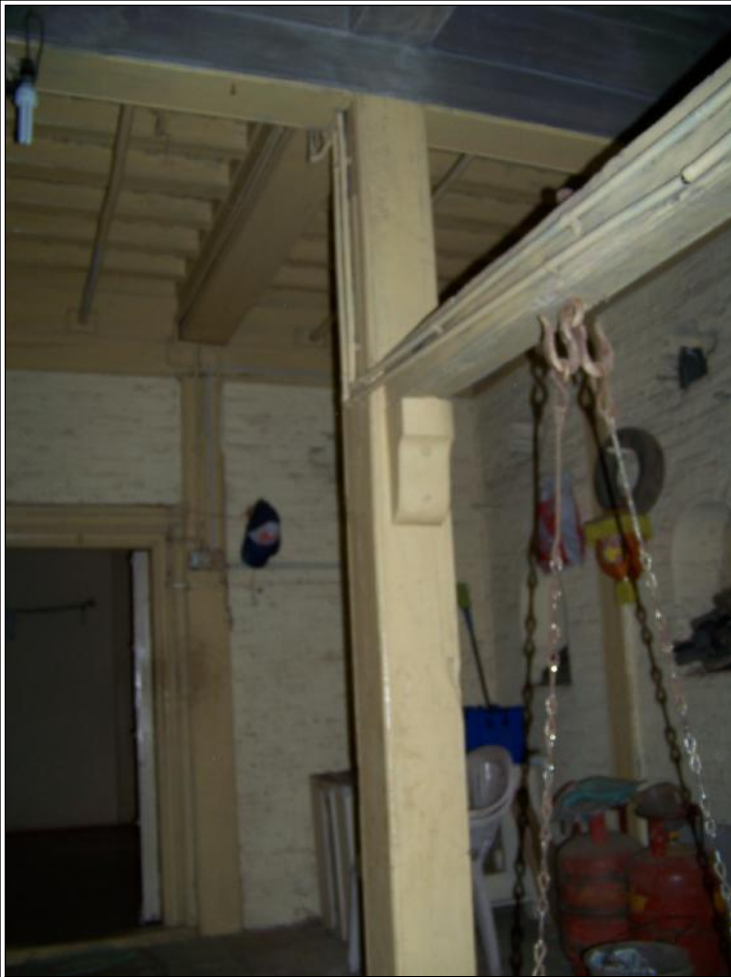
Image Title: Medhi House
Image Type: Top-View
Reference: Wooden construction in the interiors

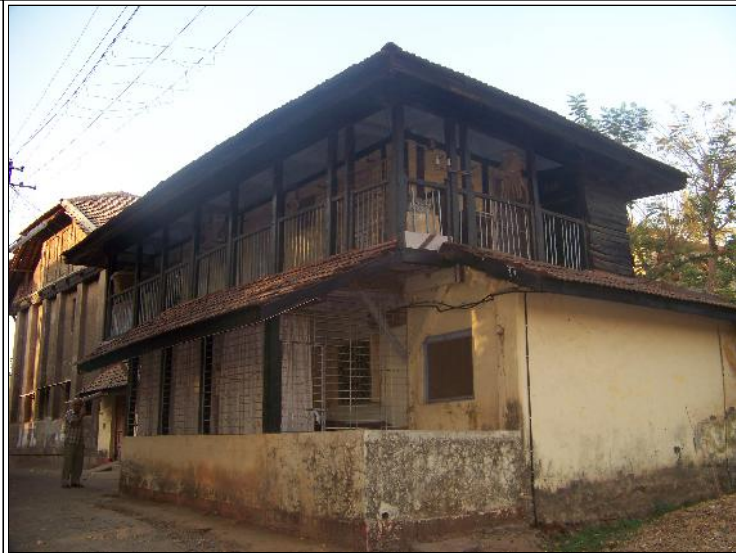
Image Title: Medhi House
Image Type: Front-View
Reference: Street view of the house.

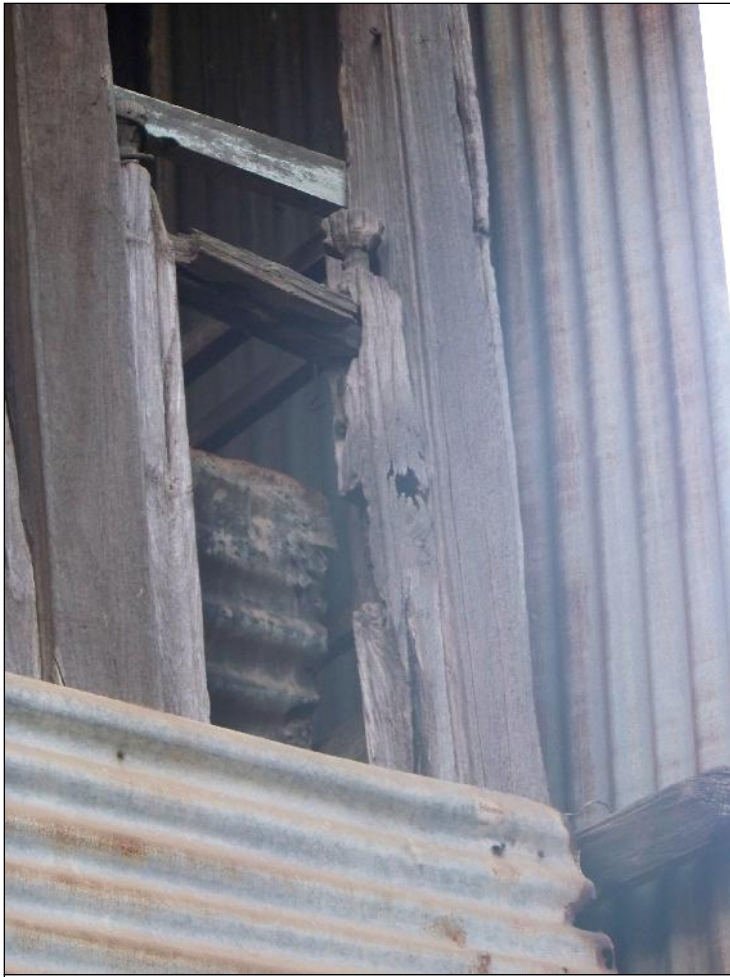
Image Title: Medhi House
Image Type: Front-View
Reference: deteriorating timber work

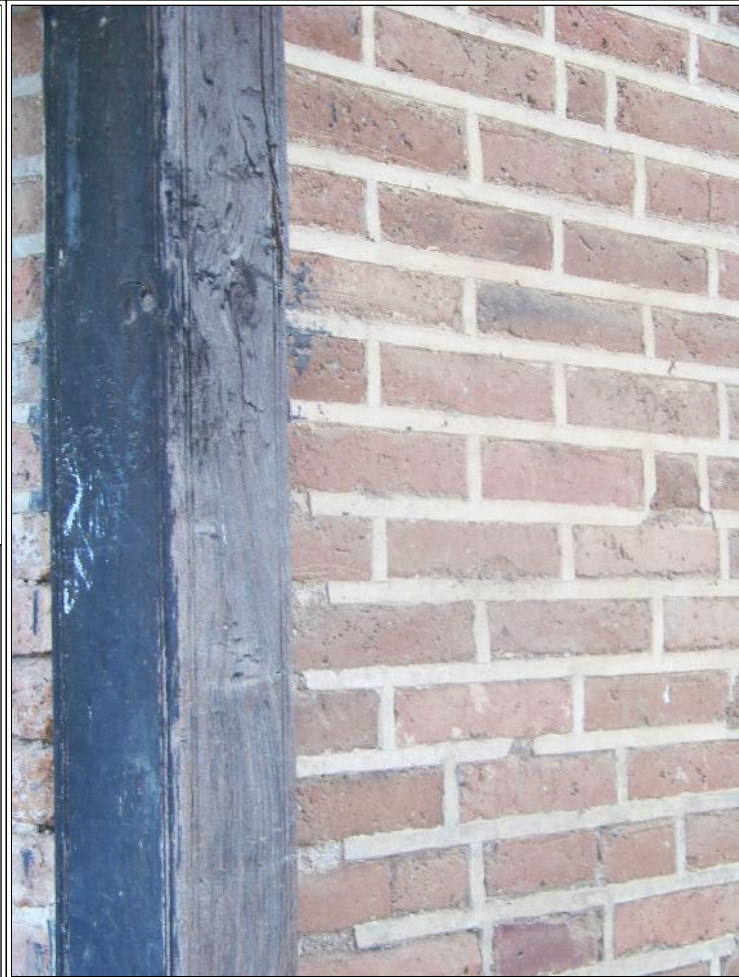
Image Title: Medhi House
Image Type: Front-View
Reference: Close up of the stretcher bond brick work

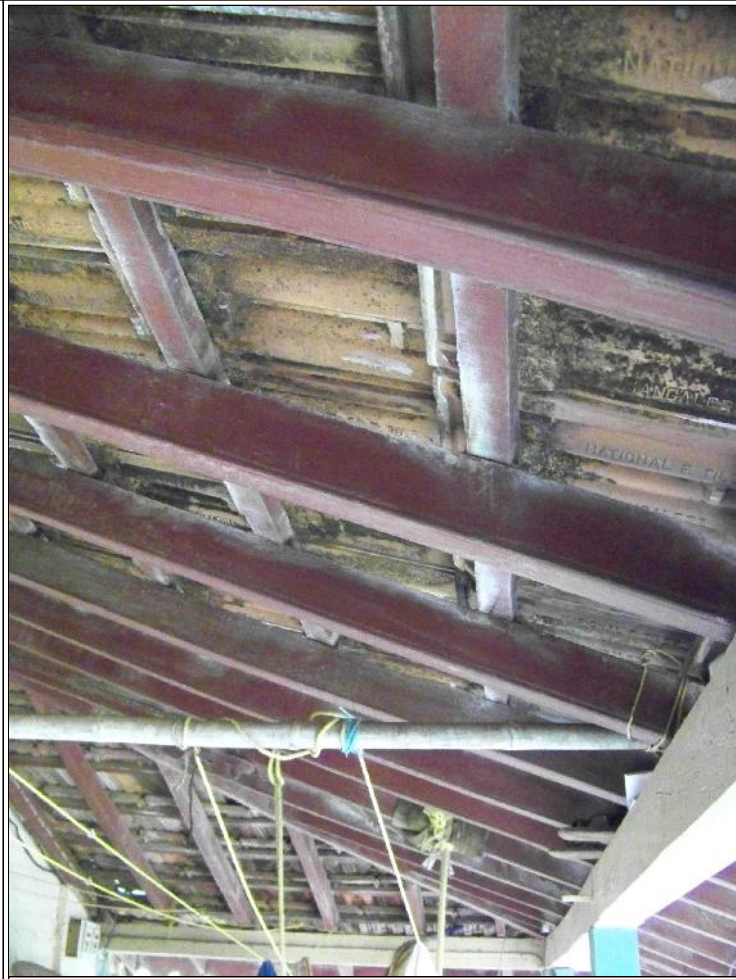
Image Title: Mukadam House
Image Type: Top-View
Reference: Close up of ceiling with timber members and mangalore tiles

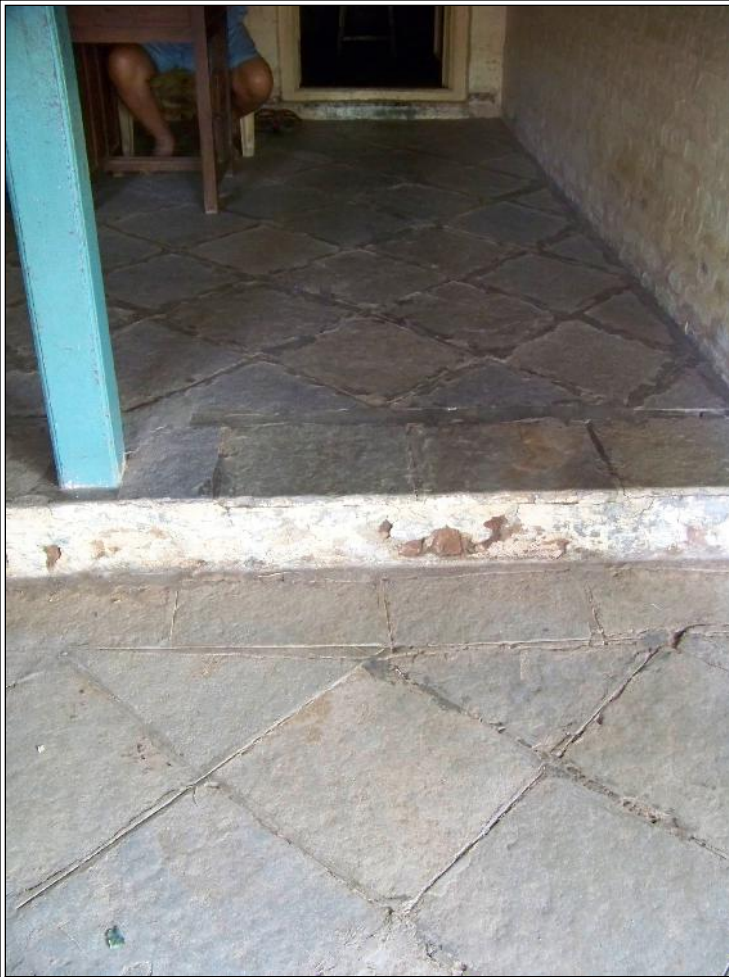
Image Title: Mukadam House
Image Type: Front-View
Reference: Diamond pattern shahabad flooring inside the house.

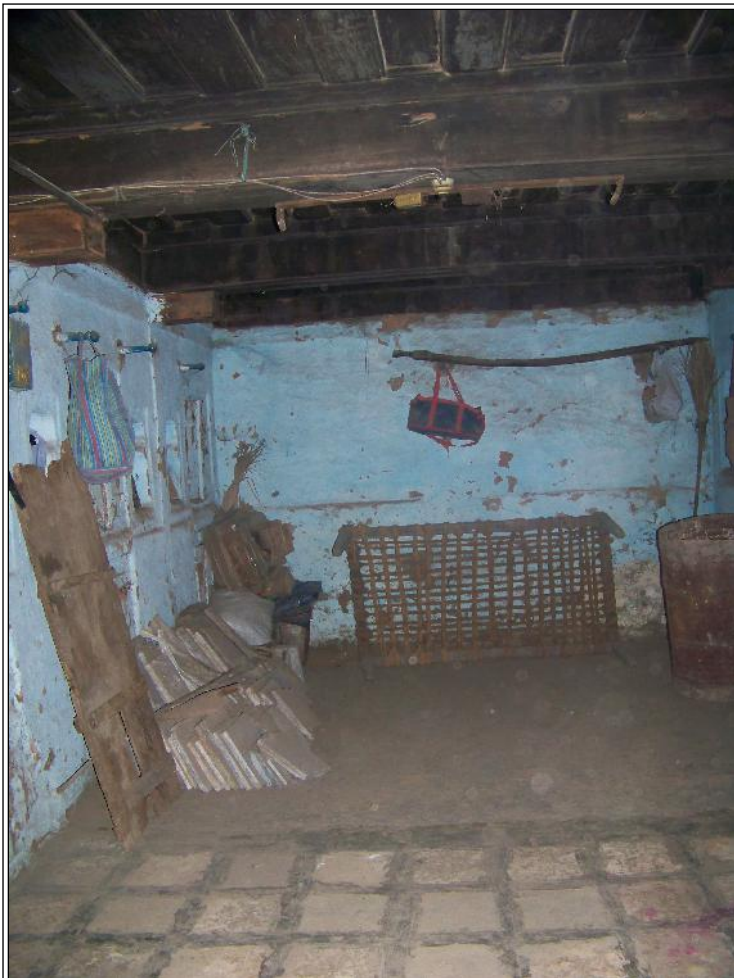
4.01	D P Remarks	Landuse - Residential The street abuts the Pimputkar Wada Premises on the East.
4.02	Overall Problems & Threats	The structure is very old and has undergone a lot of deterioration and also part demolition. In the current state, it will not survive for long and therefore calls for urgent action.

Image Title: Pimputkar Wada
Image Type: Front-View
Reference: General interior view

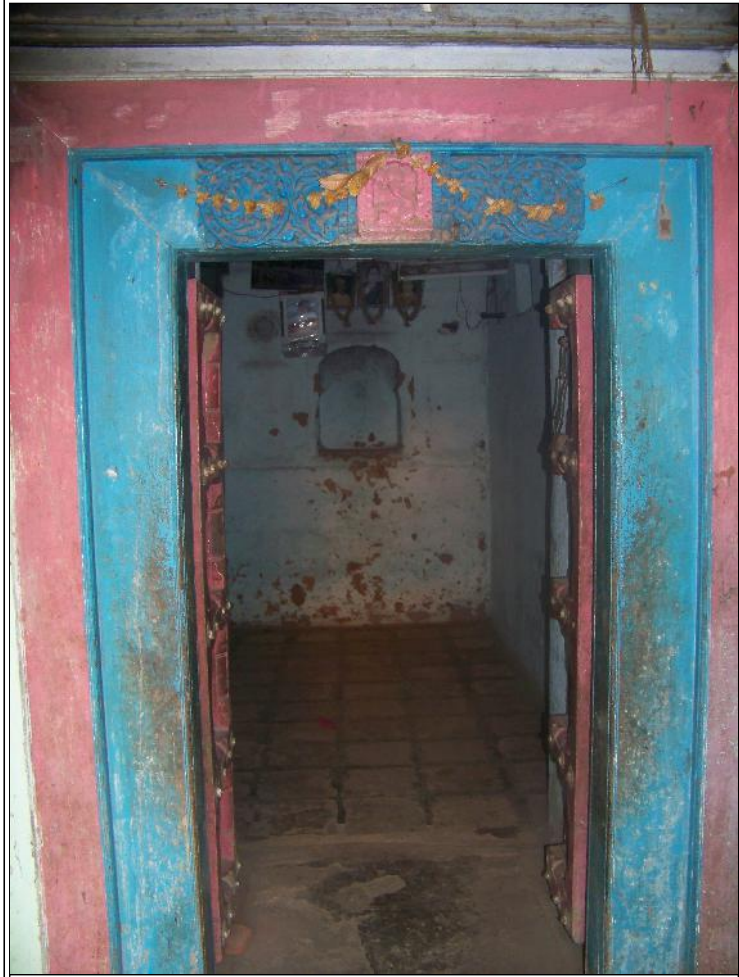
Reference: Decorative lintel on the entrance door

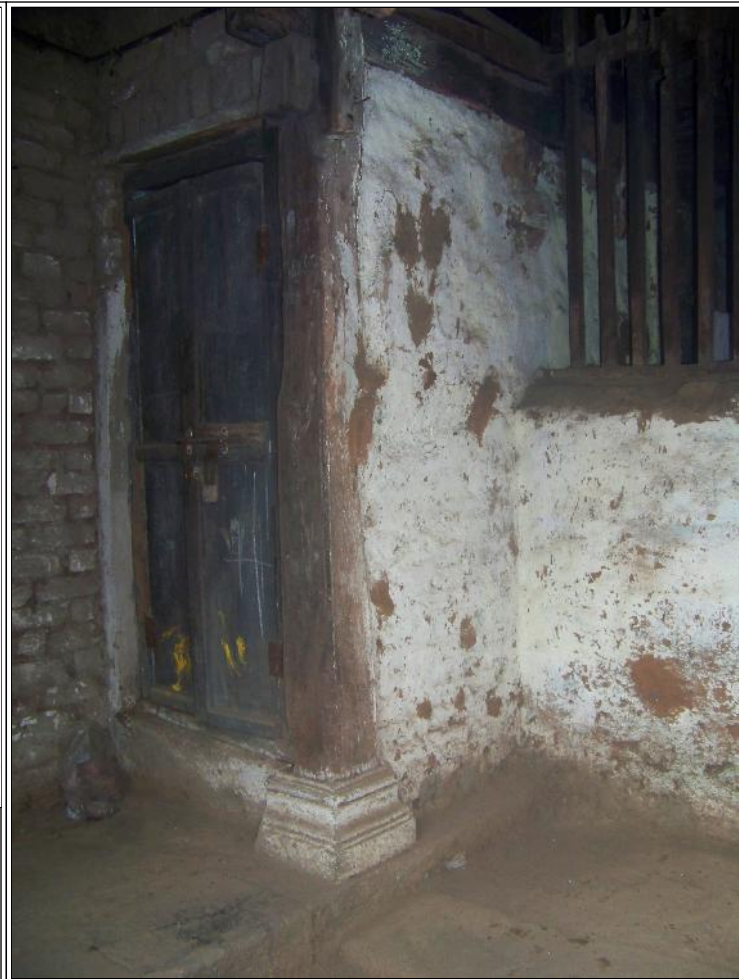
3.01	Height	NA		
3.02	No. of Floors	Ground + 1 Upper		
		Description	Problem/Threat	Condition
3.03	Structural System	Timber structure with load bearing mud walls on stone plinth	Timber columns in Dilapidated state with flaking, cracks and termites	Ruin

Image Title: Pimputkar Wada
 Image Type: Front-View
 Reference: Wooden column of load bearing walls form the structural support.

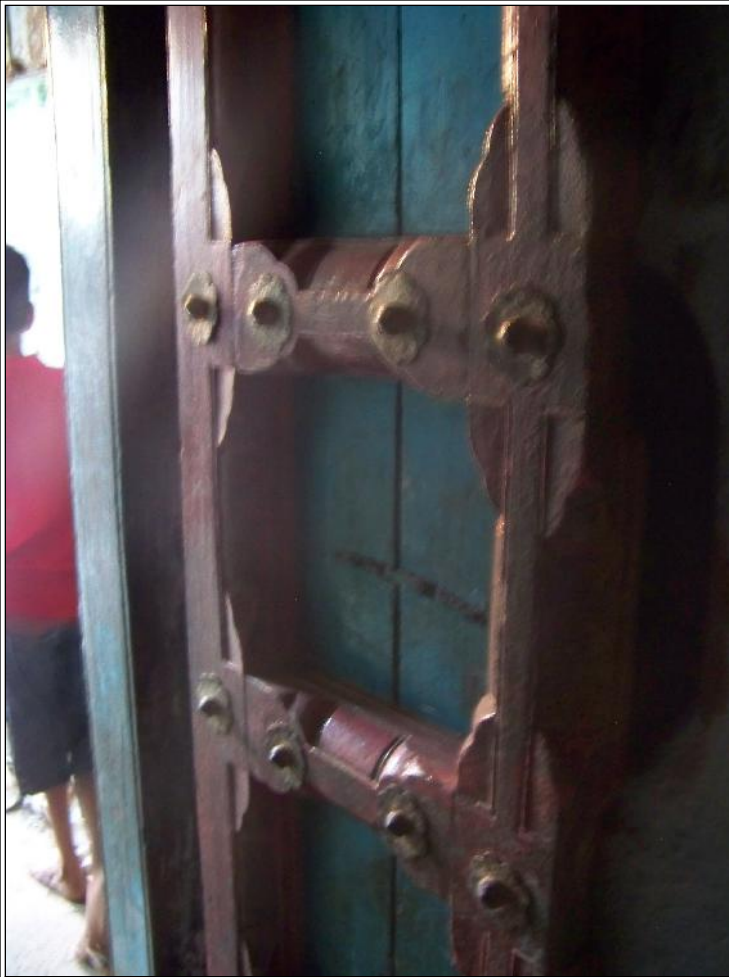
Image Title: Pimputkar Wada
Image Type: Front-View
Reference: Close up of the main door

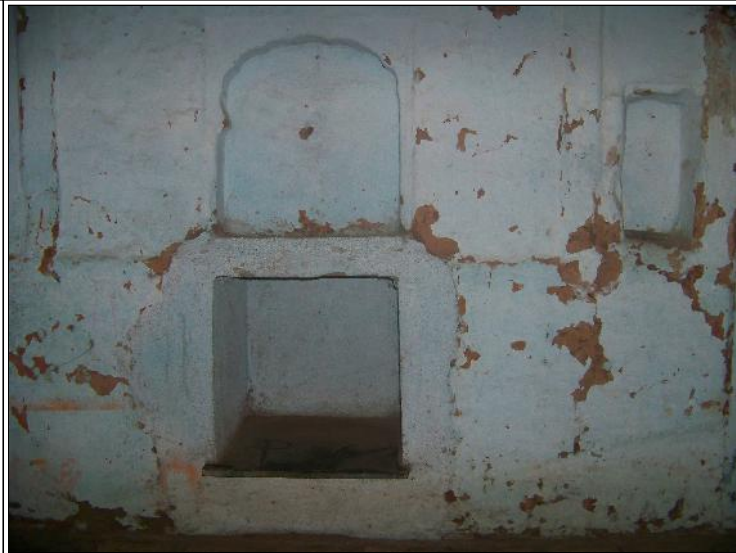
Image Title: Pimputkar Wada
Image Type: Front-View
Reference: Niches in the load bearing walls

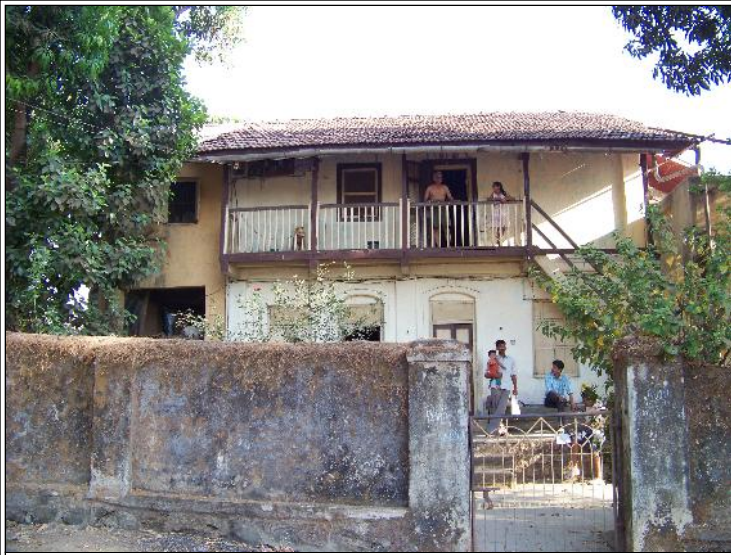
Image Title: Salaye House
Image Type: Front-View
Reference: Street View of the house

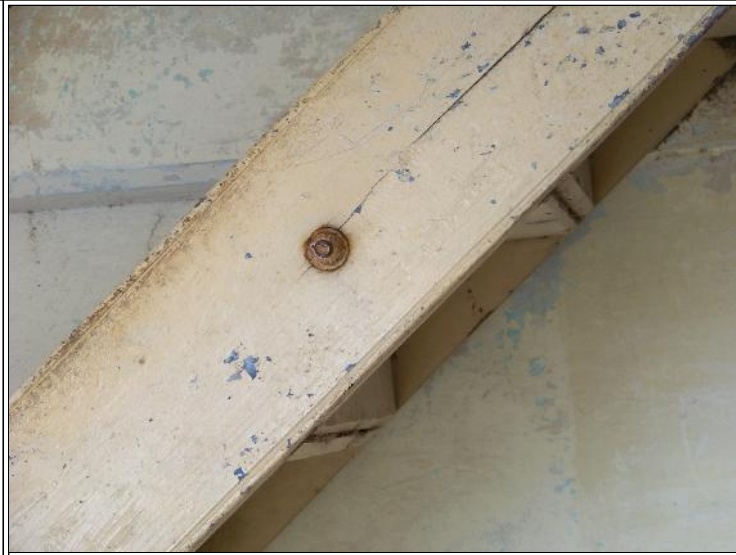
3.06	Floors	Timber floor beams and joists support the first floor. Timber roof with Mangalore tiles.	no major problems	Minor Repair
3.07	Stairs	Timber stairs tied with MS bolt rods.	Loosening of joinery	Minor Repair

Image Title: Salaye House
Image Type: Front-View
Reference: Detail of timber joinery and hardware of the stairs.

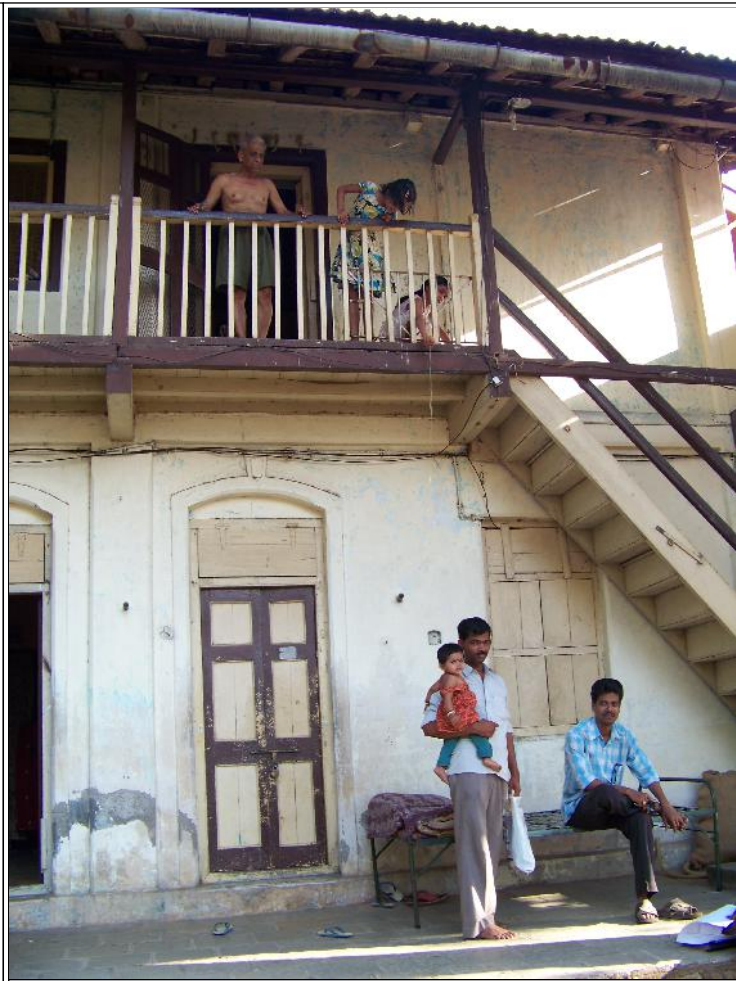
Image Title: Salaye House
Image Type: Side-View2
Reference: Close up of front door of the ground floor apartment

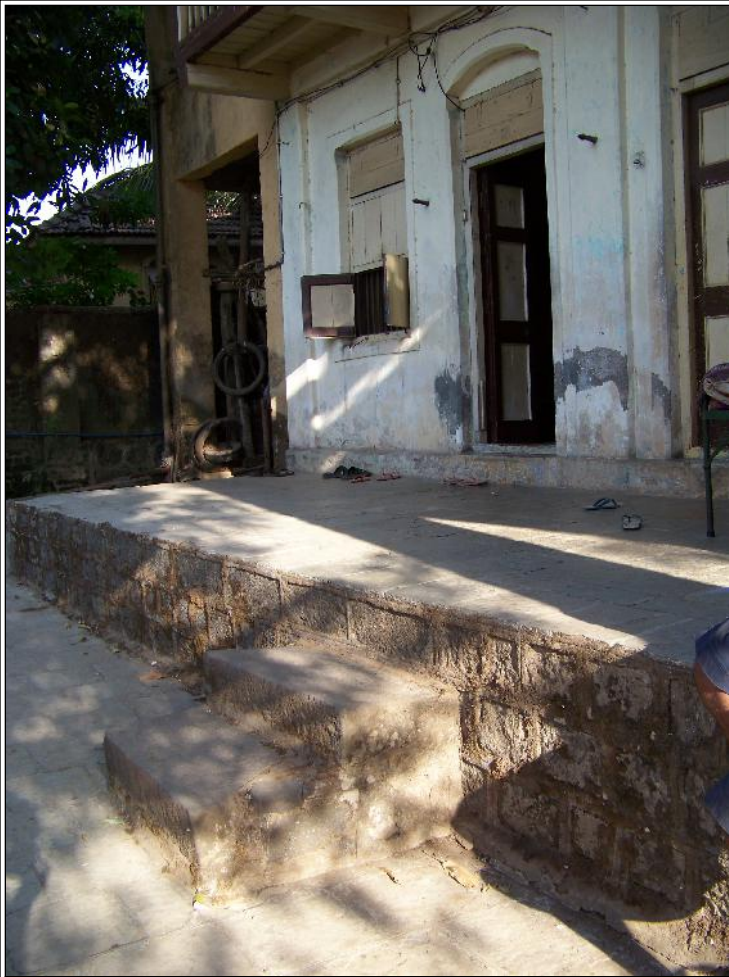
Image Title: Salaye House
Image Type: Side-View1
Reference: Extended plinth in front of the entrance to the apartments on the ground floor

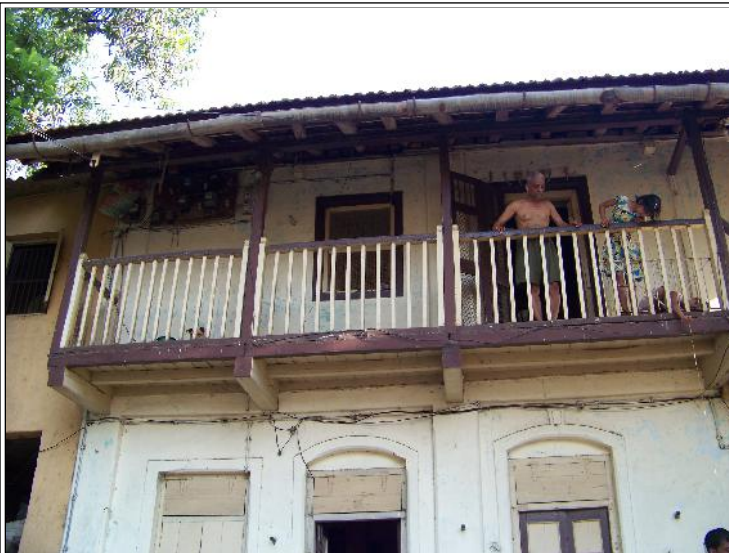
Image Title: Salaye House
Image Type: Top-View
Reference: Close up view of the first floor balcony on the front side of the house

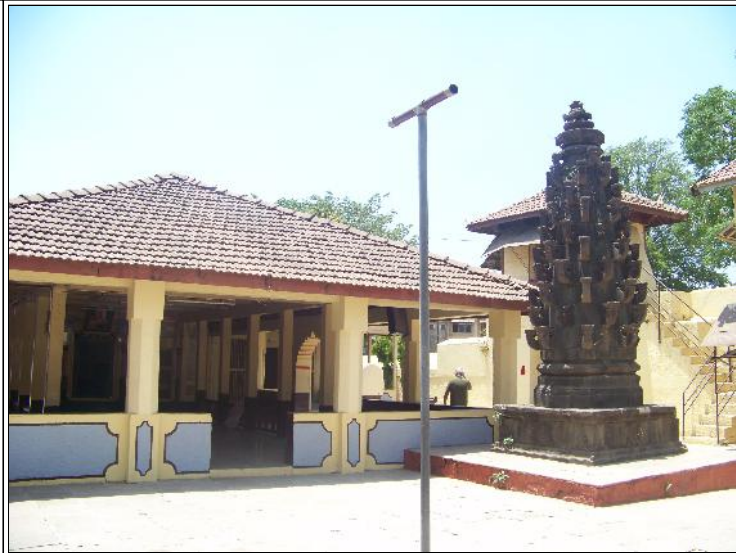
Image Title: Vitthal Mandir Sansthanandir Sansthan2
 Image Type: Front-View
 Reference: Steps leading to the nagarkhana with the new railing

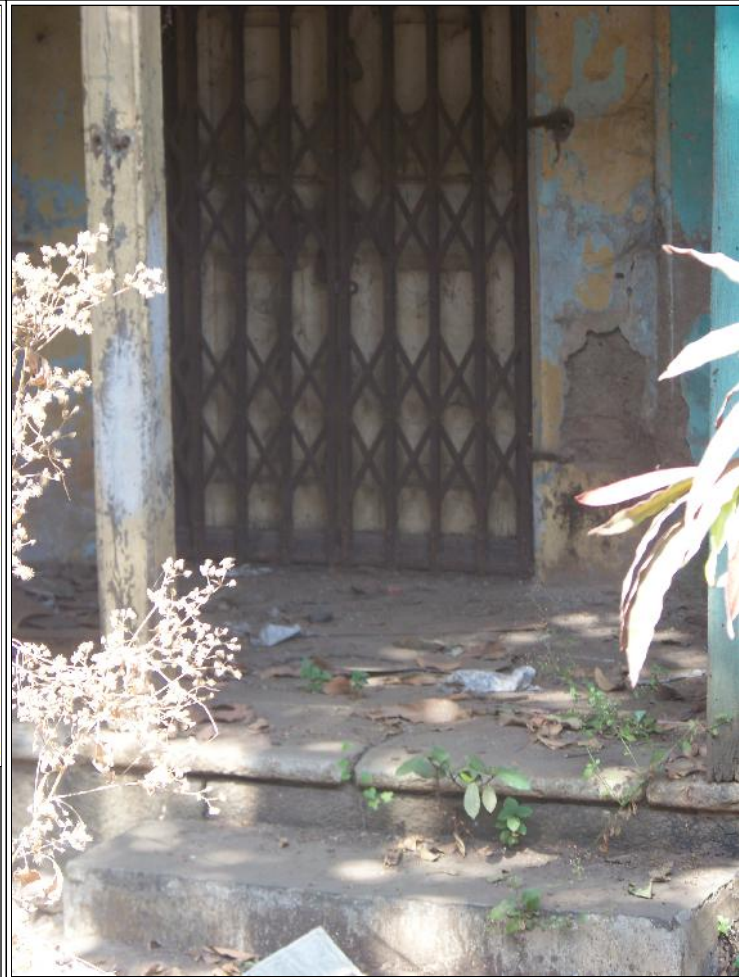
Image Title: Bafna House
Image Type: Front-View
Reference: Newly added collapsible gate

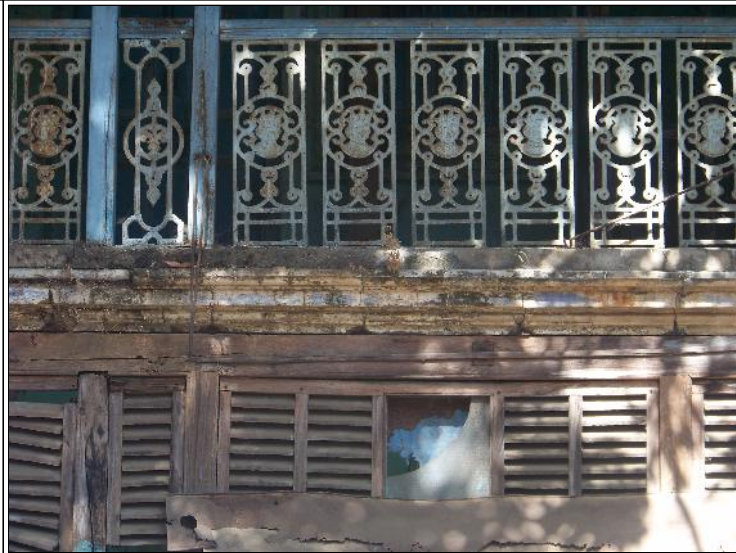
Image Title: Bafna House
Image Type: Top-View
Reference: The wooden ventilators of the cast iron balusters of the first floor

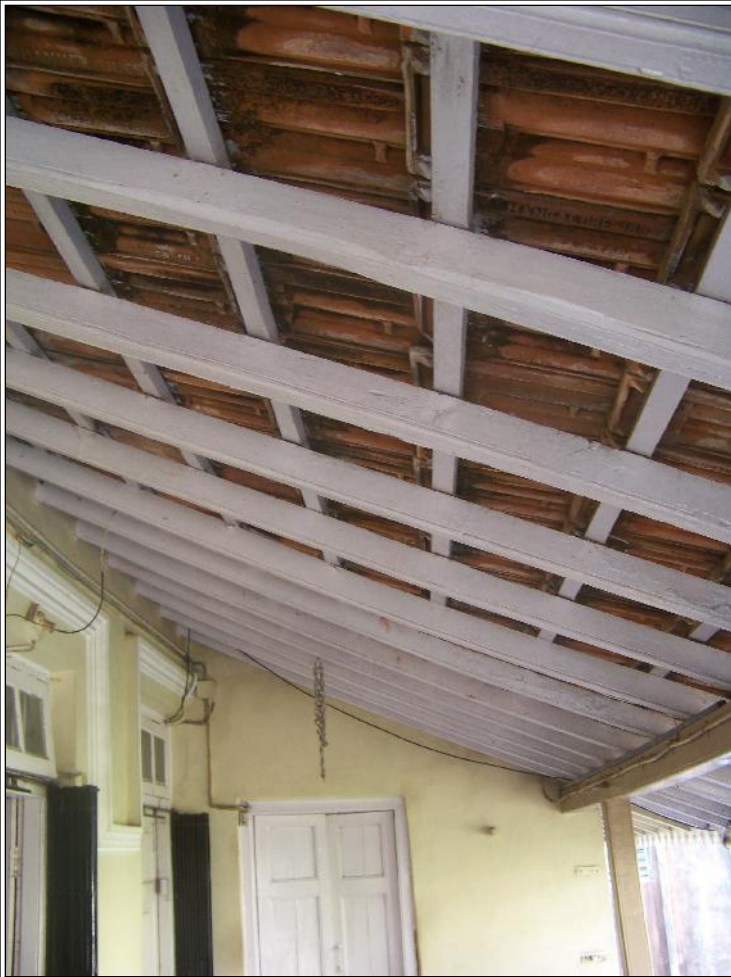
Image Title: Kale House
Image Type: Top-View
Reference: Leaned Mangalore tile and wooden roof from inside

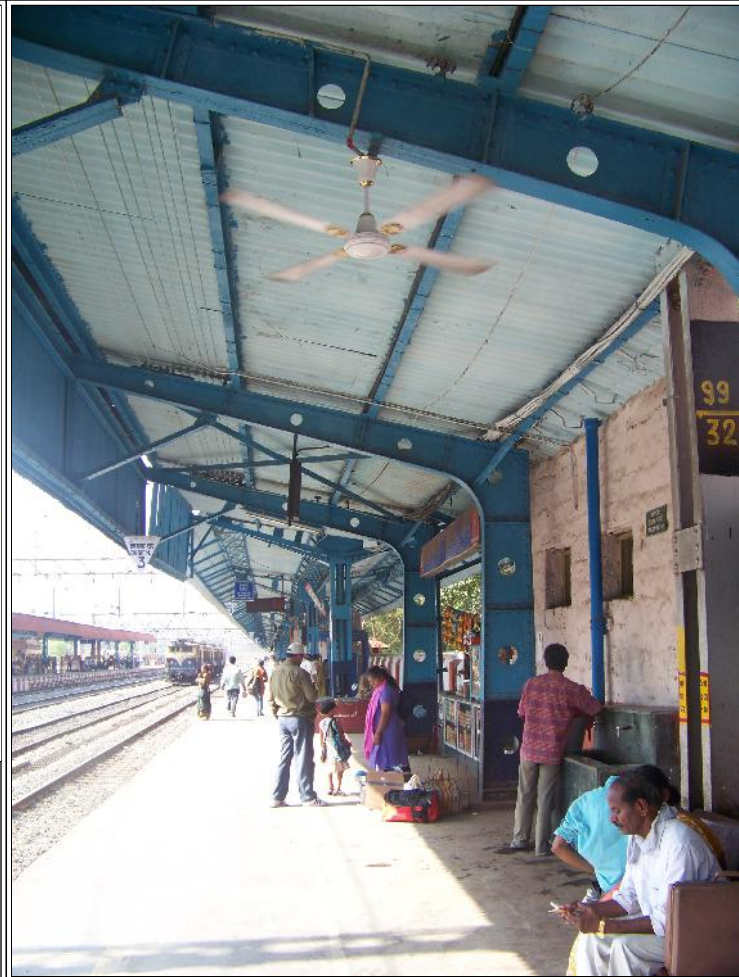
Image Title: Railway Station
Image Type: Side-View2
Reference: General view of the platform showing in construction

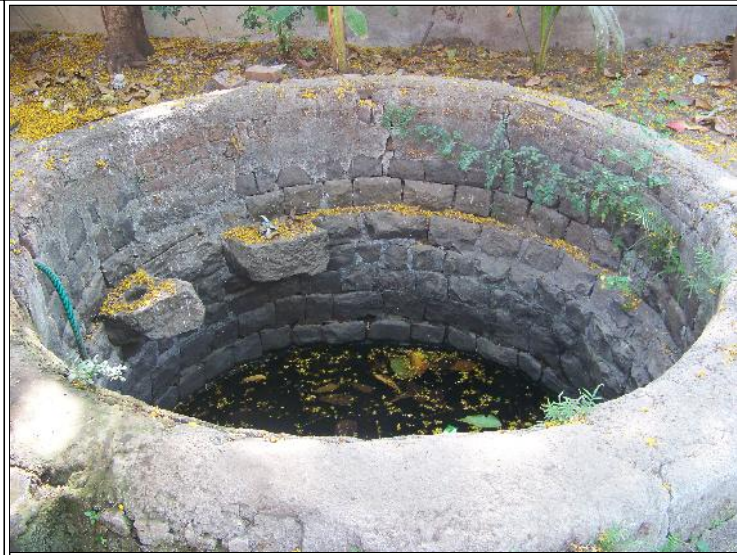
3.17	Electricity	Yes	nil	Good
3.18	Water Supply	Well in the compound	Needs maintenance so that water can be used. But it has a good water level.	Minor Repair

Image Title: Shiv Mandir
Image Type: Front-View
Reference: View of the well in the premises

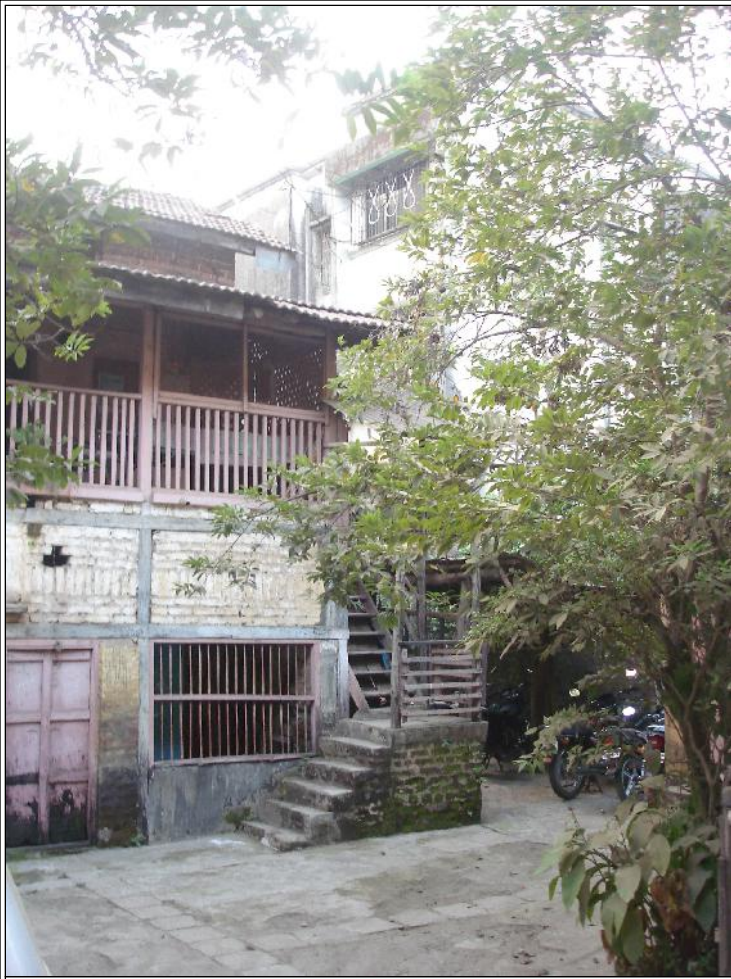
Image Title: Vaidya House
Image Type: Front-View
Reference: View of the house from the street

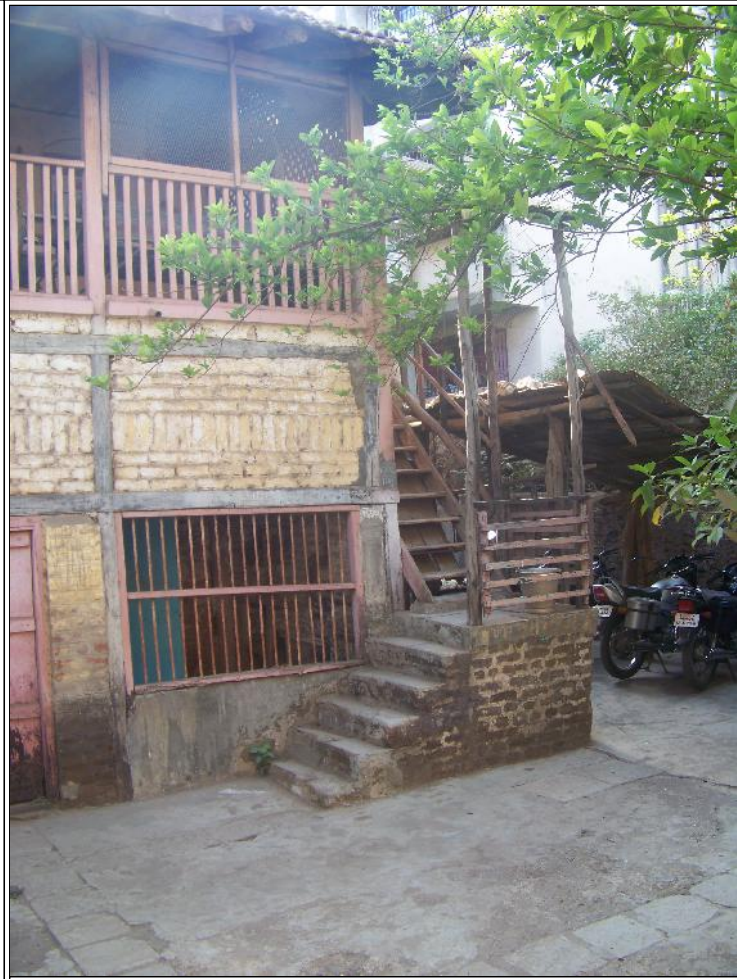
Image Title: Vaidya House
Image Type: Top-View
Reference: Street view of the house

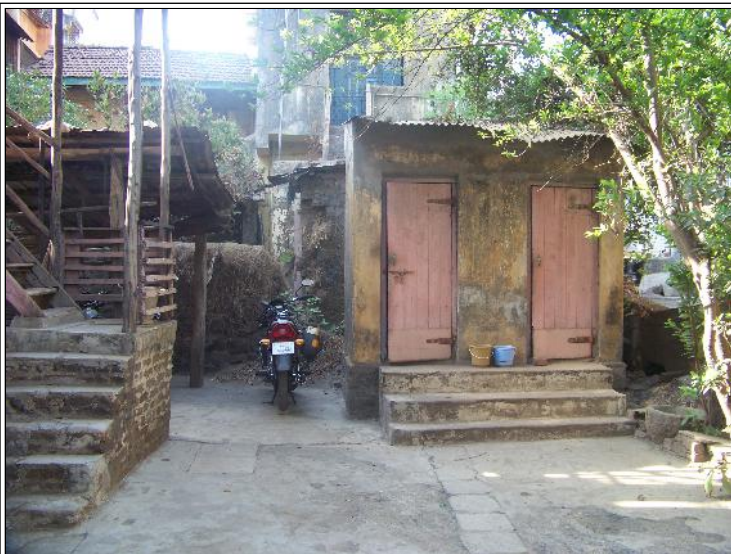
Image Title: Vaidya House
Image Type: Side-View2
Reference: Toilet block in the front yard

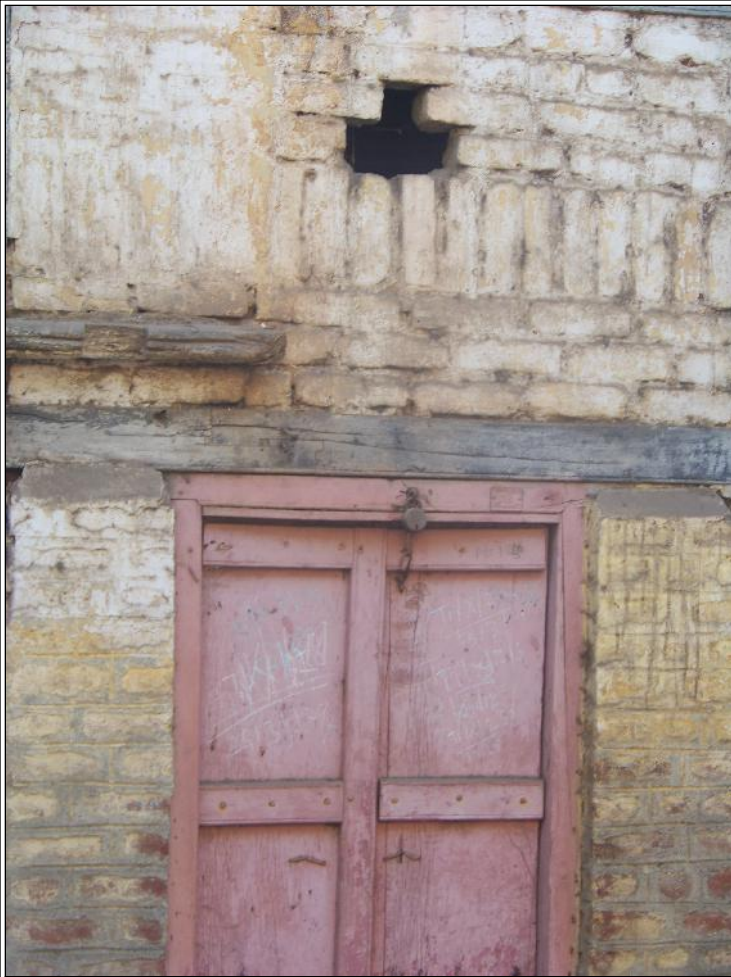
Image Title: Vaidya House
Image Type: Front-View
Reference: View of the main door

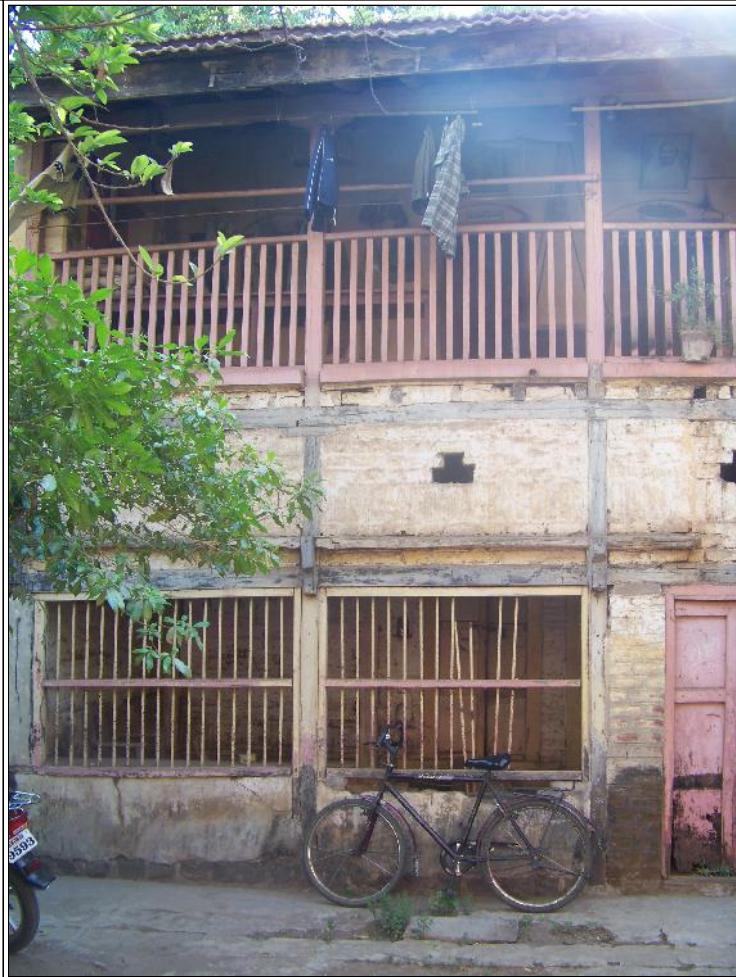
3.10	Articulation	Louvered openings, railings and eves. Patterned brickwork	Brickwork deteriorated	Minor Repair
3.11	Finishes	Plastered Painted	NA	Minor Repair

Image Title: Vaidya House
Image Type: Top-View
Reference: Close up of the front facade

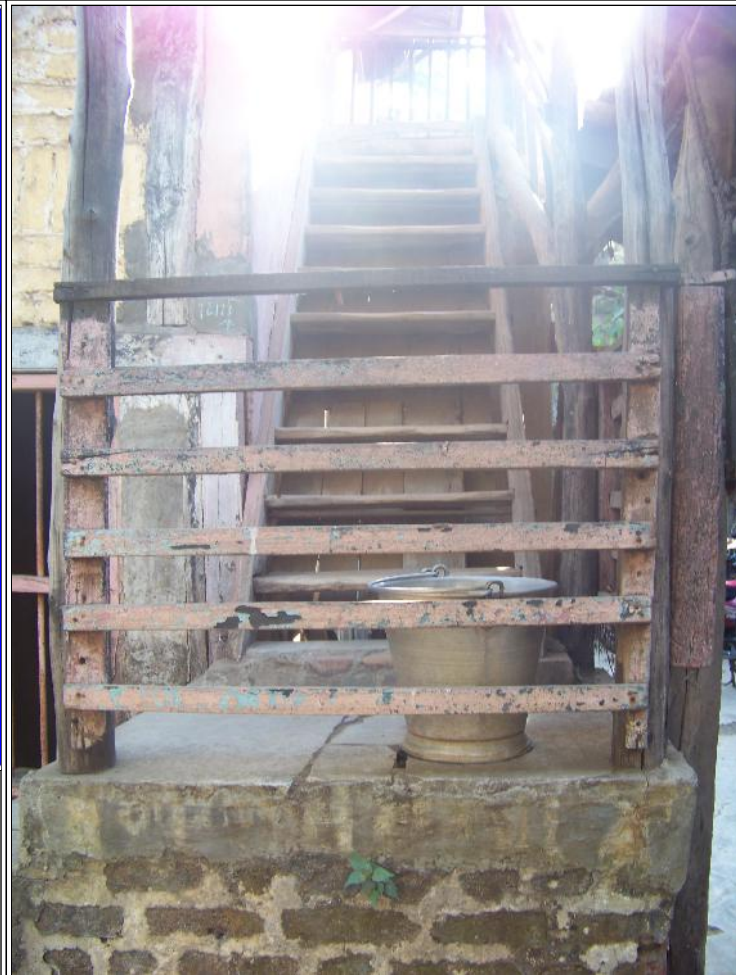
3.06	Floors	Timber floor, interior floor, interior flooring replaced with tiles.	Timber deterioration due to moisture	Minor Repair
3.07	Stairs	Timber Stairs	Weekened due to deterioration	Minor Repair

Image Title: Vaidya House
Image Type: Front-View
Reference: View of the outside staircase
