# GUIDELINES FOR SHIVAJI PARK HERITAGE PRECINCT

for  
MMR-Heritage Conservation Society

Final Report  
April 2014

Consultants

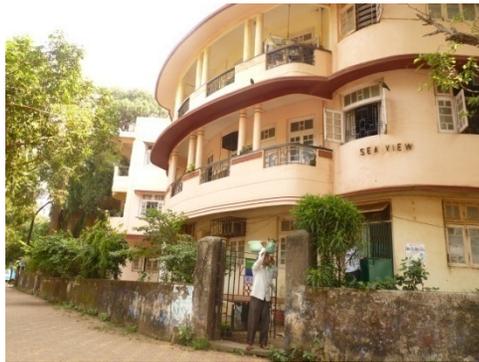
Good Precinct character

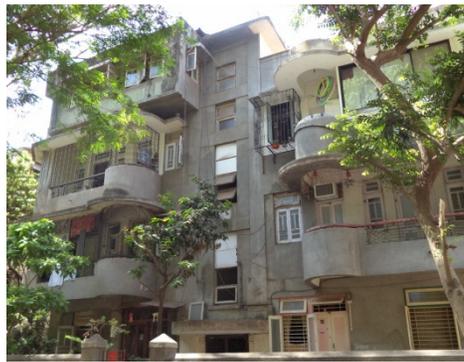
Fair Precinct character

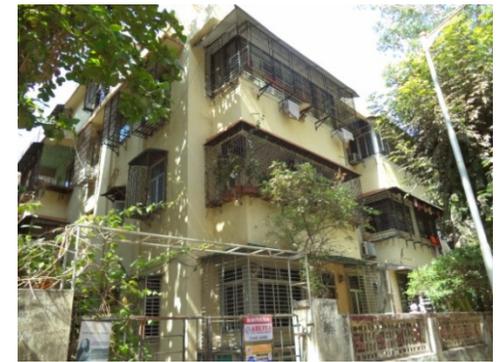
Basic Precinct character

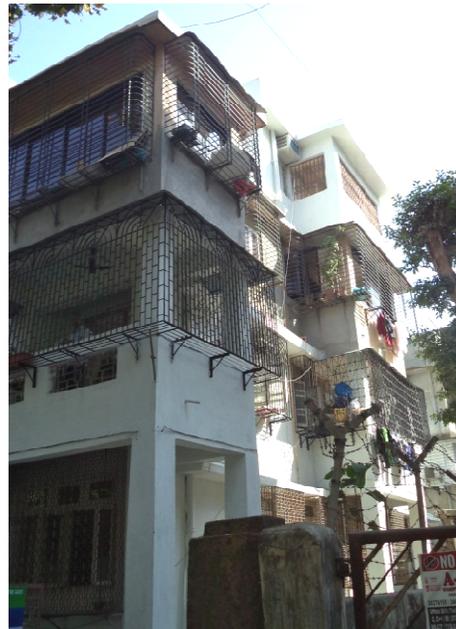
**Modifications**  
Grills added

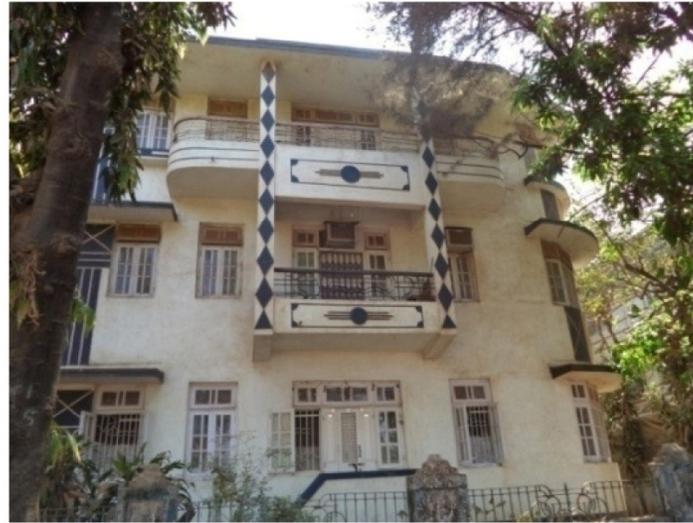
INNER RING : Cts.1788

Category of “Good” precinct character

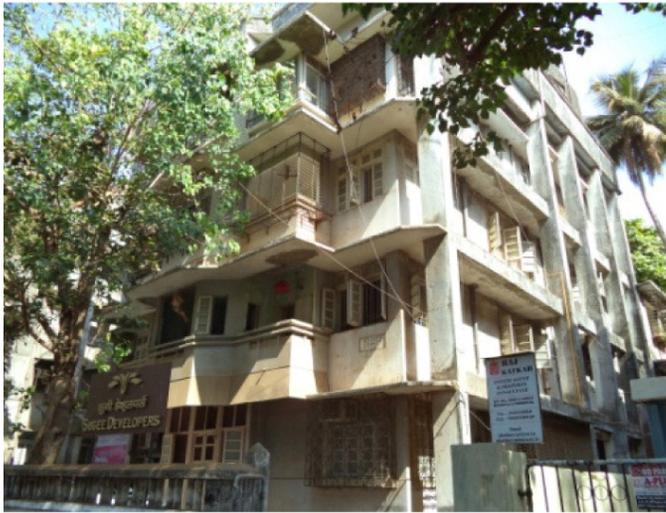
INNER RING : Cts.1774

Category of “Fair” precinct character

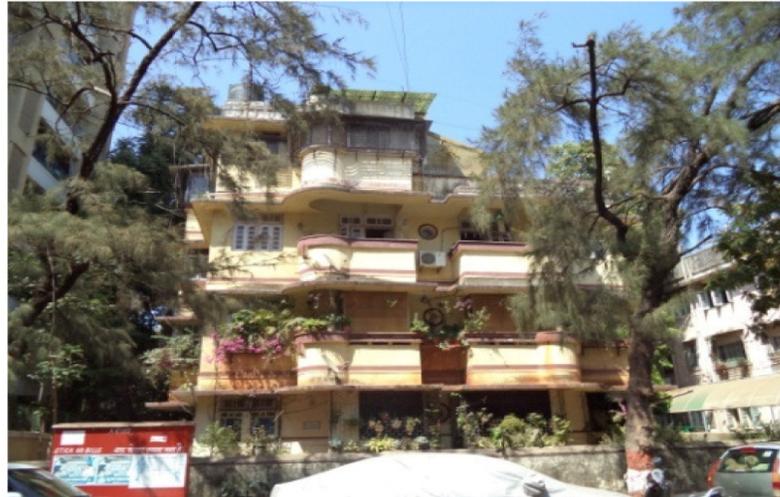
OUTER RING : Cts. 1807

Category of “Good” precinct character

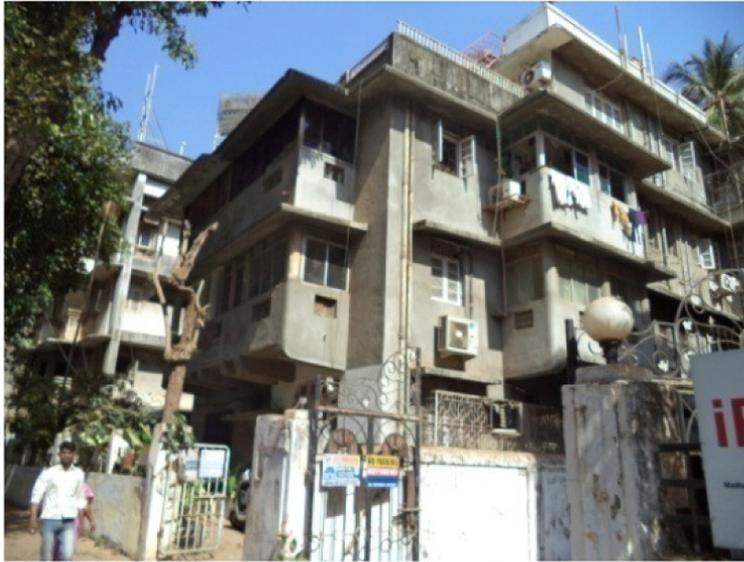
INNER RING : Cts.1776

# Category of "Basic" precinct character

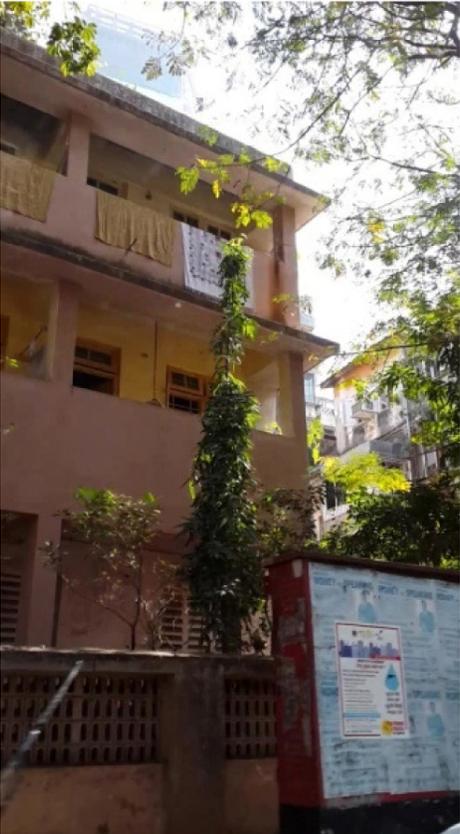
MIDDLE RING : Cts-1824

Category of "Basic" precinct character

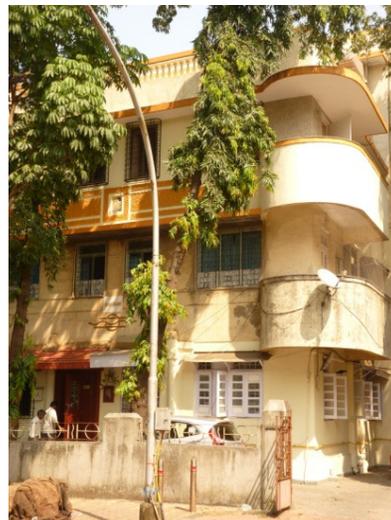
Front view - Additional floor not visible from the road, keeping the streetscape

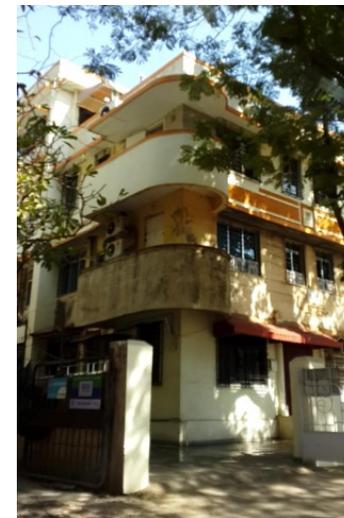
Side view - Additional floor seen having a setback

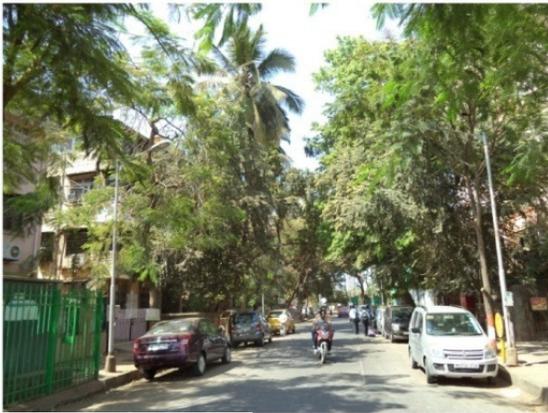
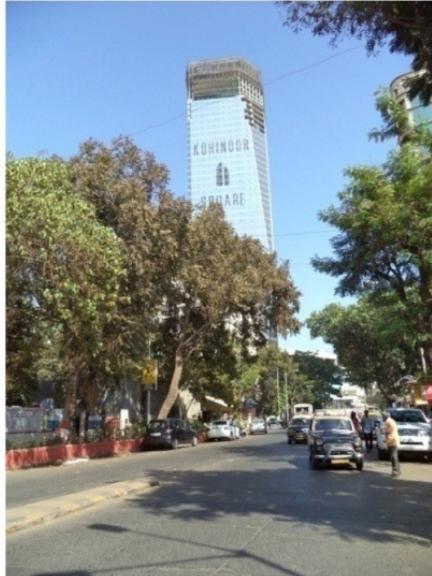
Vegetation

The green cover is provided by the trees planted along the streets to create shaded avenues in the Precinct. However Keluskar Road North and South and M.B. Raut Road is disturbed in the stretches where new high rise buildings are constructed. The vegetation appears to be very less near these high rise buildings as seen below.

Loss of greenery is evident in stretches which have newly constructed buildings.

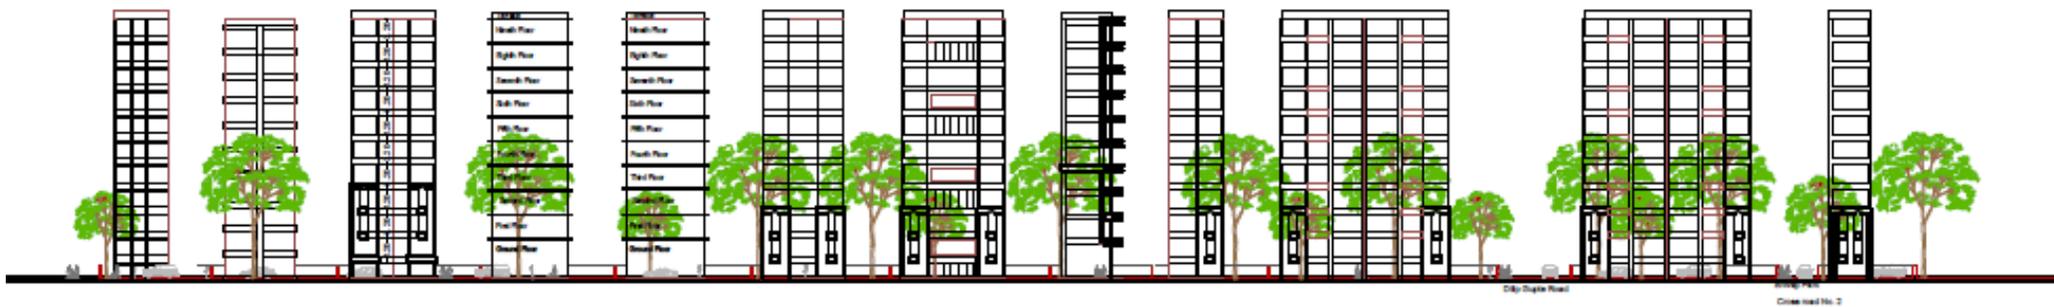
Schematic Section showing Undesirable effect to the Elevation if higher Reconstruction is allowed.
